Building at Risk:

A Historic Structure Report for Bostwick in Bladensburg, MD

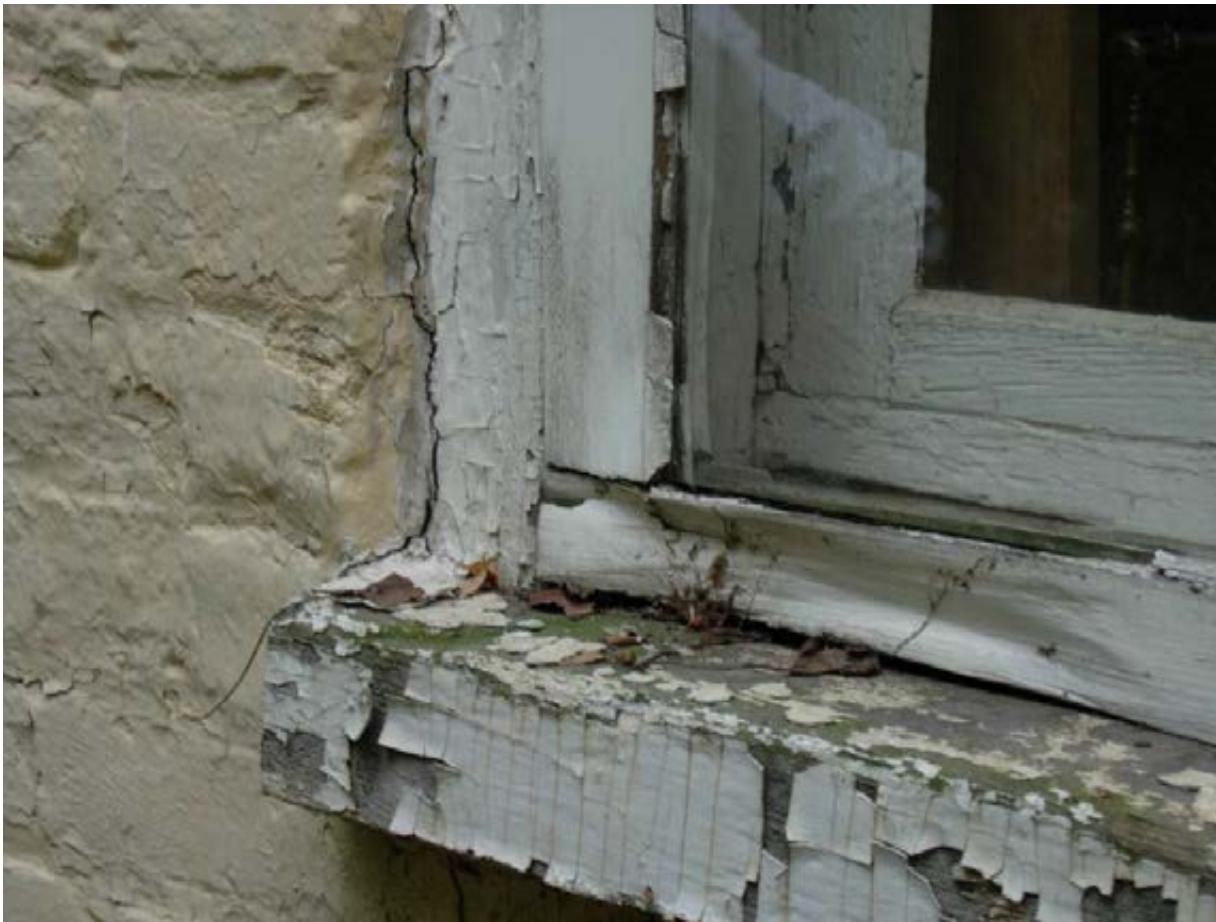
Figure 3-18. Failing paint and rot on the east façade's northern window in the Stoddert addition. Photograph by Kathleen Manicke.

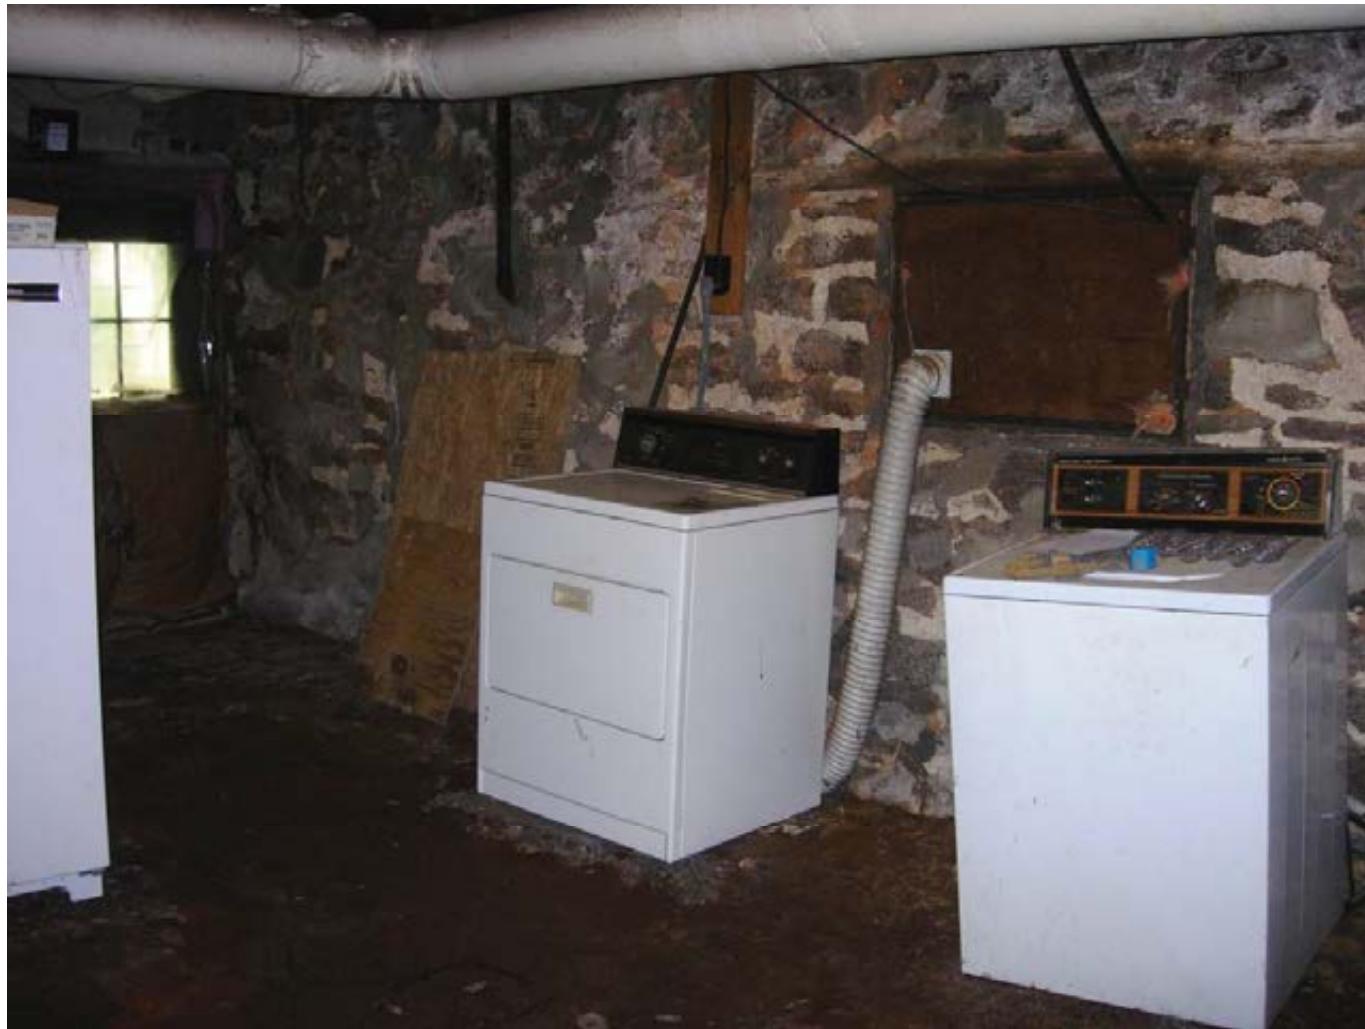
Figure 4-3. The west wall of the south bay in Bostwick's basement. The window sash has been removed and a dryer vent added. Notice the inappropriate repointing and parging of the stonework. Photograph by Kathleen Manicke.

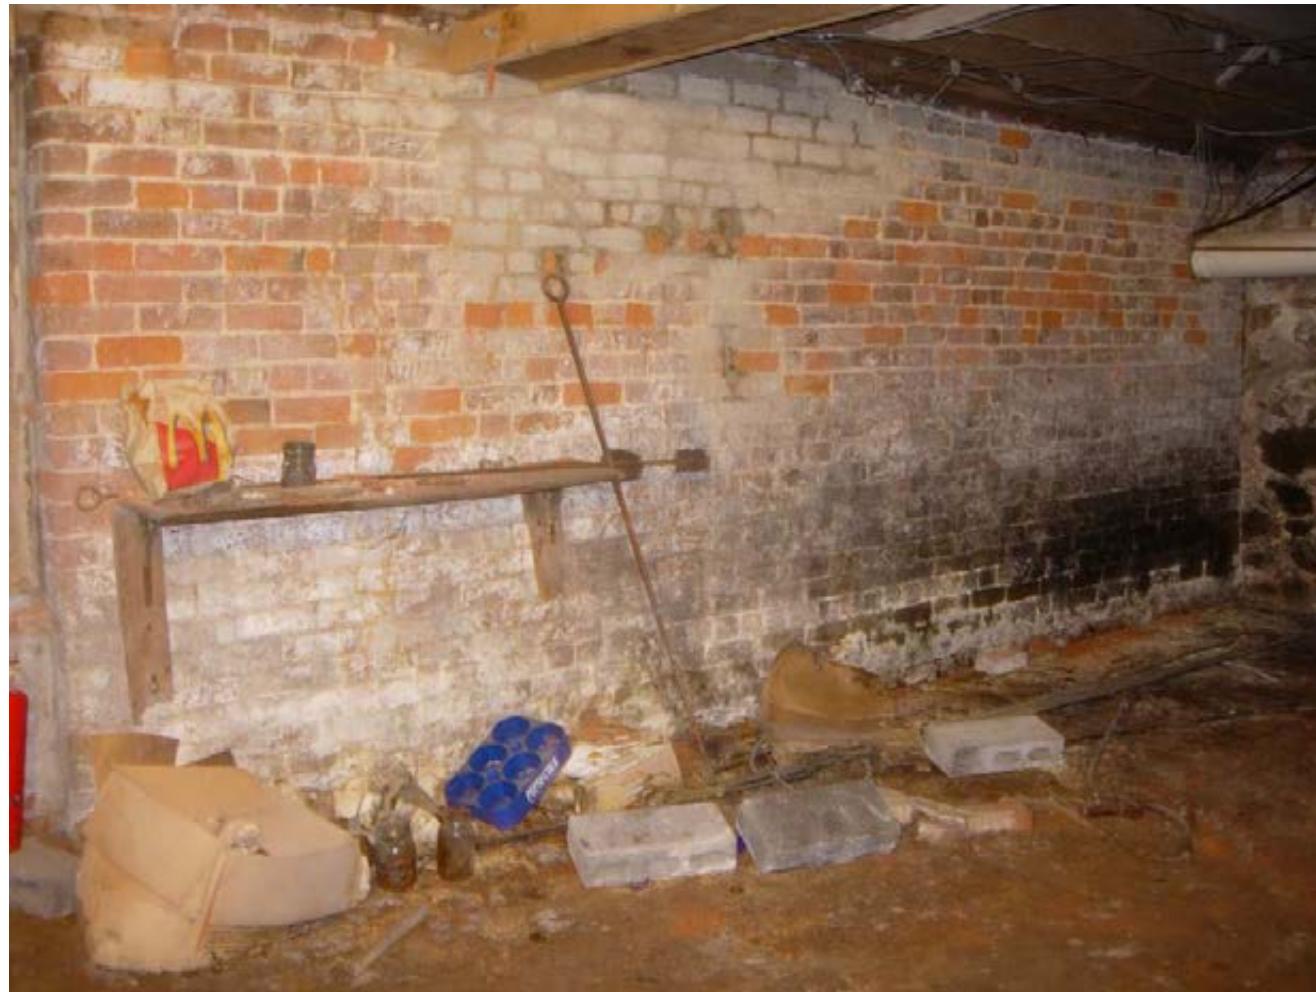
Figure 4-4. The north wall of the basement's south bay. The dark area on the wall is mold resulting from the damp conditions caused by moisture infiltration into the basement. Also notice the parged areas. Photograph by Kathleen Manicke.

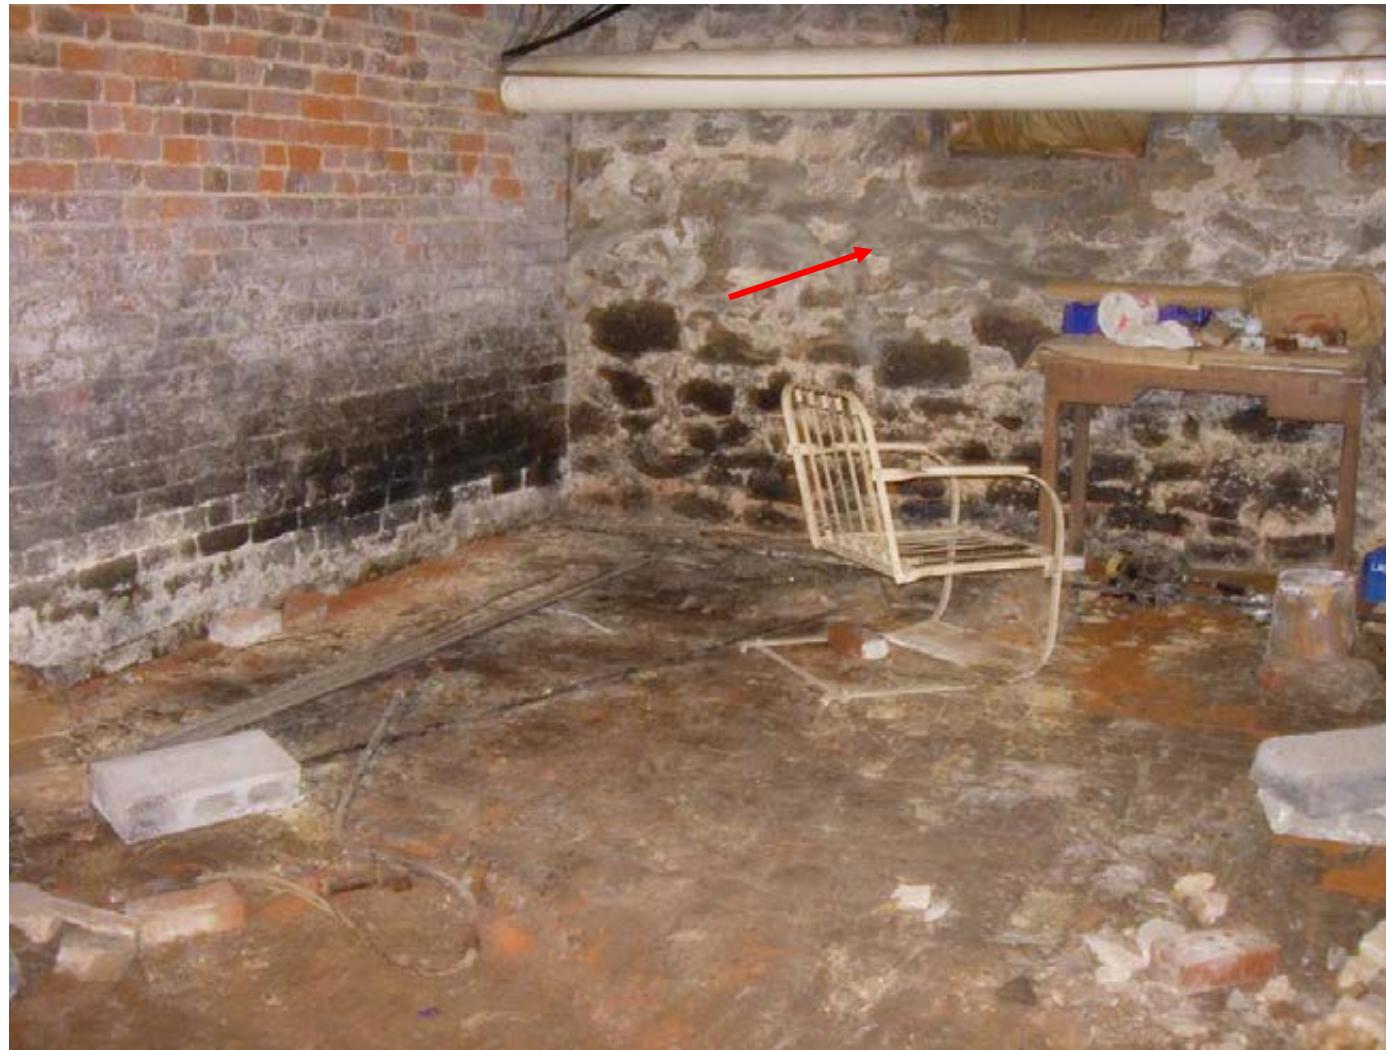
Figure 4-7. The northeast corner of the south bay. The east wall is constructed of stone, and its lower half has significant mold growth. The window (red arrow) is largely obscured by the piping for the steam heat system. Photograph by Kathleen Manicke.

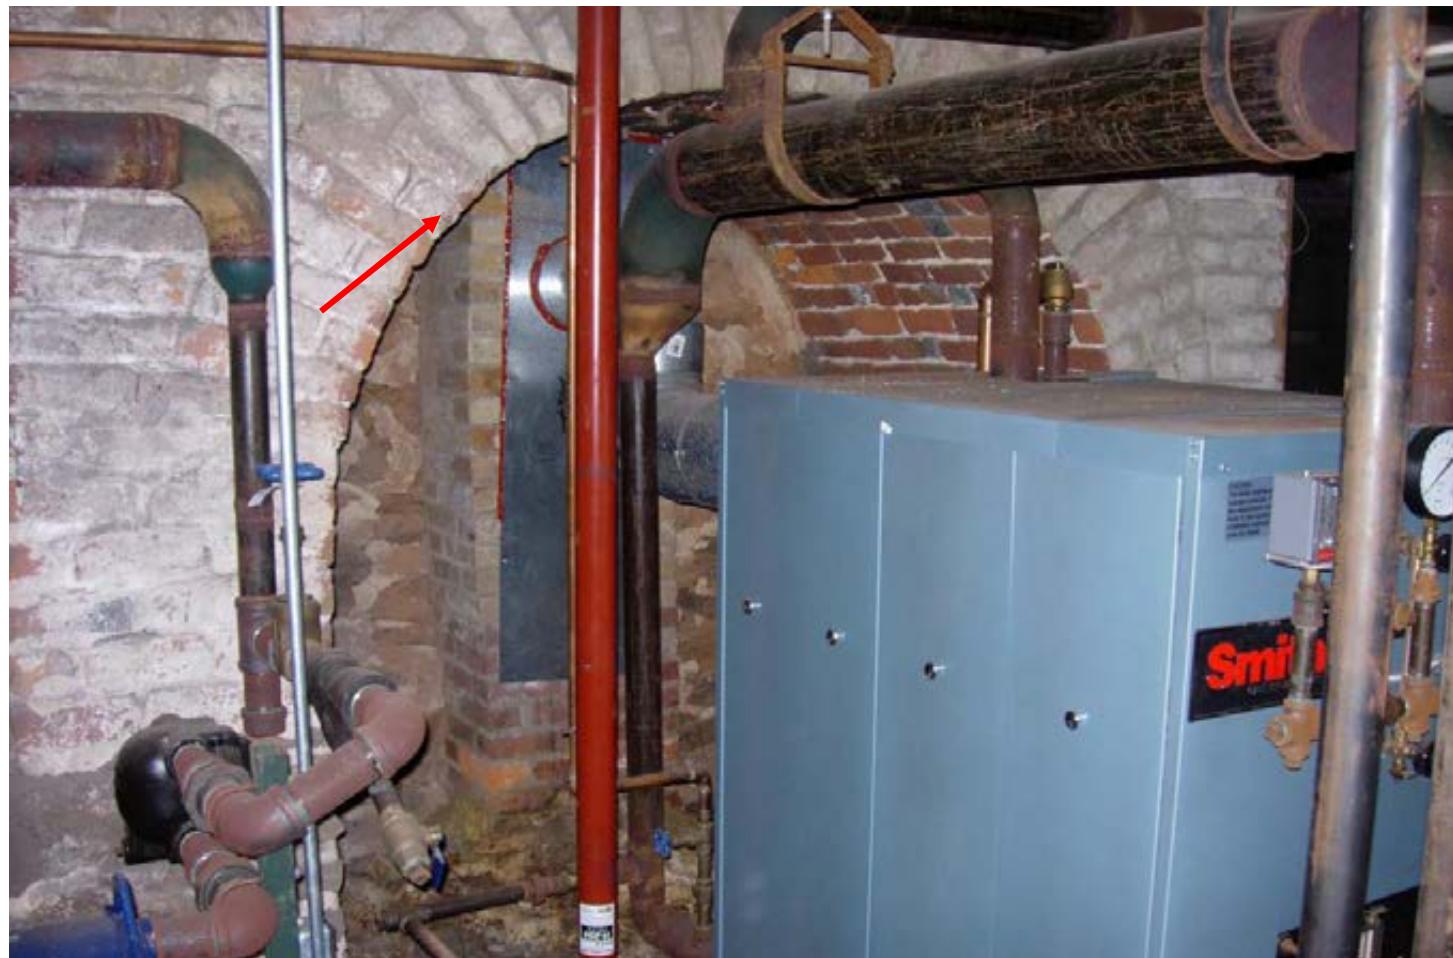
Figure 4-8. The strength of the relieving arch on the south wall of the south bay has been compromised by the opening cut for the furnace's flue (red arrow). Photograph by Kathleen Manicke.

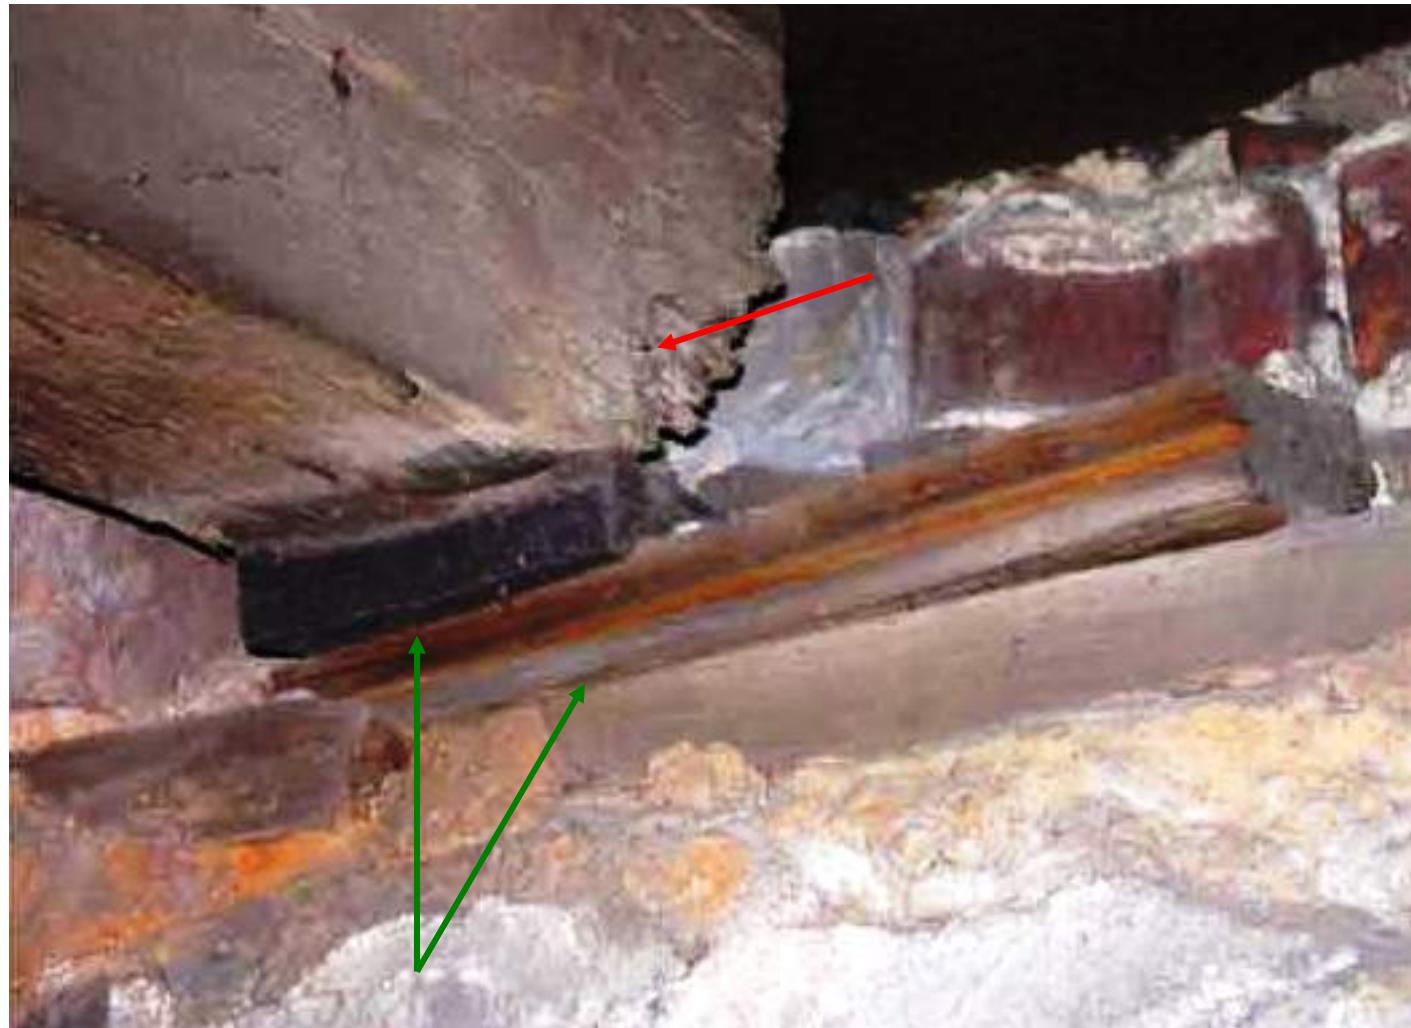
Figure 4-9. The joist ends that rest on the east wall of the south bay have largely rotted away (red arrow). Many now rest on small blocks of wood (green arrows). Photograph by Kathleen Manicke.

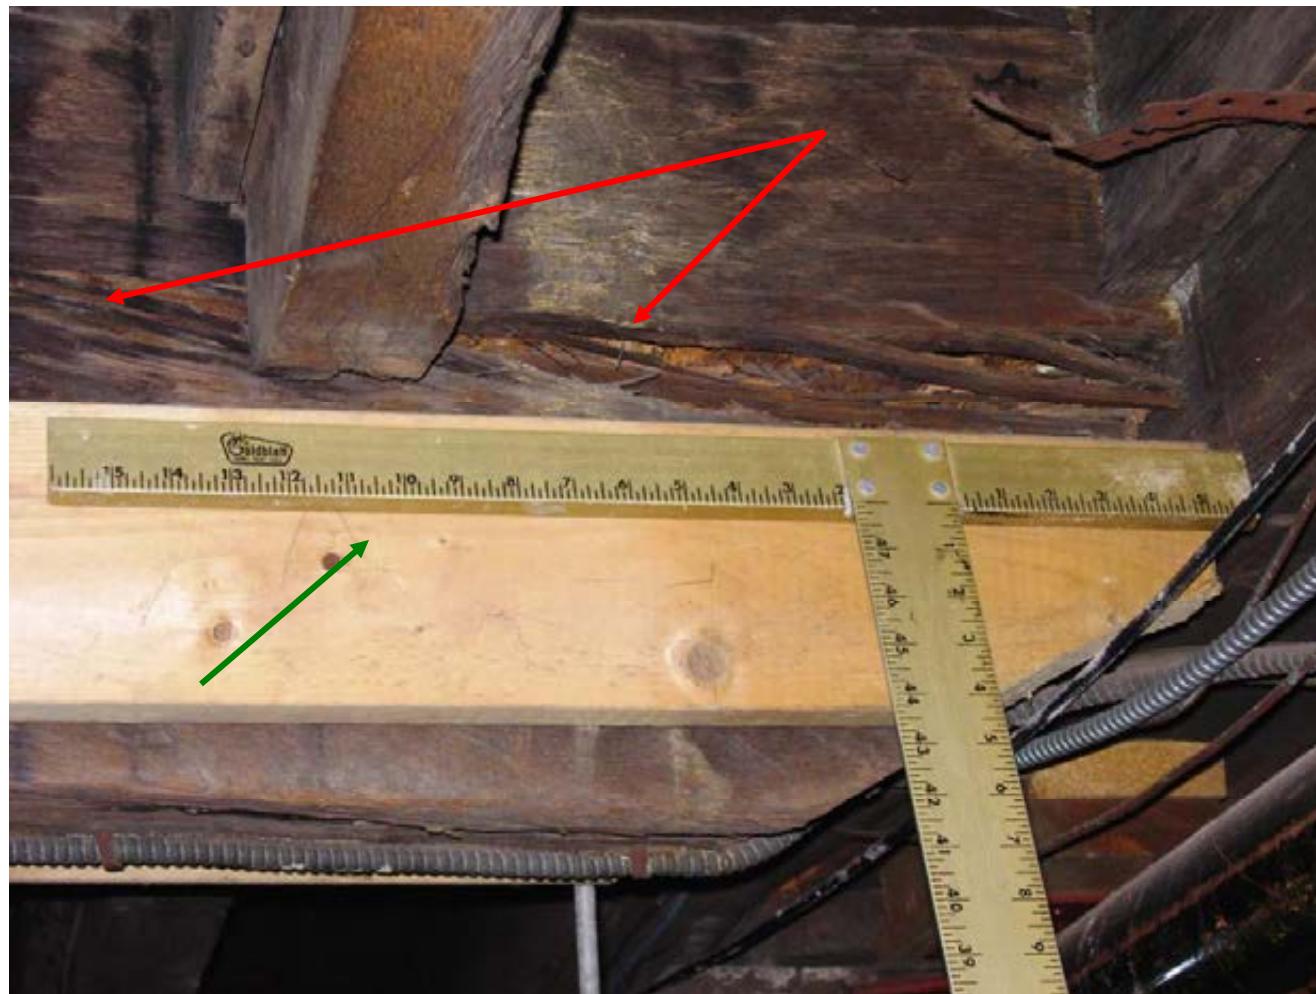
Figure 4-10. The large summer beam in the south bay of the basement has cracked (red arrows). The sistered 2" x 6" fails to support the cracked area resulting in less strength (green arrow). Photograph by Kathleen Manicke.

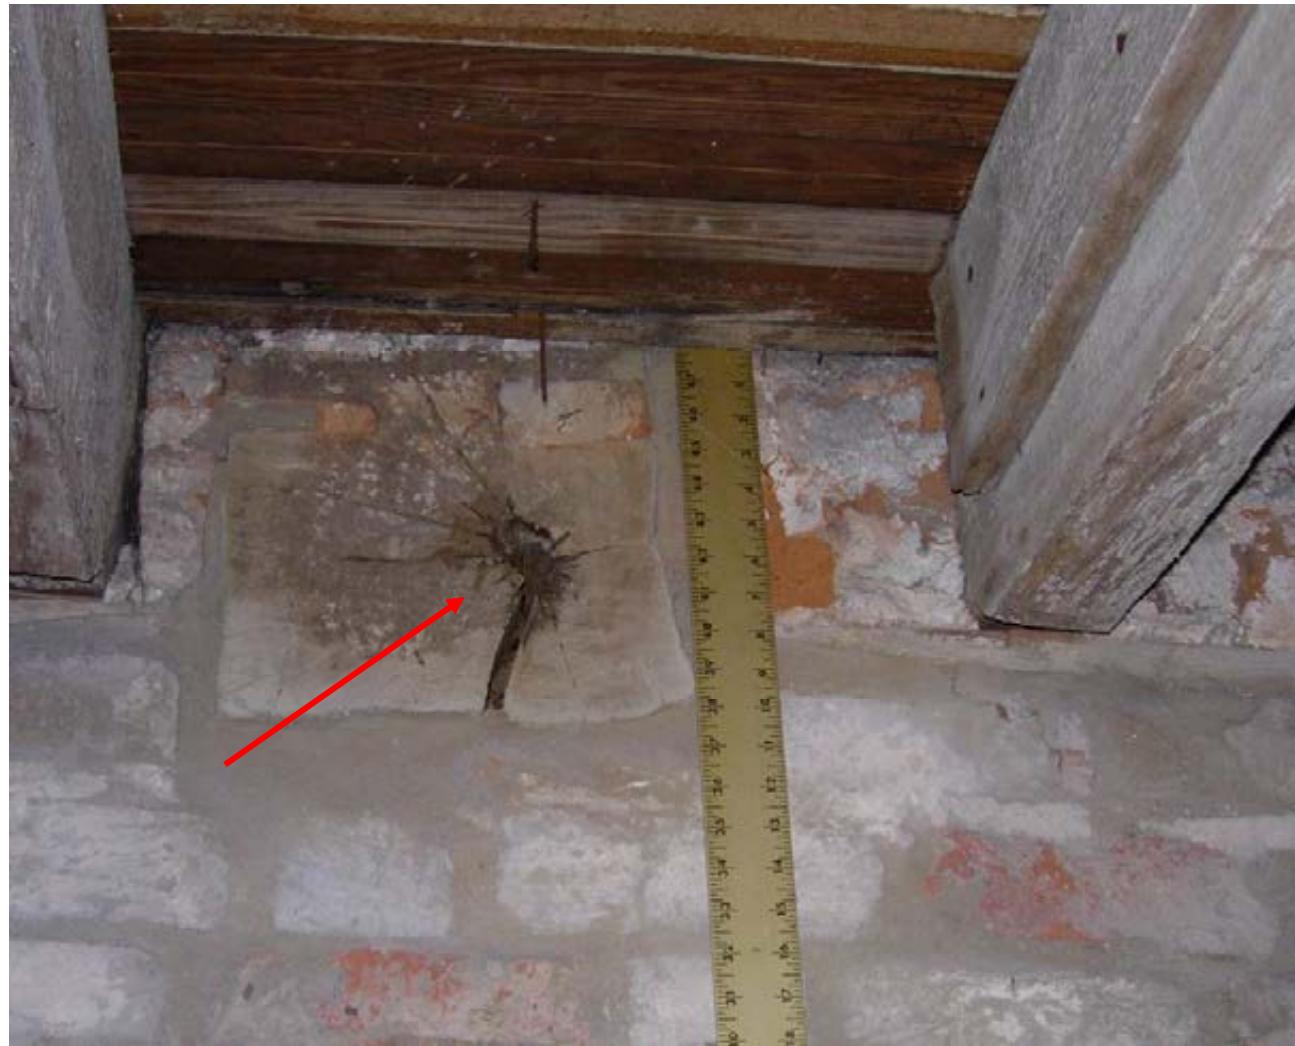
Figure 4-11. The end of the summer beam showing a rotten area at its center that was probably there when the house was constructed (red arrow). Photograph by Kathleen Manicke.

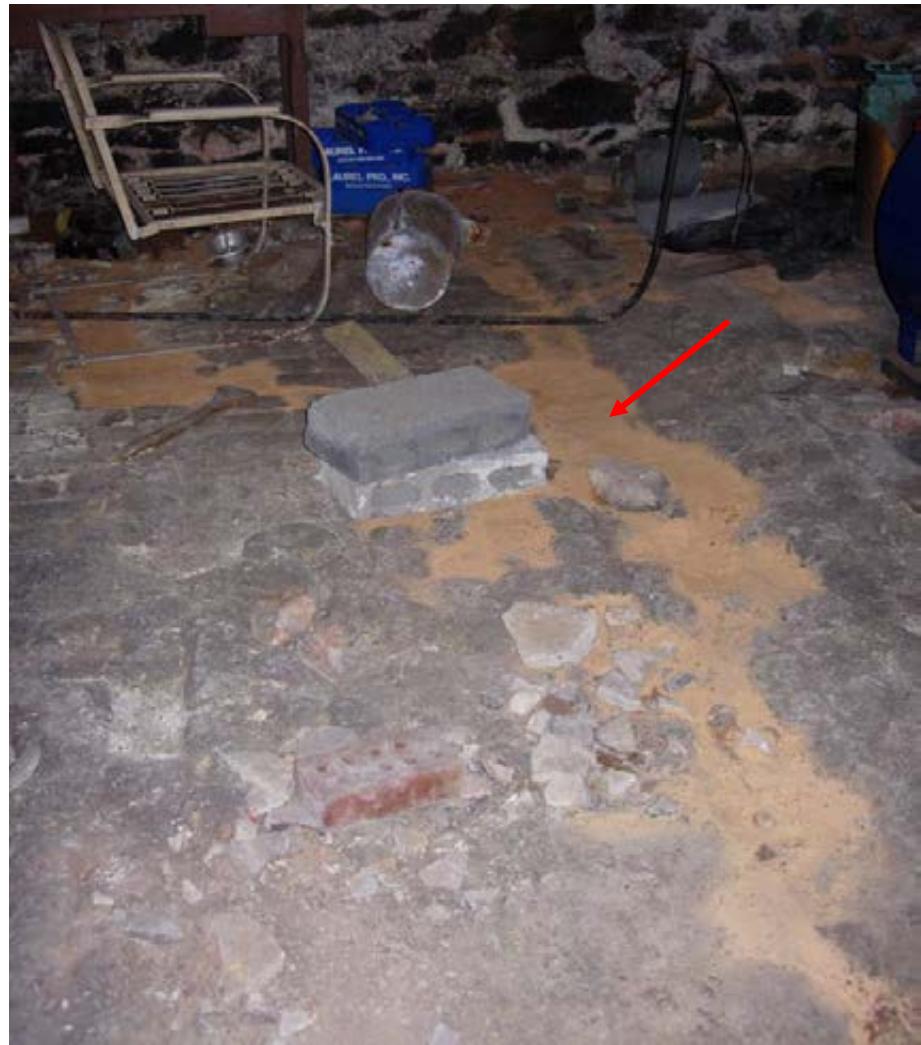
Figure 4-12. Path of water caused by moisture infiltration across the floor of the south bay from the east wall to the west wall (red arrow). This area continues to be damp. Photograph by Kathleen Manicke.

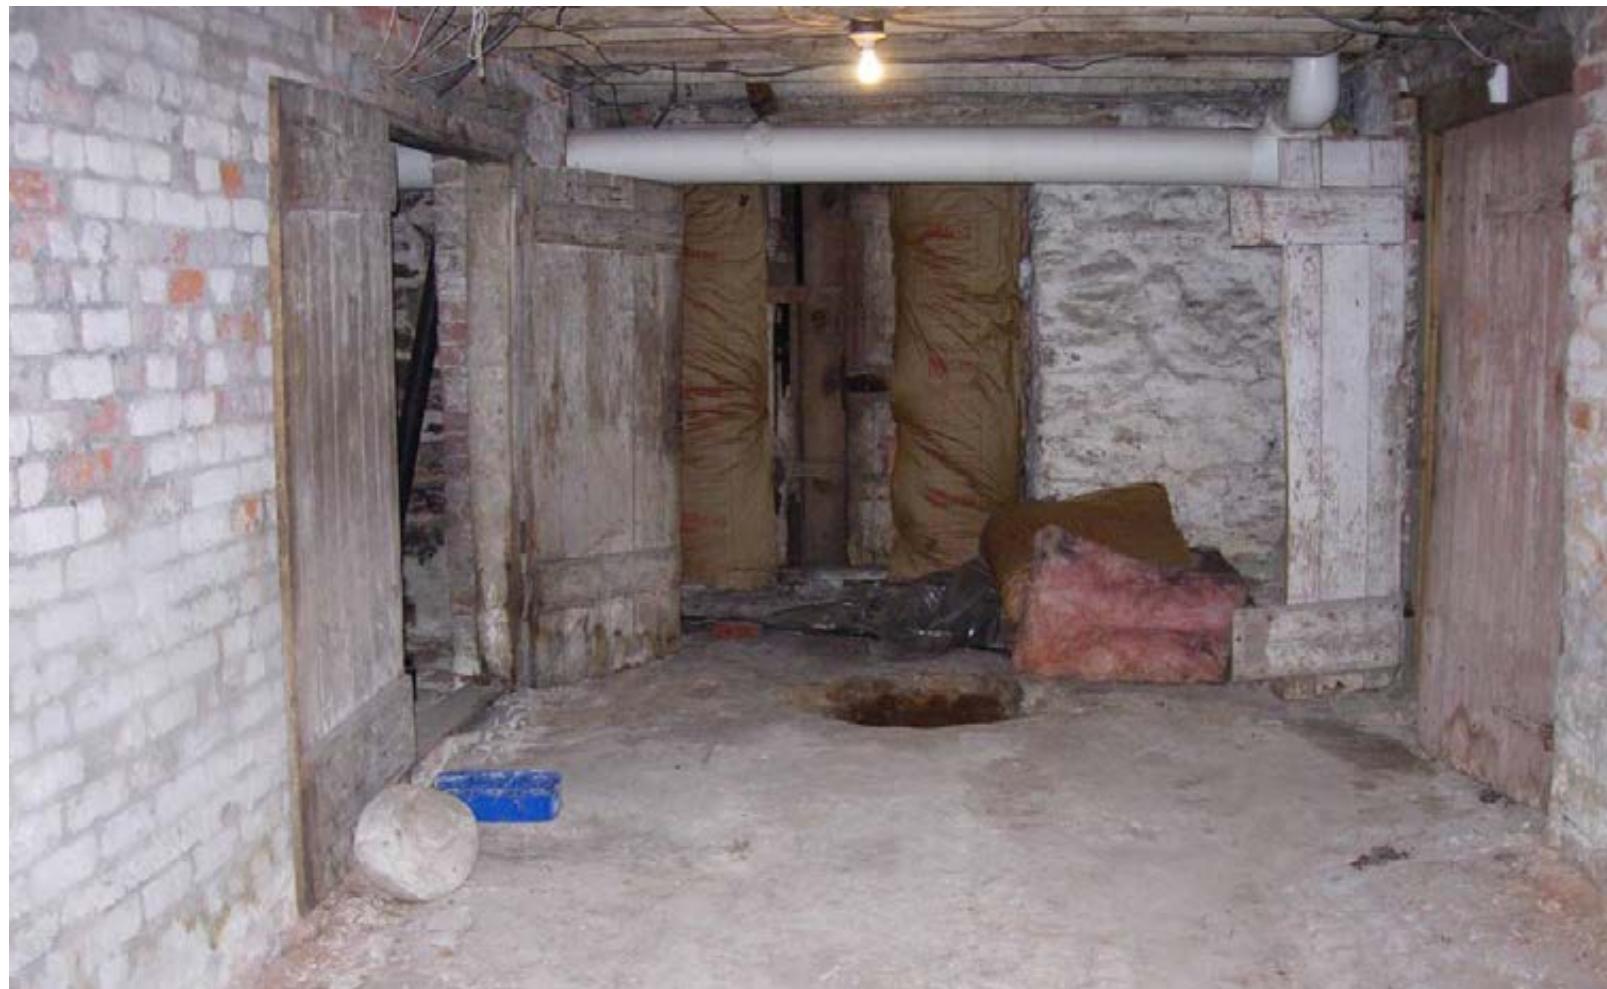
Figure 4-14. The central bay of Bostwick's basement looking toward the west wall. Notice the paring of the stone wall and the large open drain in the floor. Photograph by Kathleen Manicke.

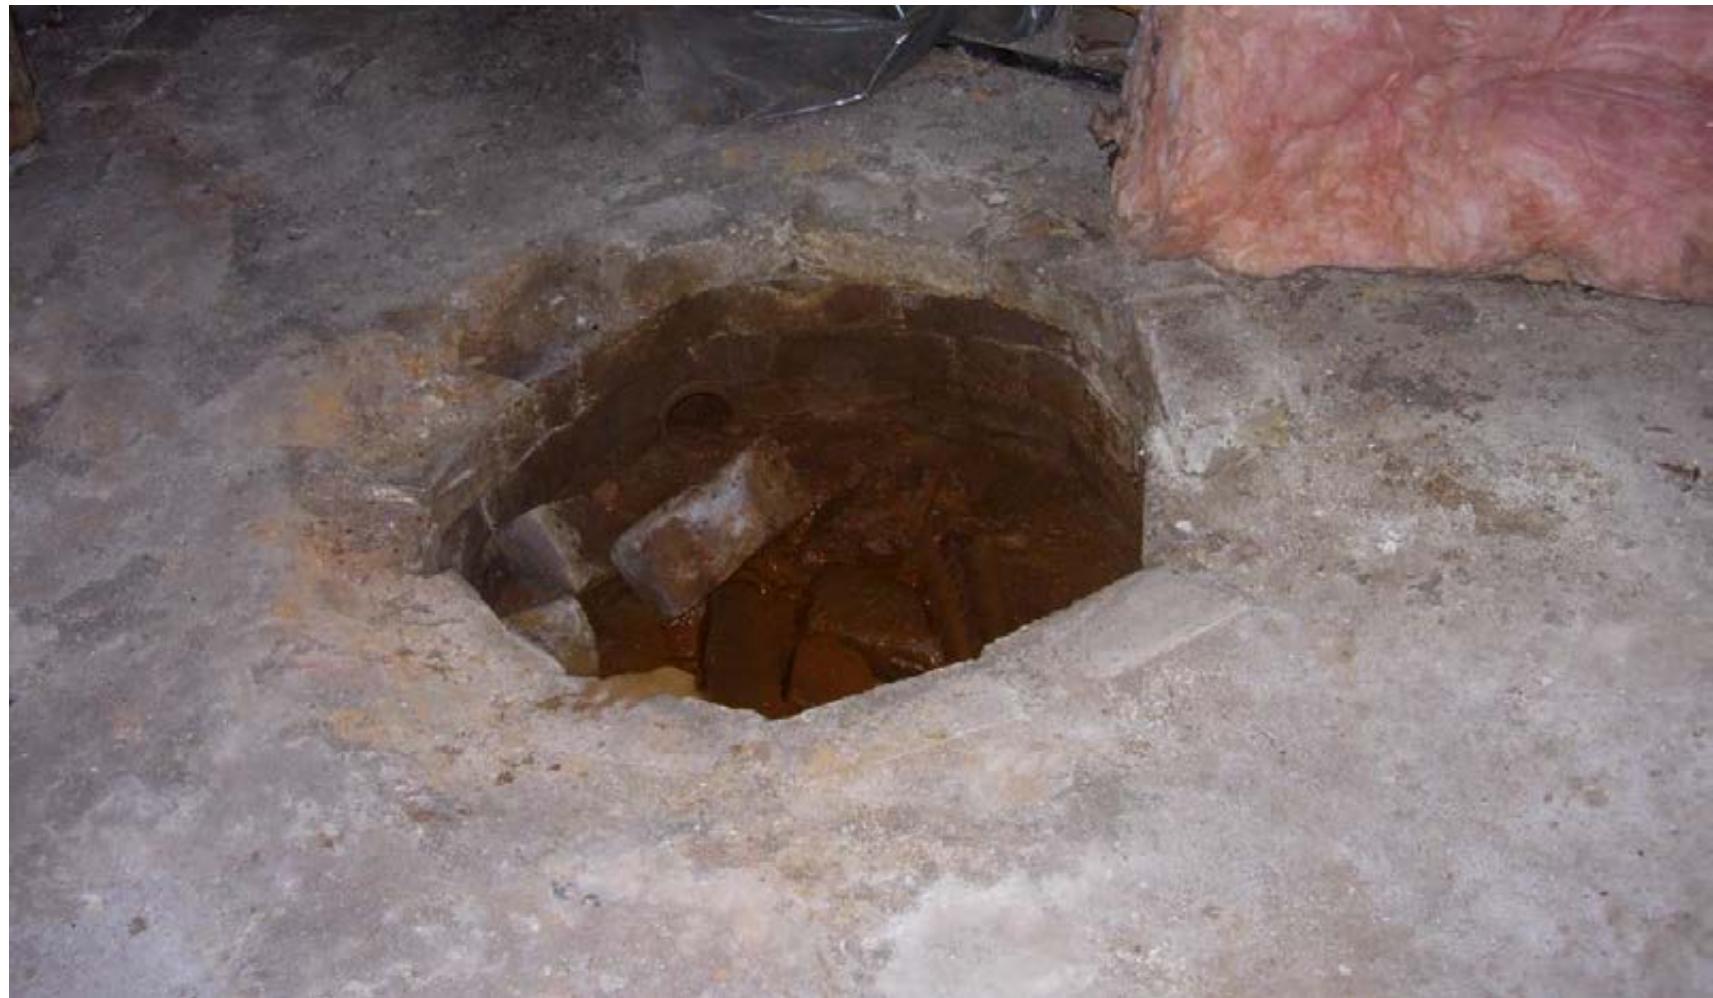
Figure 4-18. The large brick-lined floor drain in the central bay. Notice the uneven surface of the floor itself. Photograph by Kathleen Manicke.

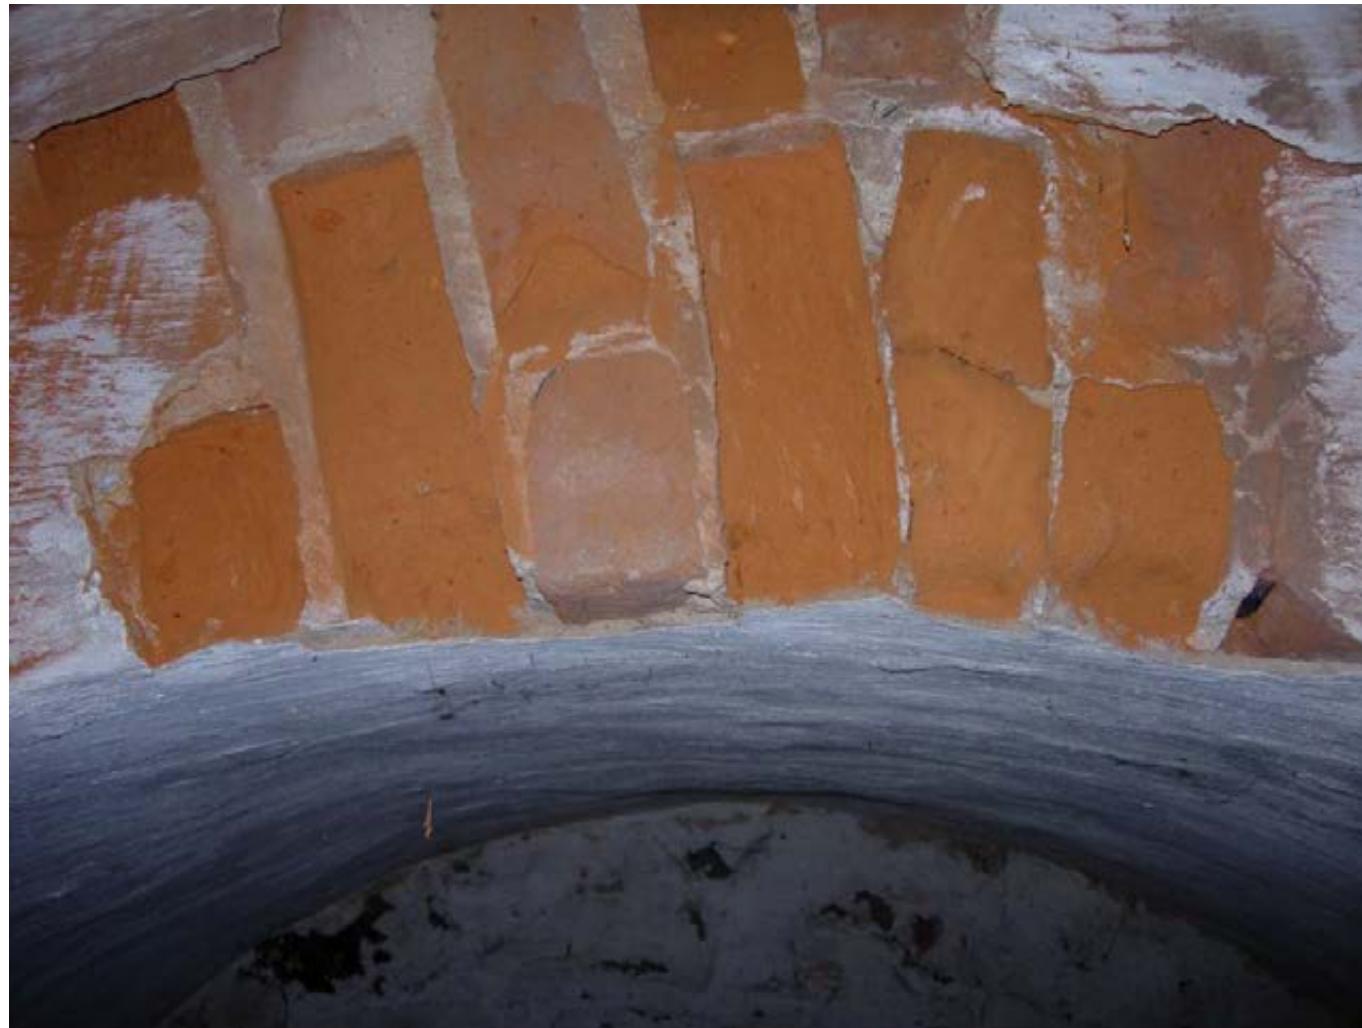
Figure 4-22. The spalling at the top of the relieving arch in the west room of the basement's north bay. Spalling is only slight at this time. Photograph by Kathleen Manicke.

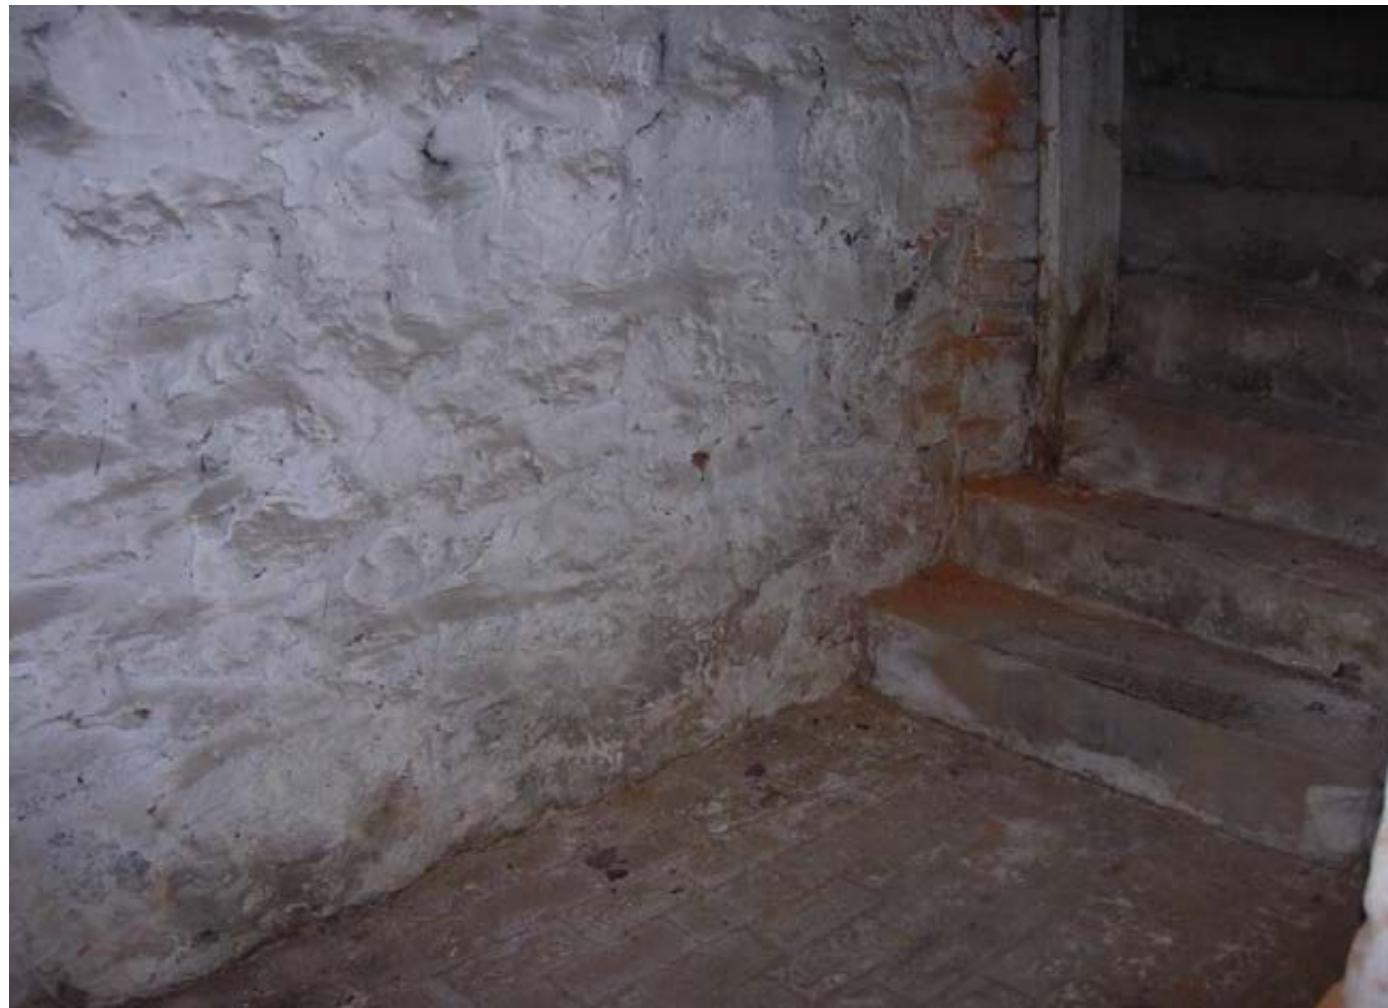
Figure 4-23. The west wall of the west room in the basement's north bay. The wall has been inappropriately treated with a waterproofing material. Photograph by Kathleen Manicke.

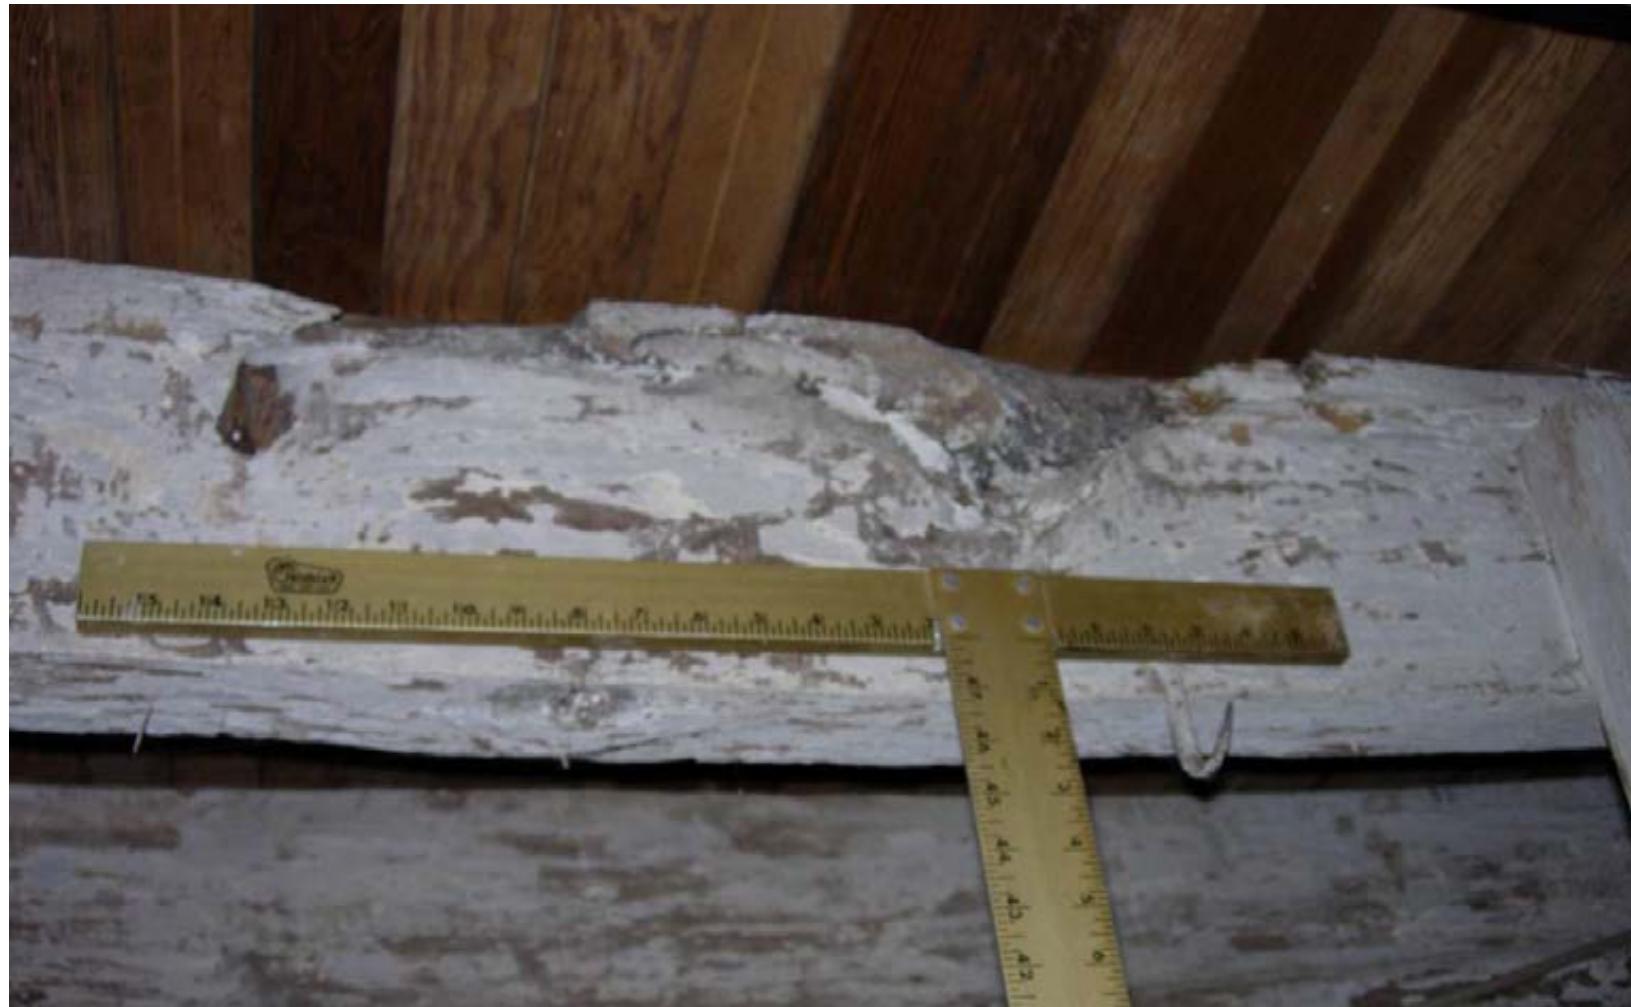
Figure 4-25. One of the joists in the west room of the basement's north bay. This joist was made from lumber containing a large knot. This has caused sagging in the joist, resulting in an uneven floor above. This joist likely dates to the construction of Bostwick in 1746. Photograph by Kathleen Manicke.

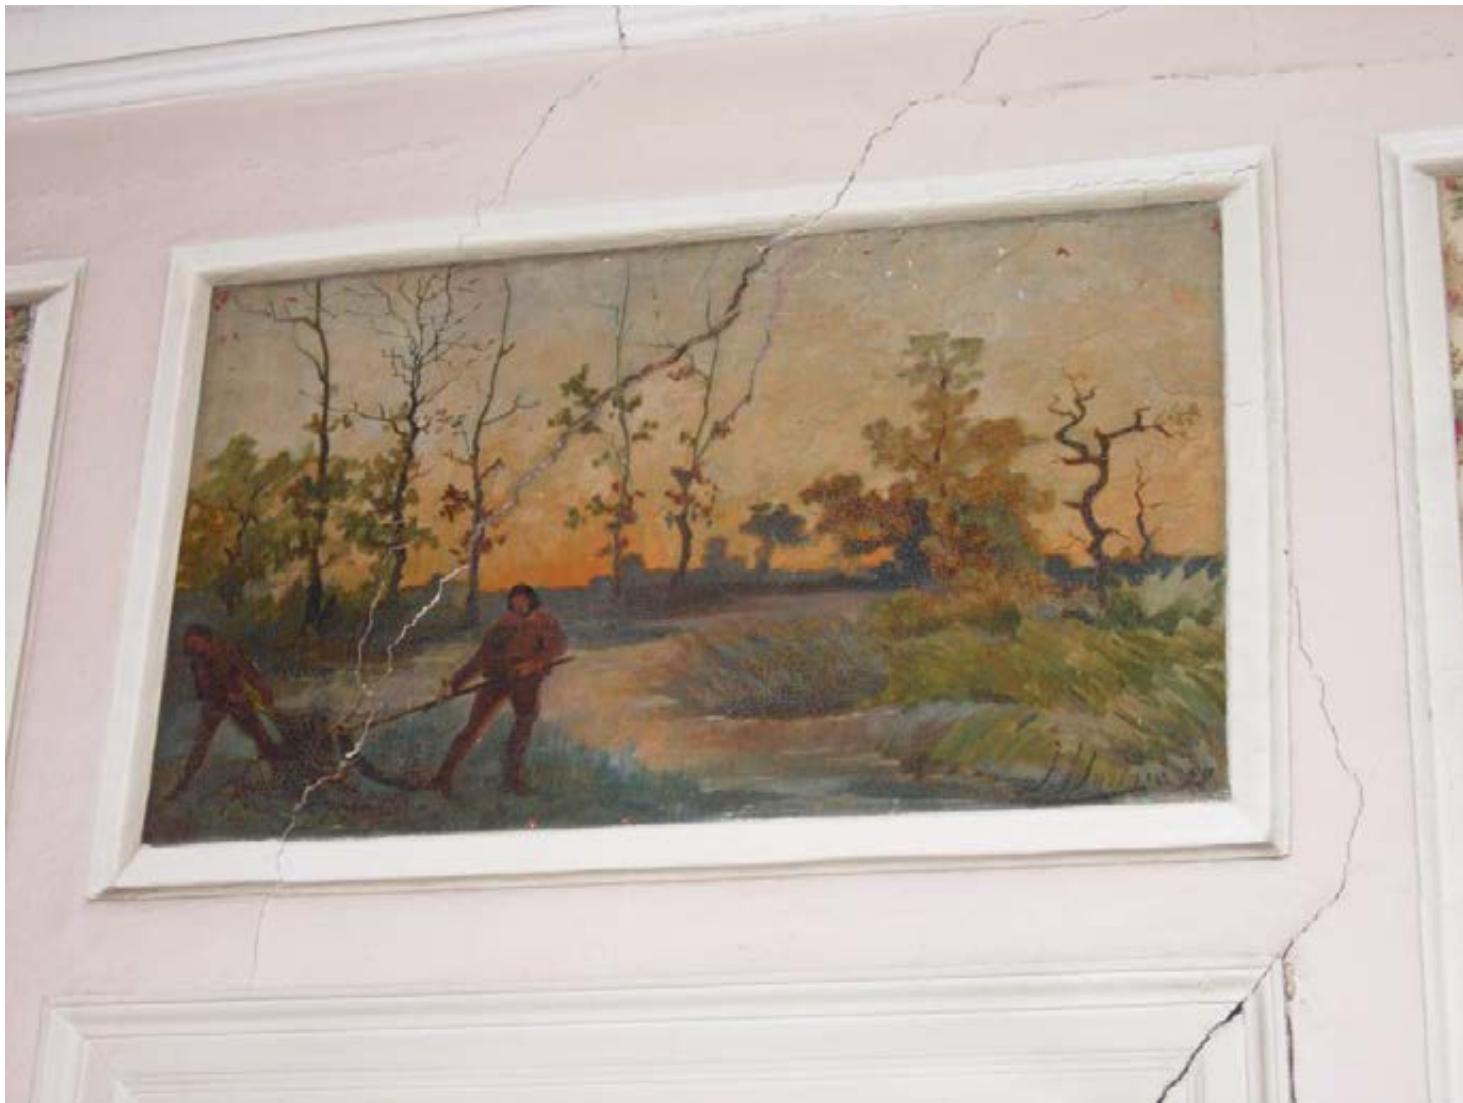
Figure 5-7. Damage to the painted panels in the south parlor. Photograph by Kathleen Manicke.
