Building at Risk:

A Historic Structure Report for Bostwick in Bladensburg, MD

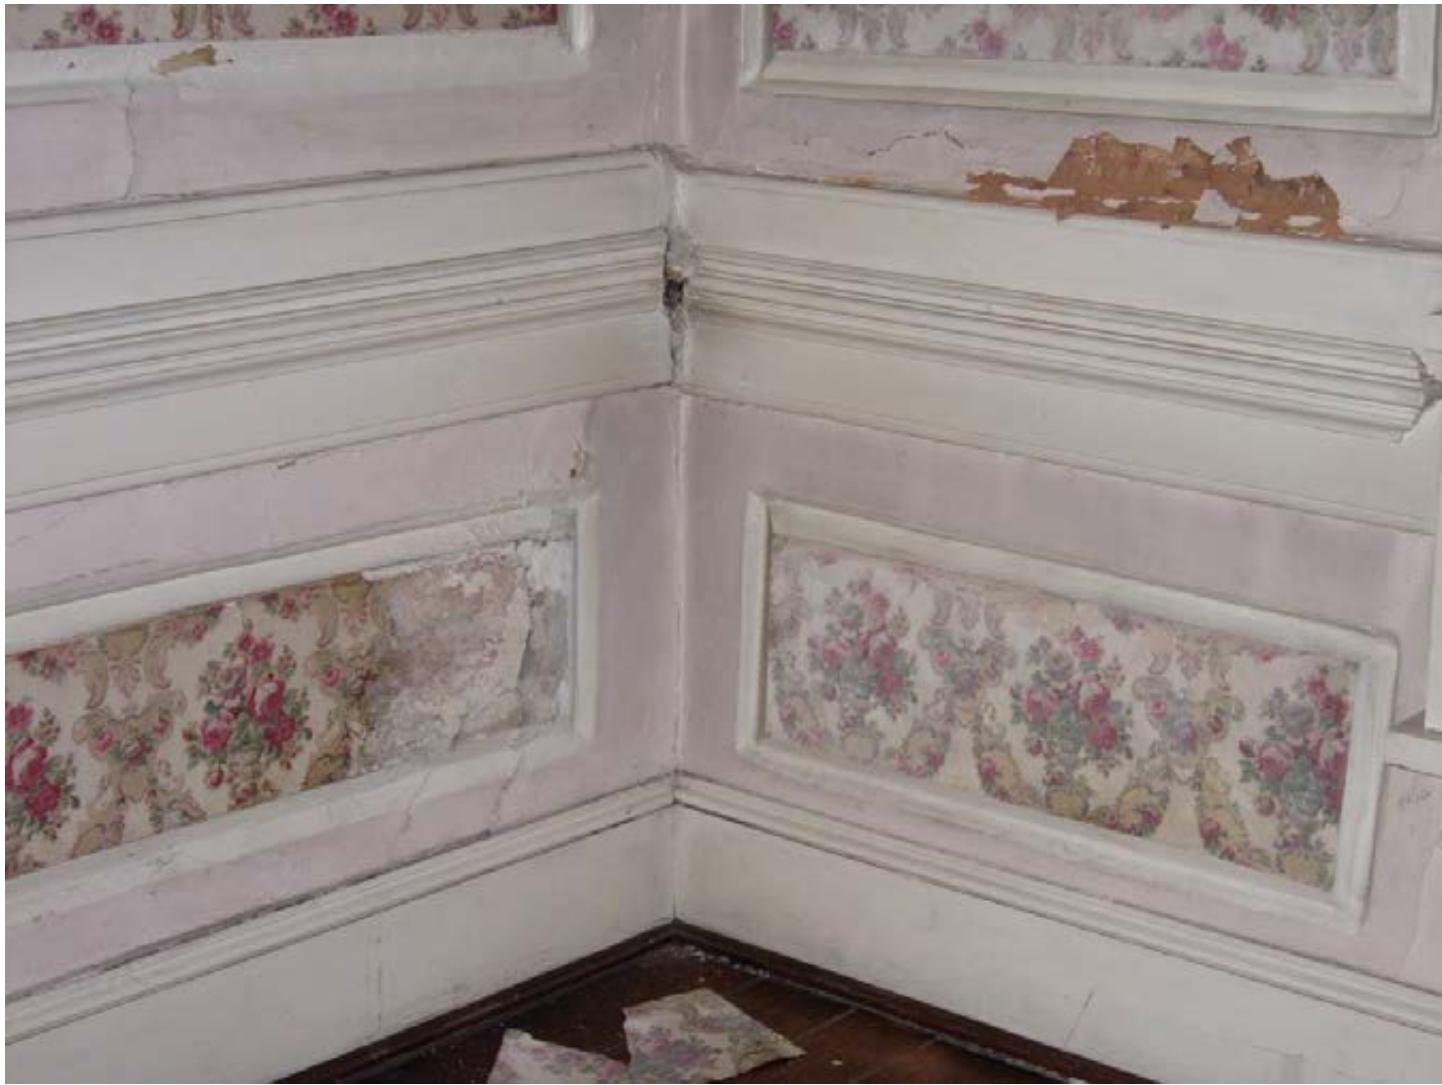
Figure 5-9. Damage from moisture infiltration at the north corner of the east wall in the south parlor. Photograph by Kathleen Manicke.

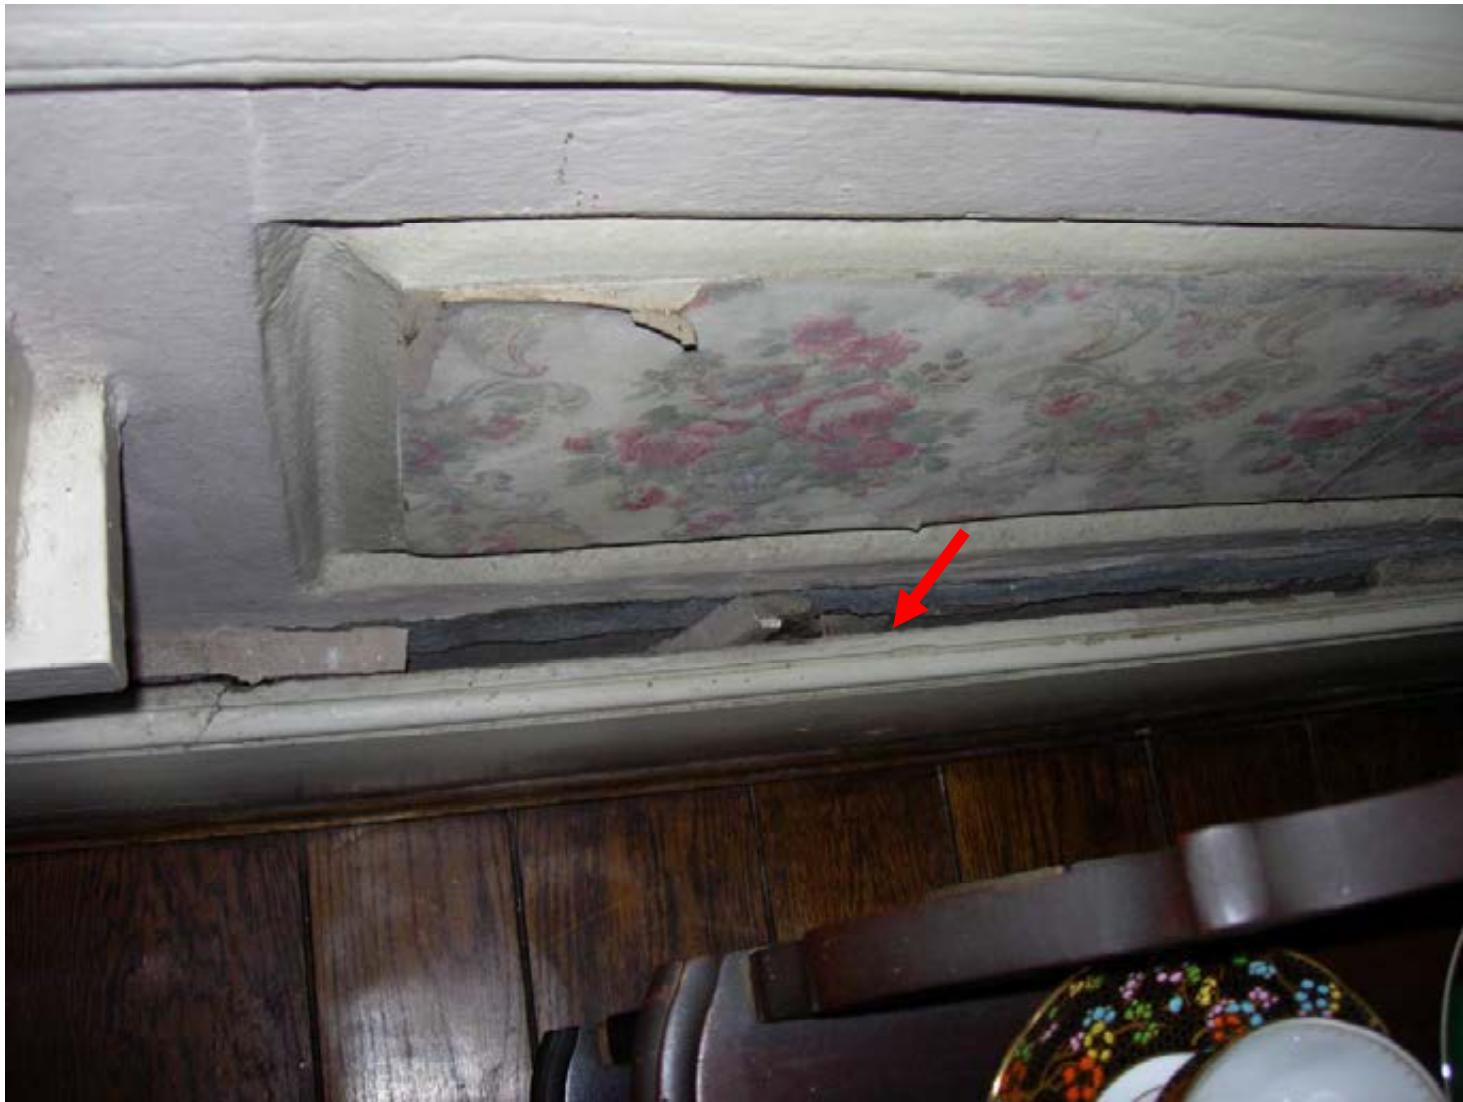
Figure 5-14. East wall damage to baseboard. Arrow points to where baseboard has pulled away from the wall. Photograph by Kathleen Manicke.

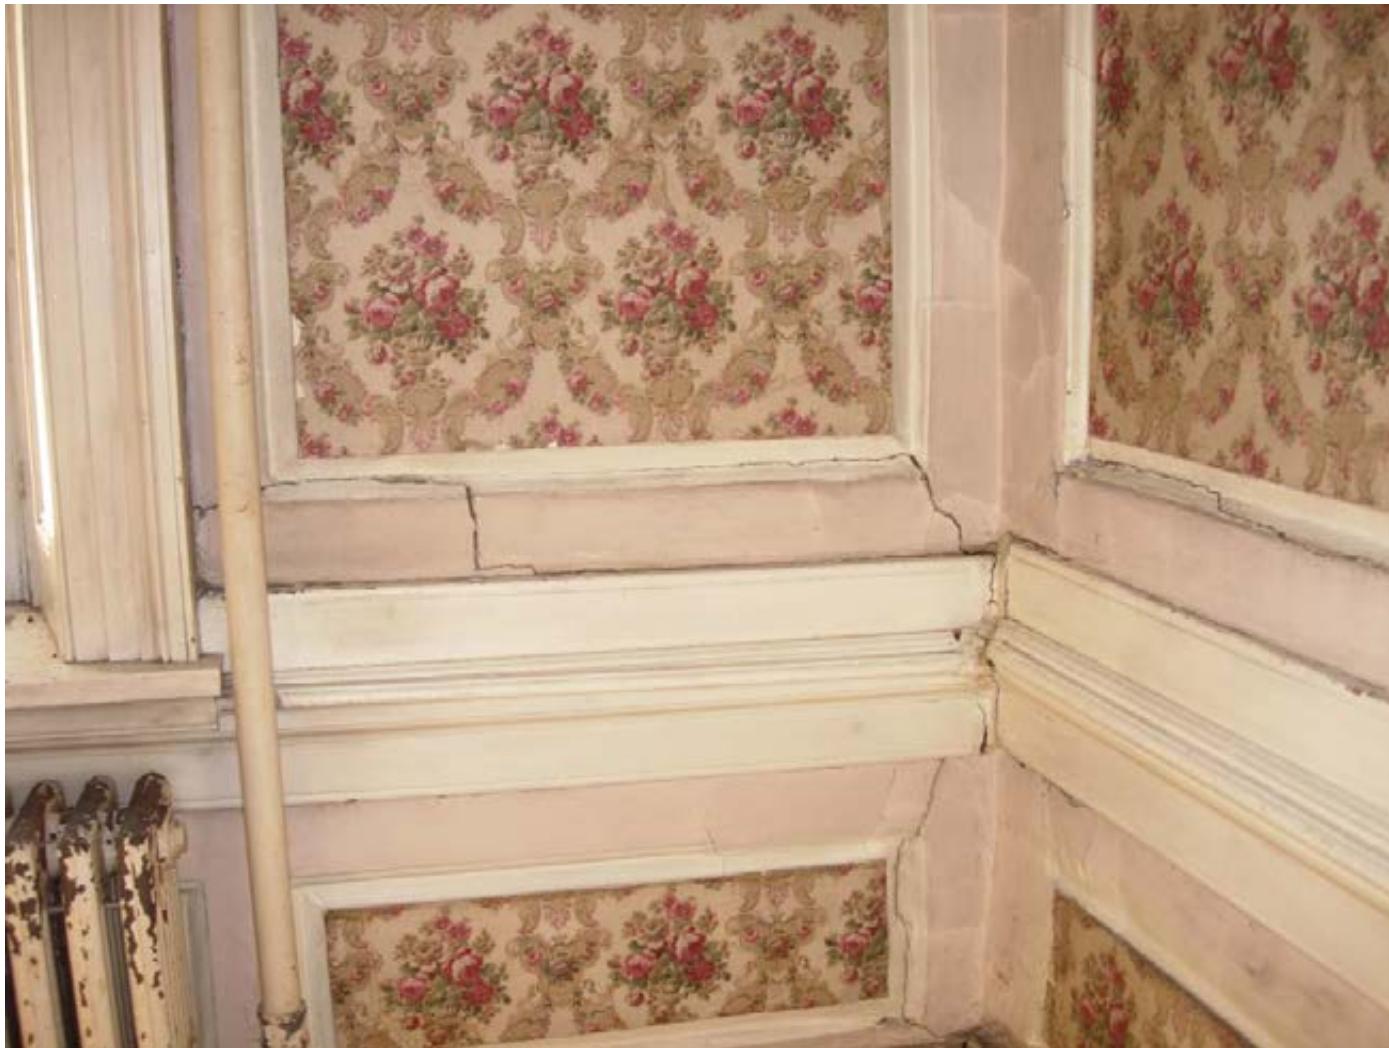
Figure 5-19. Cracking on the south wall of the parlor caused by the settling of the house at the southwest corner. Photograph by Kathleen Manicke.

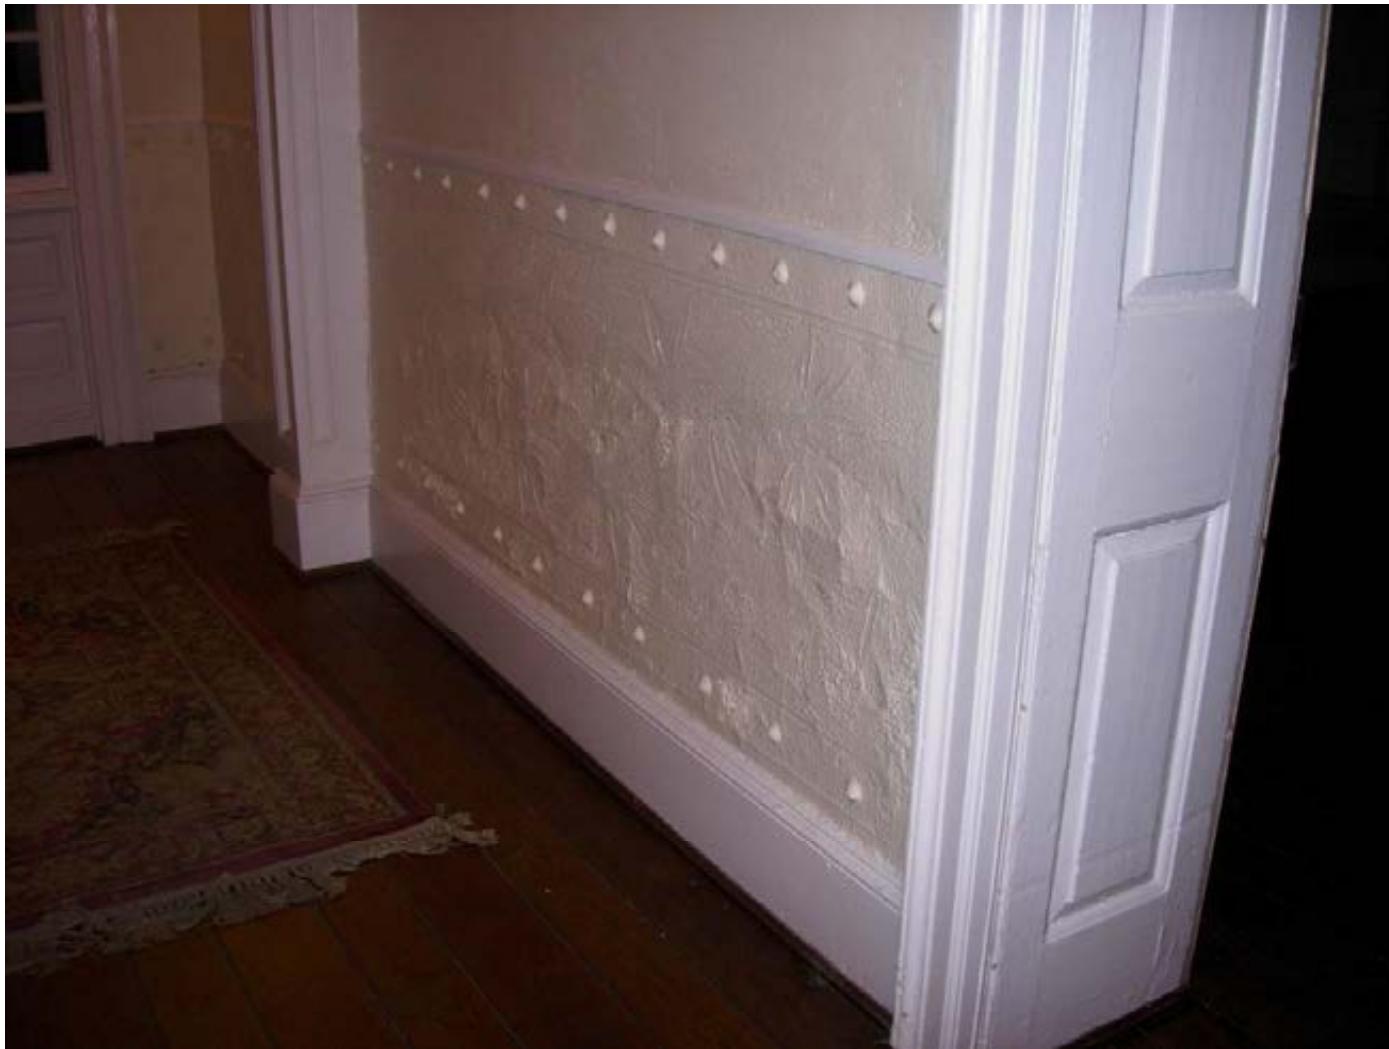
Figure 5-32. Damage to decorative paint treatment on the south wall includes buckling of the old plaster behind the decorative treatment. Photograph by Kathleen Manicke.

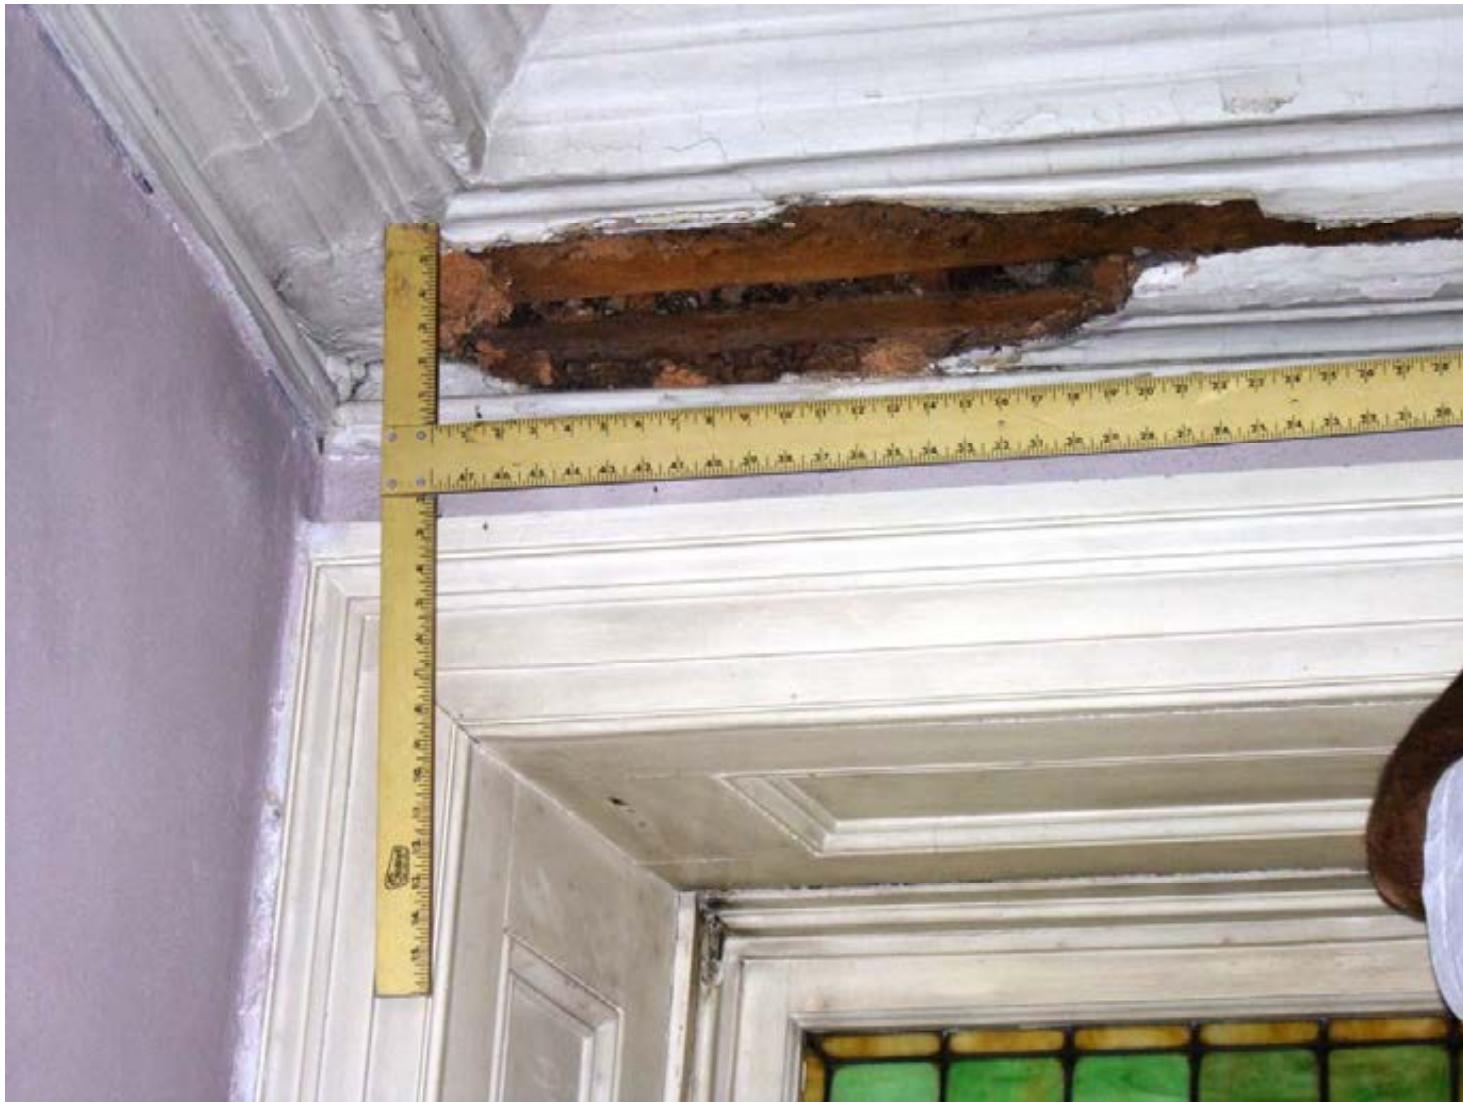
Figure 5-36. Damaged crown molding on the west wall of the dining room. Photograph by Kathleen Manicke.

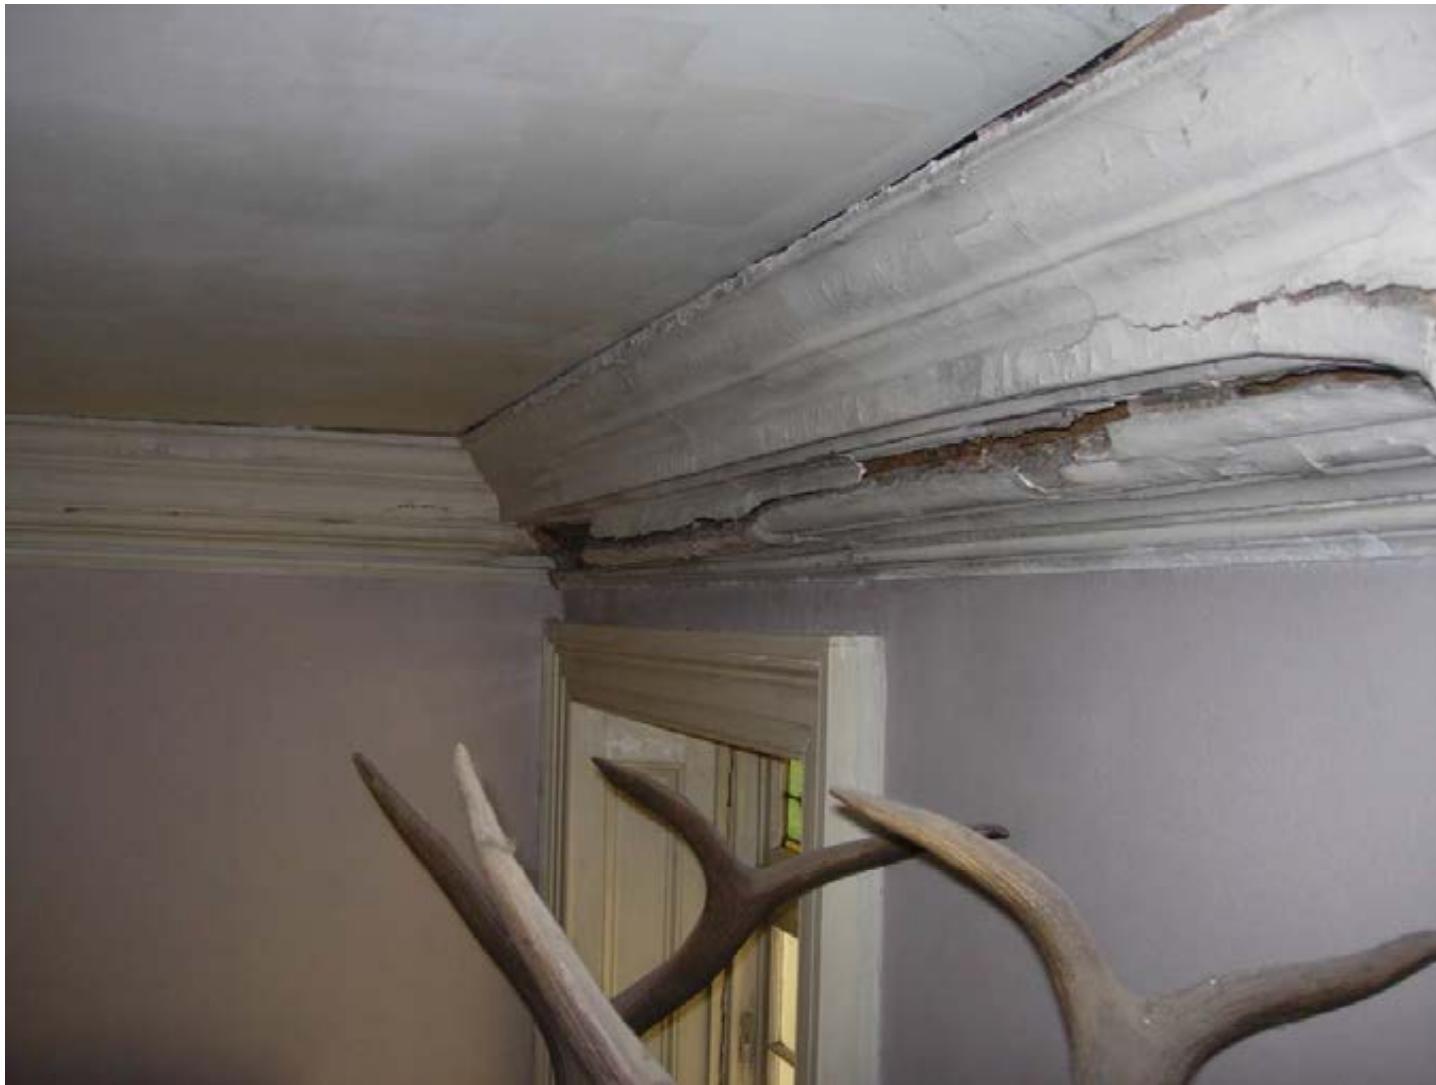
Figure 5-37. Extent of damage to the crown molding on the west wall of the dining room. Photograph by Kathleen Manicke.

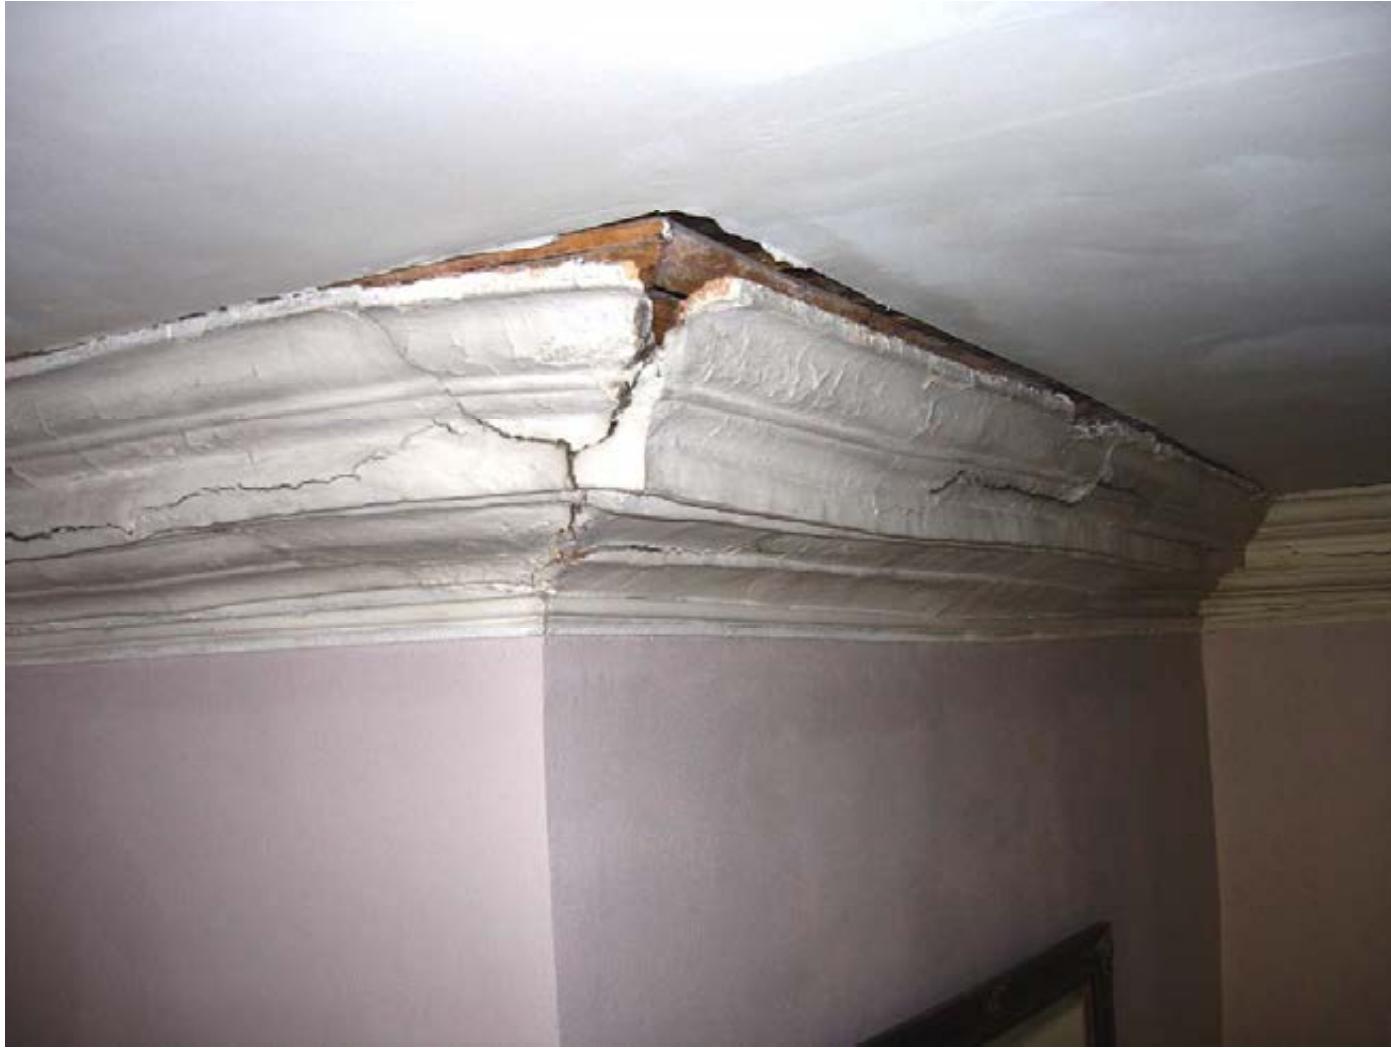
Figure 5-39. Damage to the crown molding above the fireplace on the north wall of the dining room. Photograph by Kathleen Manicke.

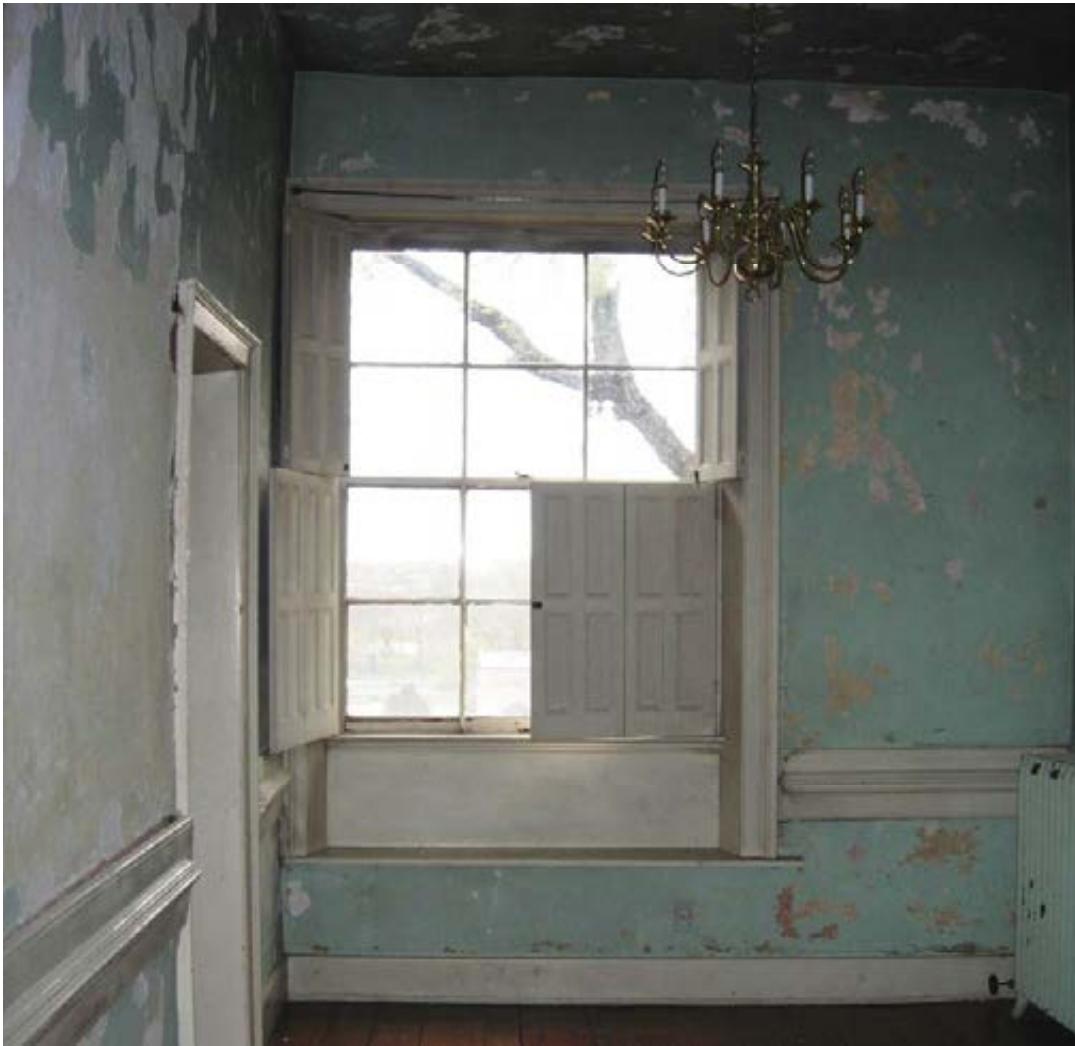
Figure 6-3. The west wall in the upstairs center hall. Notice the six-over-six window with its shutters. The paint on the flat plaster has failed. Photograph by Kathleen Manicke.

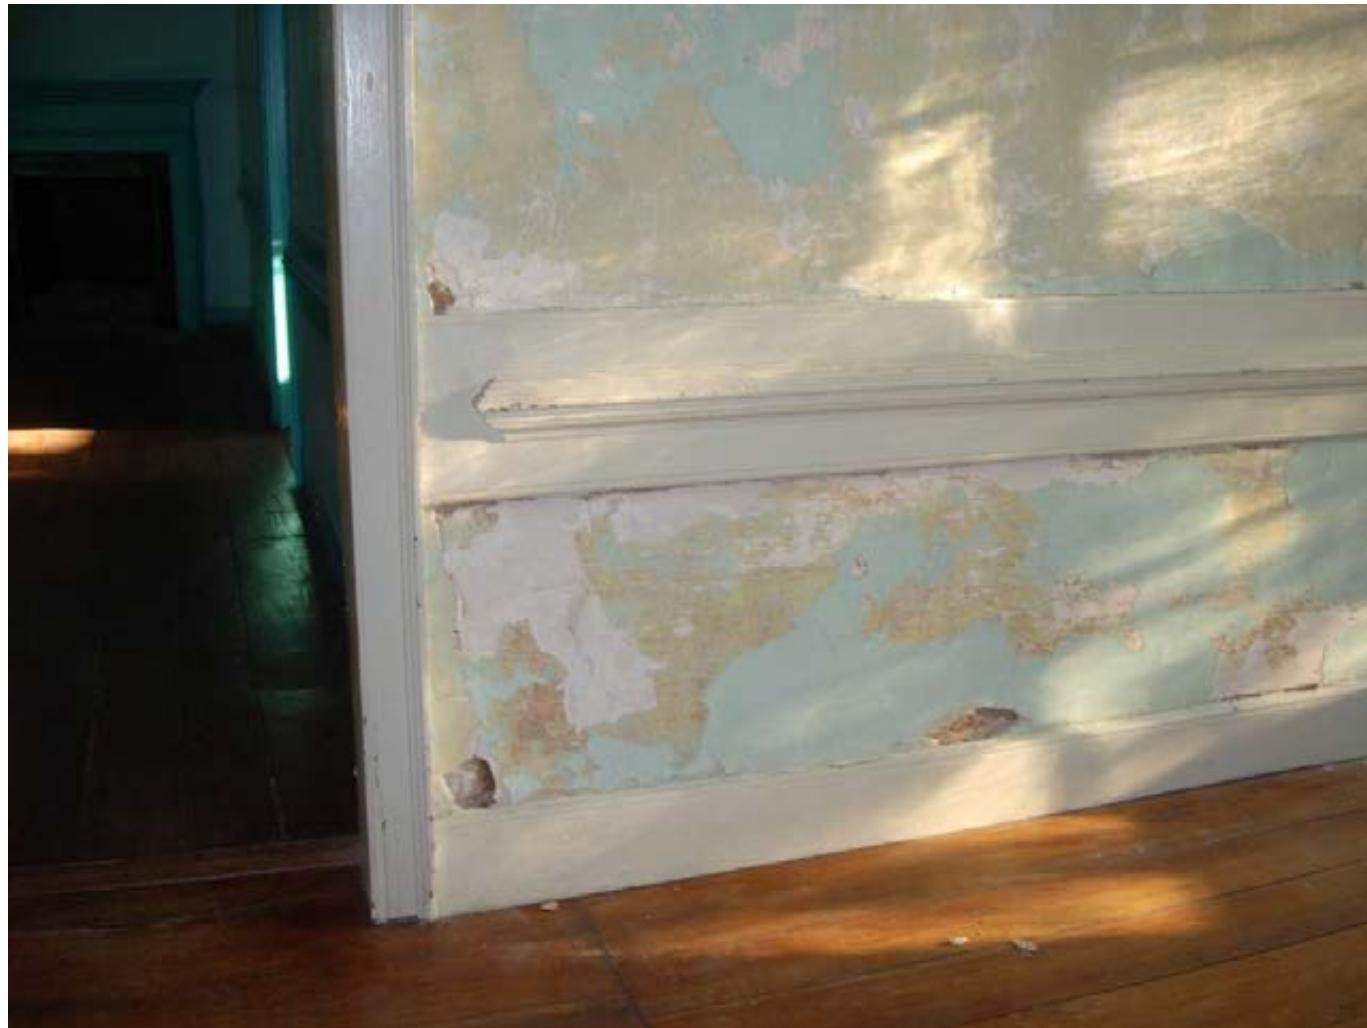
Figure 6-10. The south wall in the second floor center hall. Notice the chair rail, baseboard, and poor condition of the flat plaster. Photograph by Kathleen Manicke.

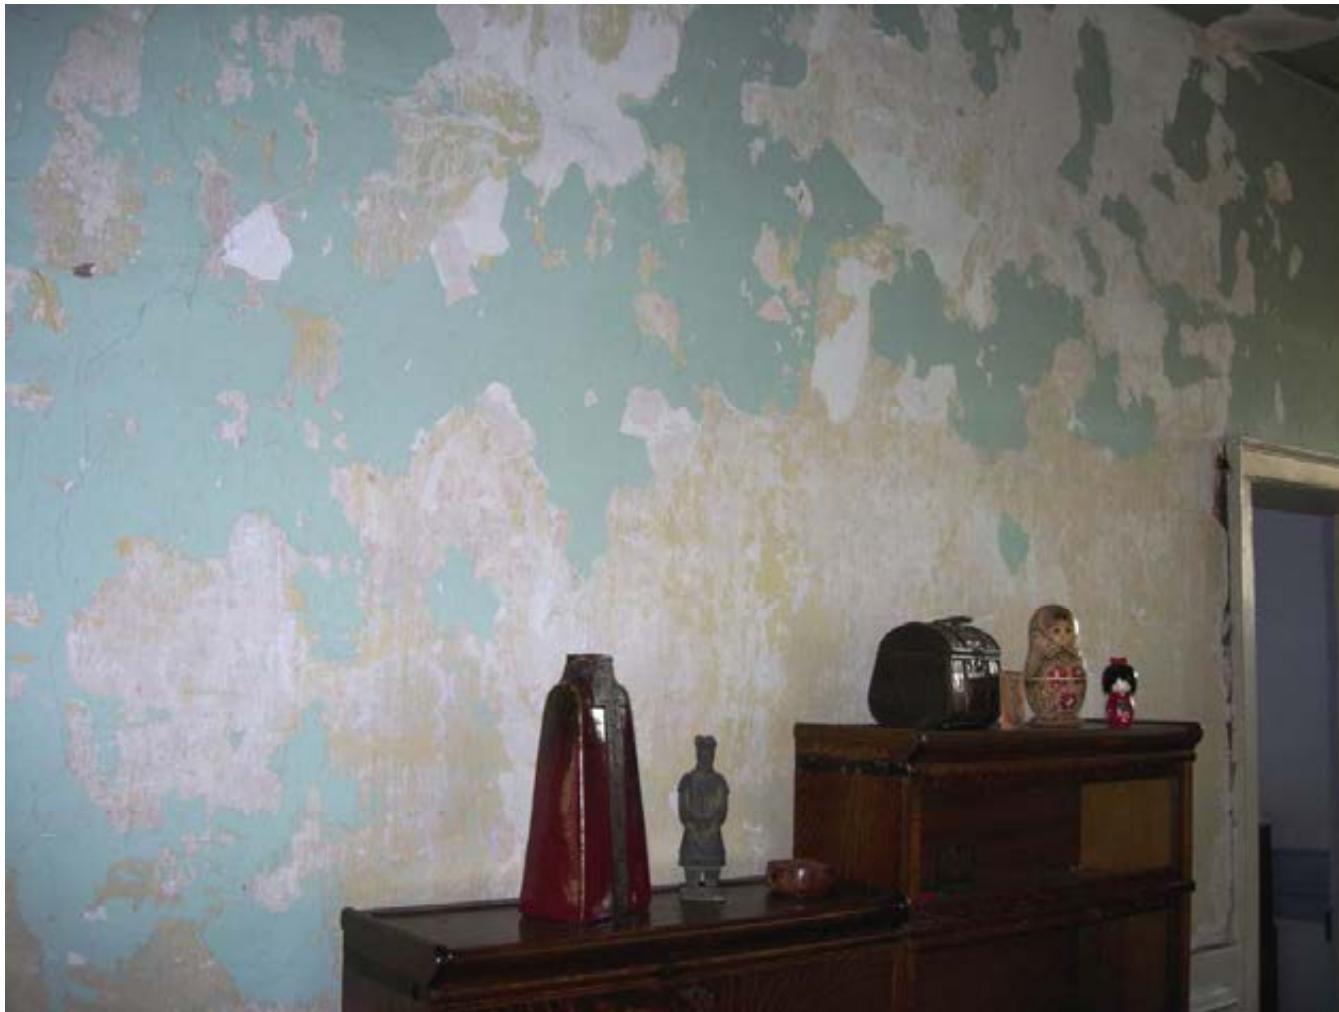
Figure 6-11. The upper portion of the south wall in the upstairs center hall showing the extent of damage to the paint.
Photograph by Kathleen Manicke.

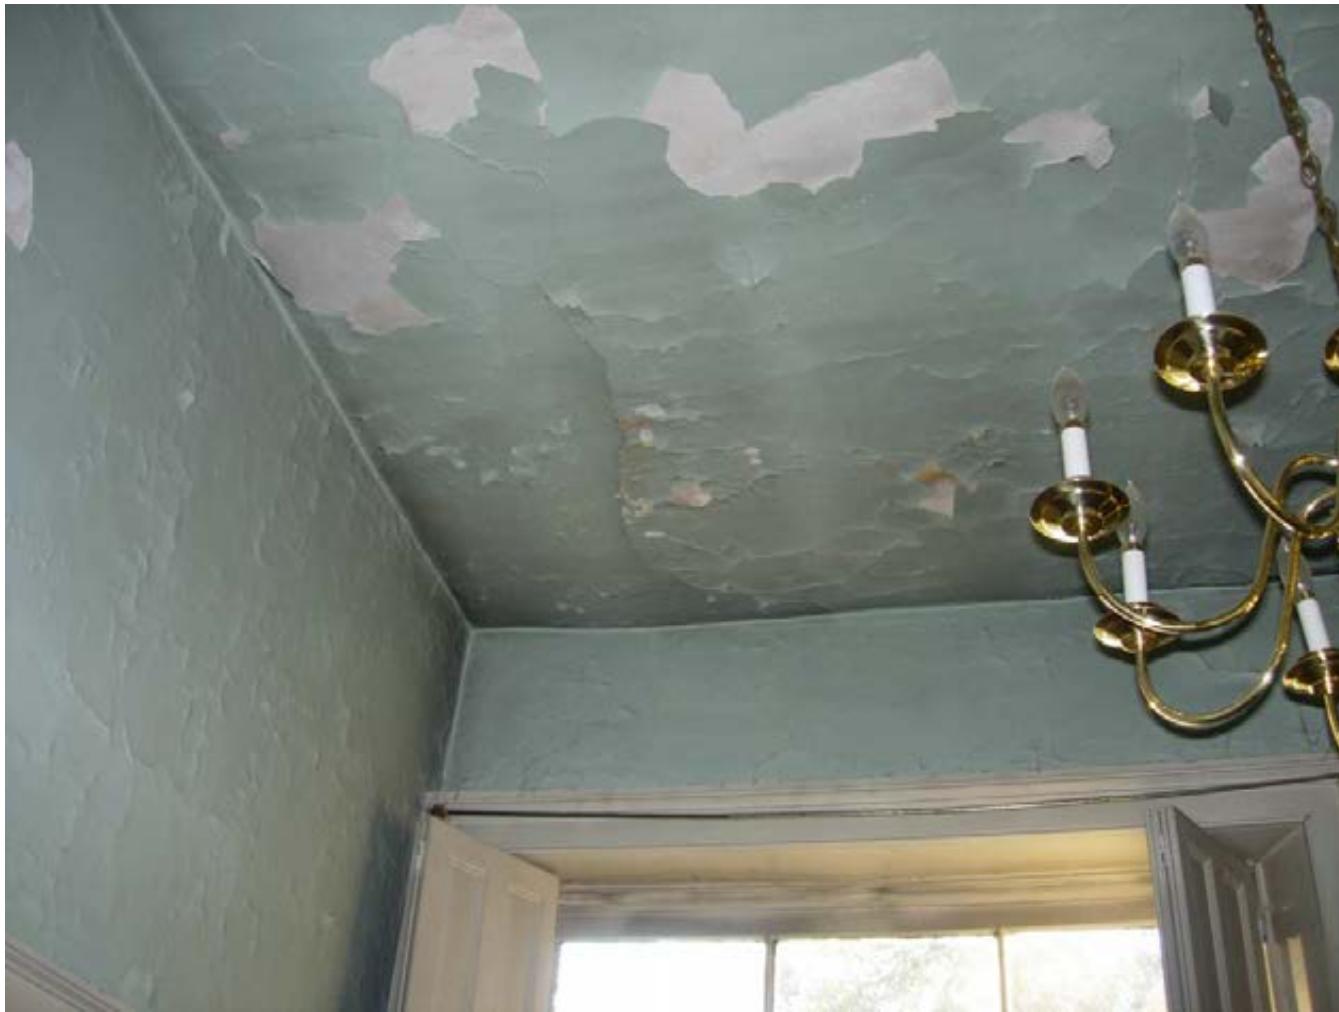
Figure 6-12. The ceiling of the second floor center hall. The plaster is cracking and buckling. The paint has failed. Photograph by Kathleen Manicke.

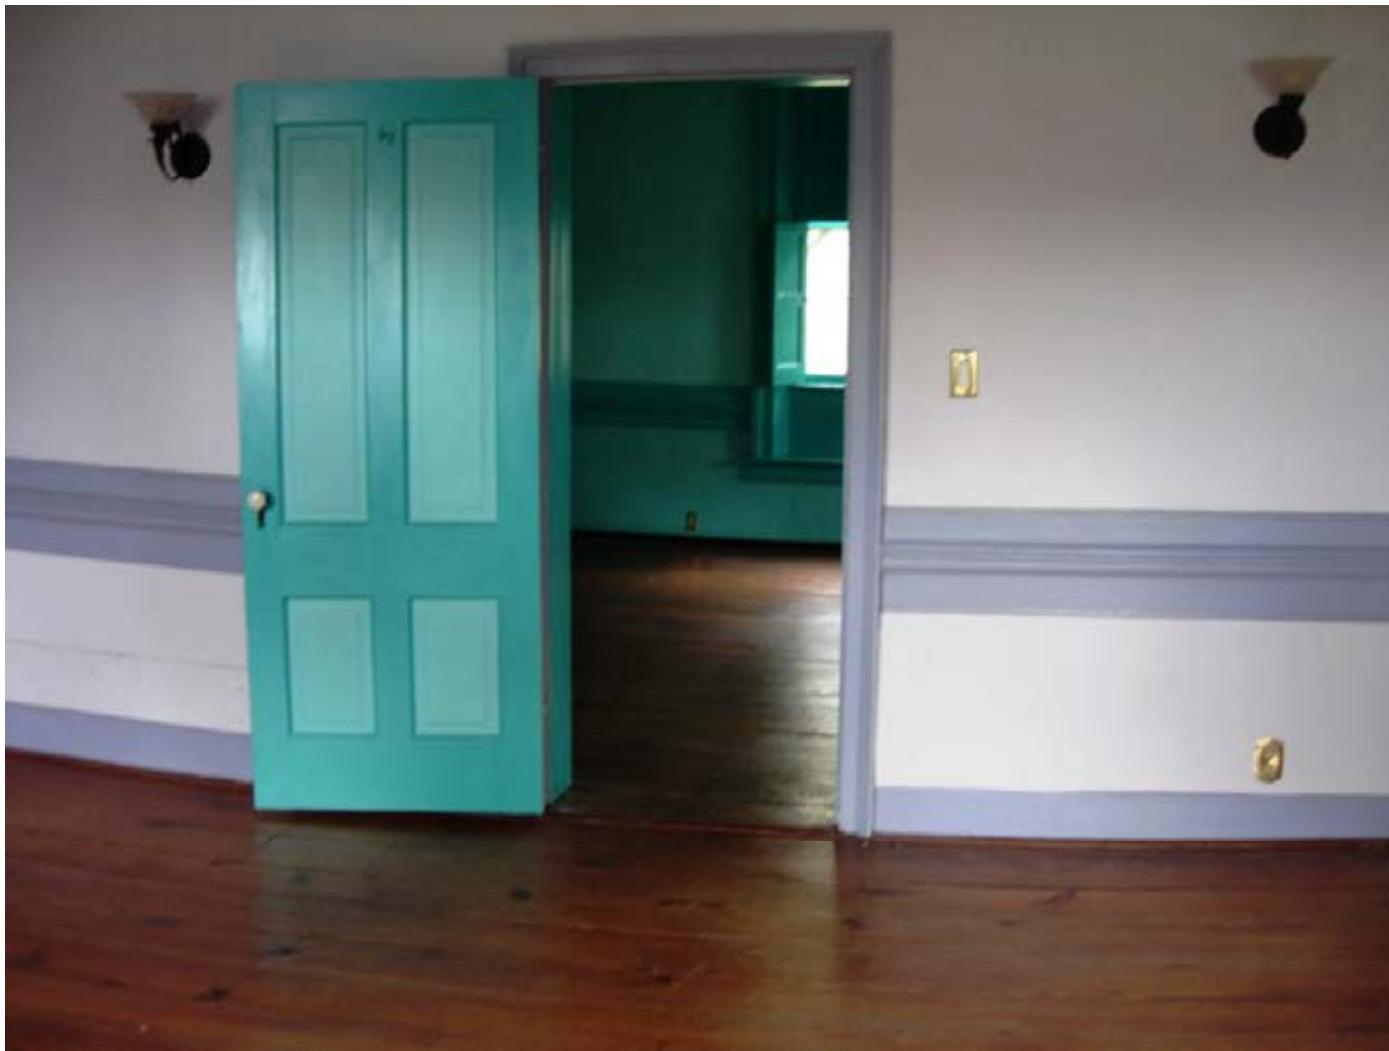
Figure 6-19. The east wall of the southwest bedroom. Note the sagging along the baseboards. Photograph by Kathleen Manicke.

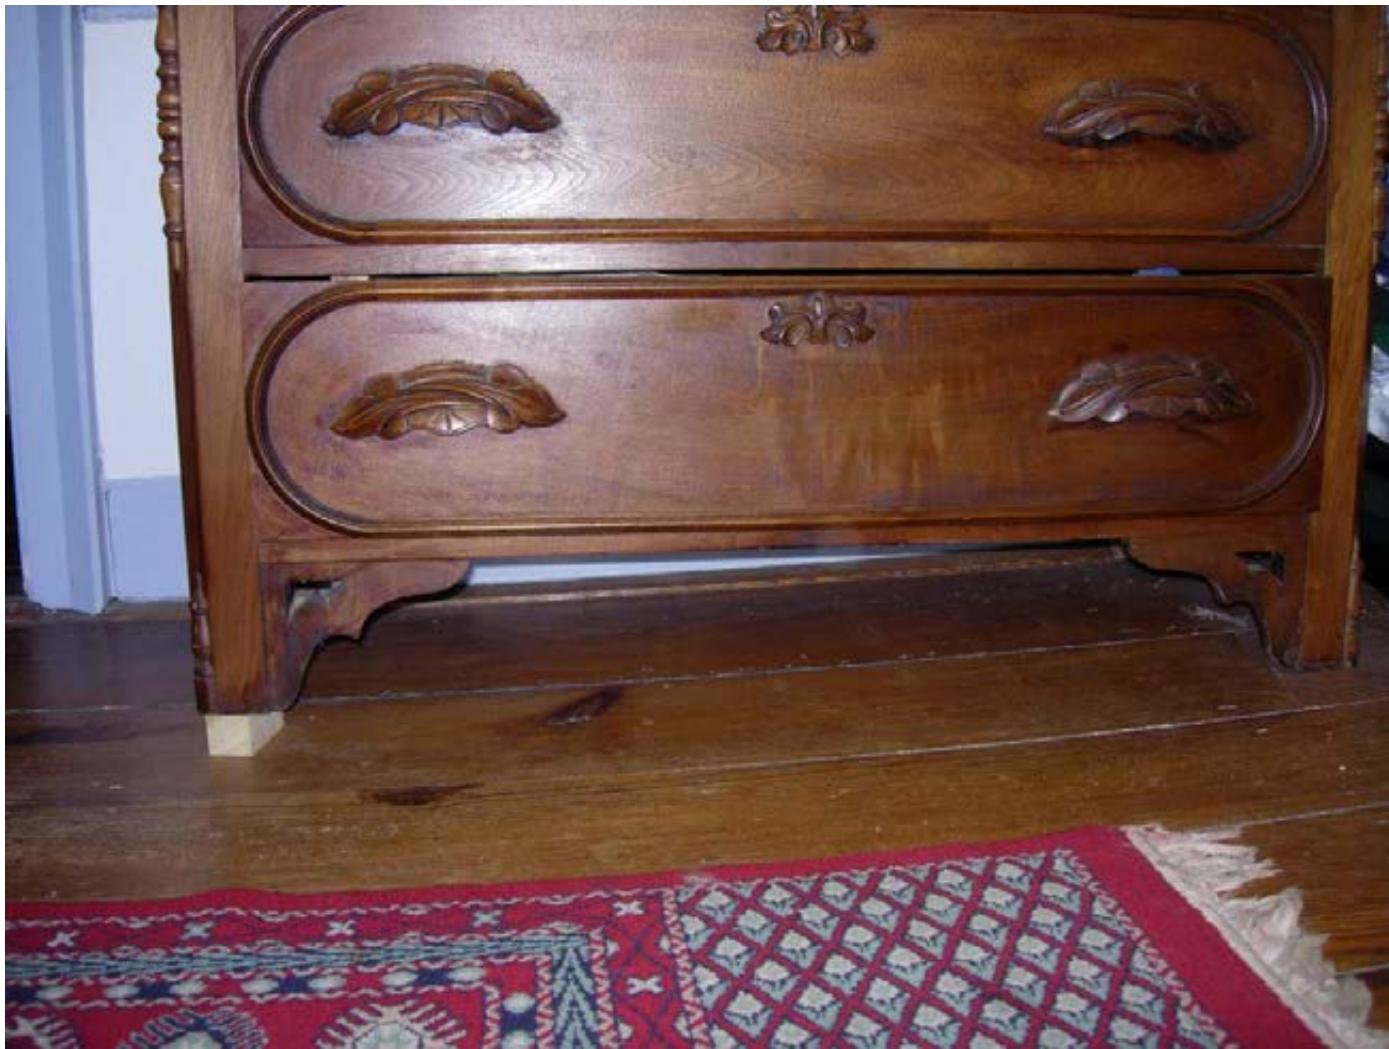
Figure 6-23. The floor in the southwest bedroom sags. Notice the block under the 3' wide dresser. Photograph by Kathleen Manicke.

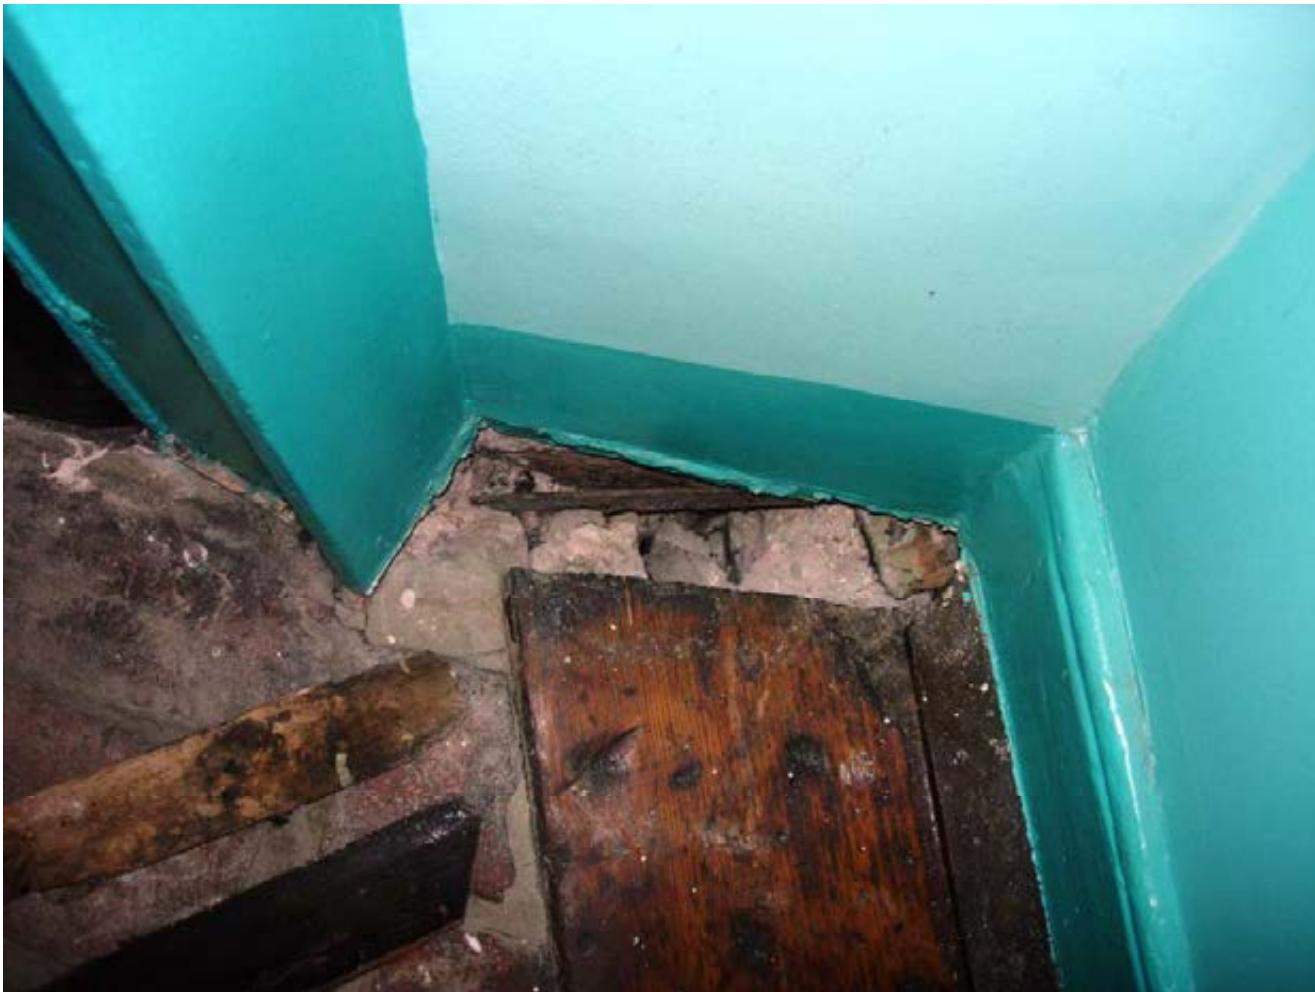
Figure 6-31. Movement of the house to the southwest has caused this gap at the southwest corner of southeast bedroom.
Photograph by Kathleen Manicke.

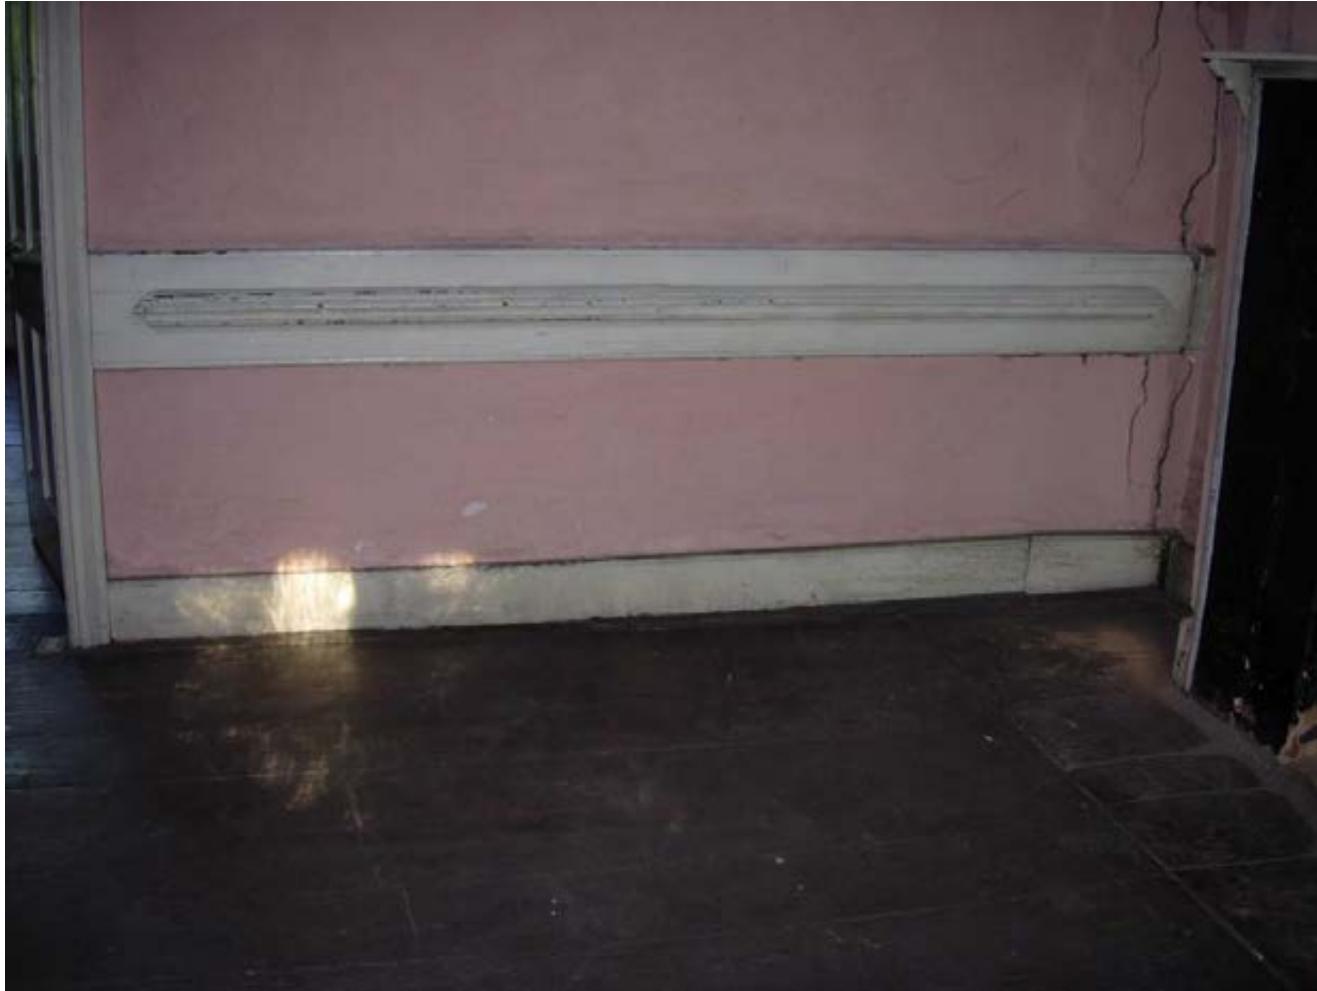
Figure 6-43. The baseboard, chair rail, and flat plaster on the west wall of the northeast chamber. Notice the large cracks in the plaster at the intersection of the north wall. Photograph by Kathleen Manicke.
