Building at Risk:

A Historic Structure Report for Bostwick in Bladensburg, MD

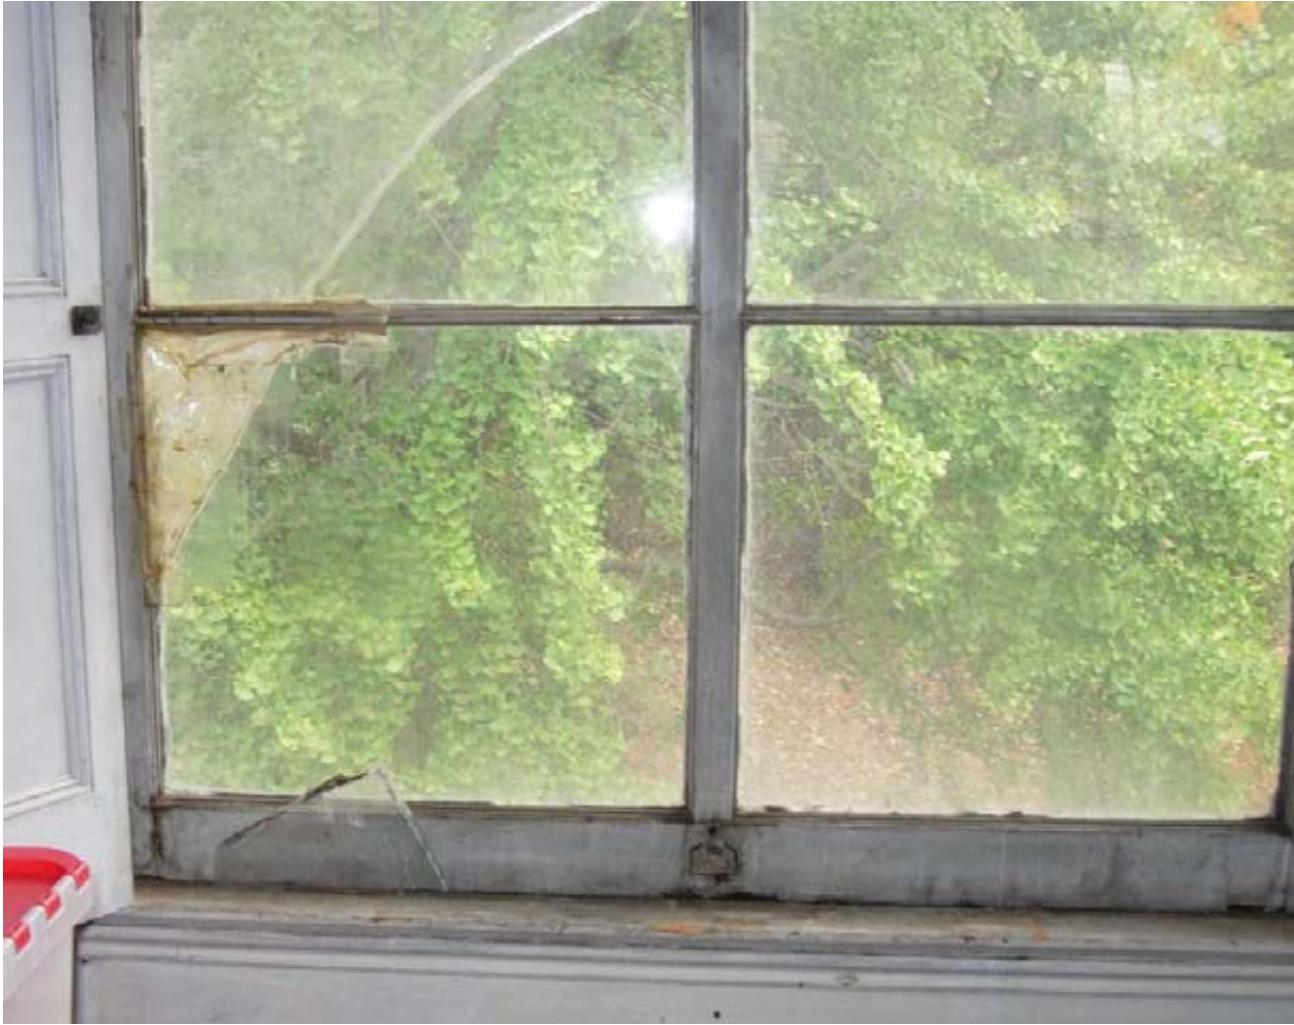
Figure 6-50. Window conditions on the east wall of the northeast chamber. Photograph by Kathleen Manicke.

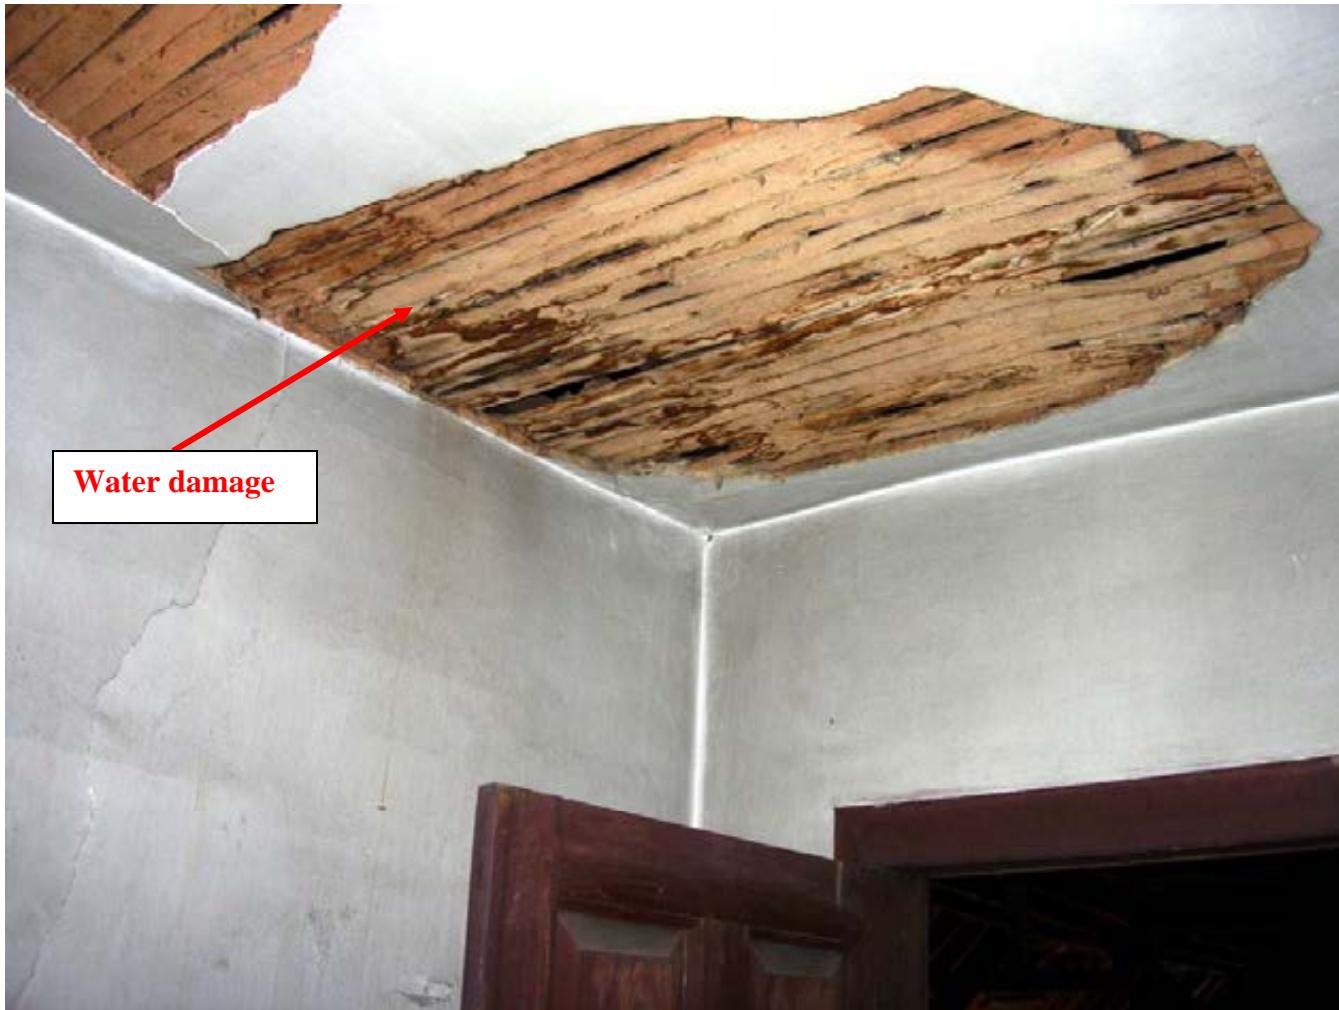
Figure 7-18. Moisture infiltration along the ridgeline has caused damage to the plaster ceiling in the northwest chamber. There is also evidence of water damage to the lath. Photograph by Kathleen Manicke.

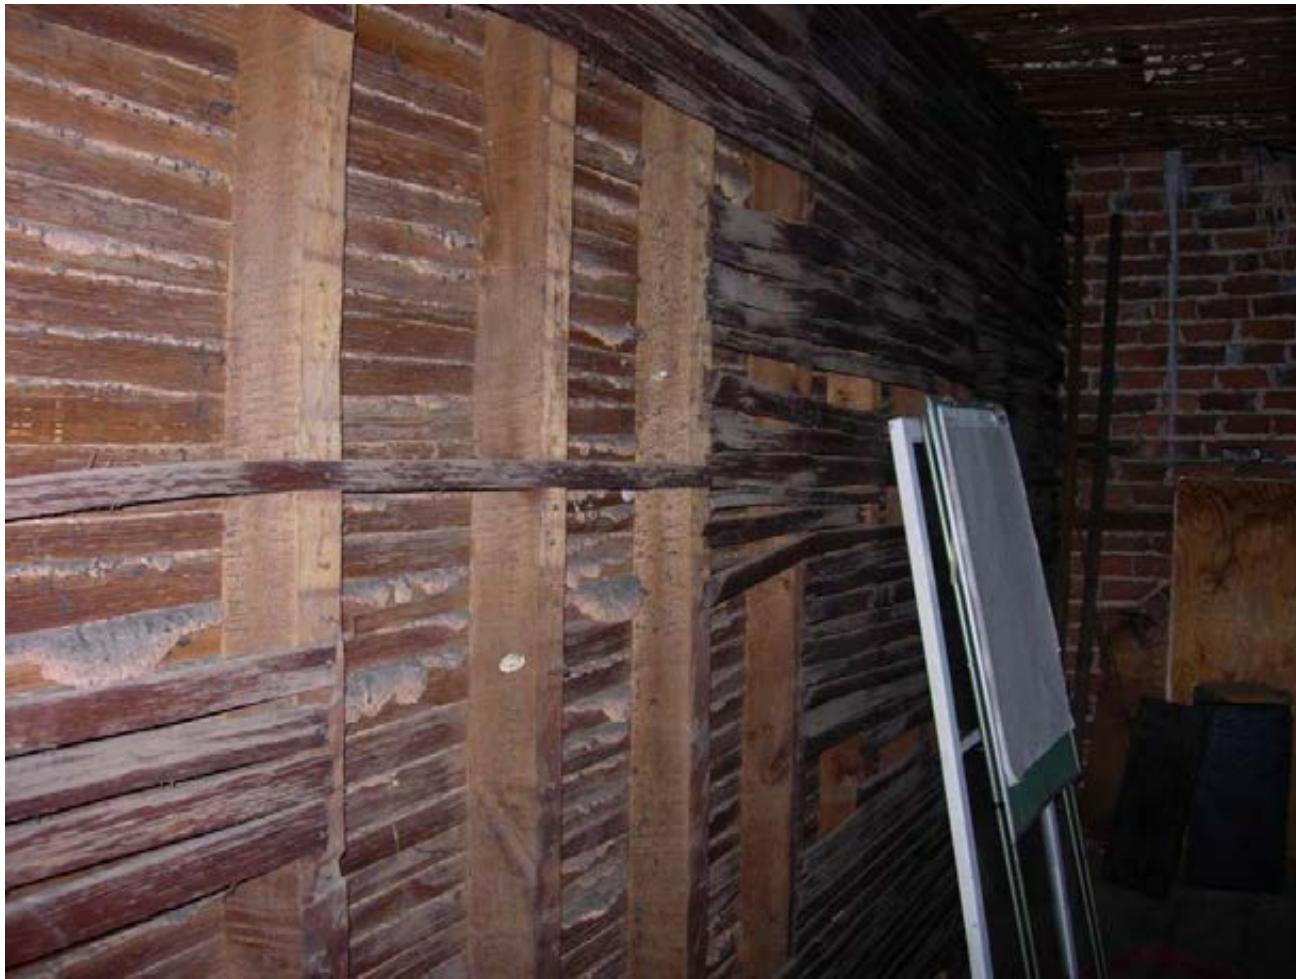
Figure 7-21. View of the west wall of the northeast chamber showing studs and riven lath. Some of the lath is missing.
Photograph by Kathleen Manicke.

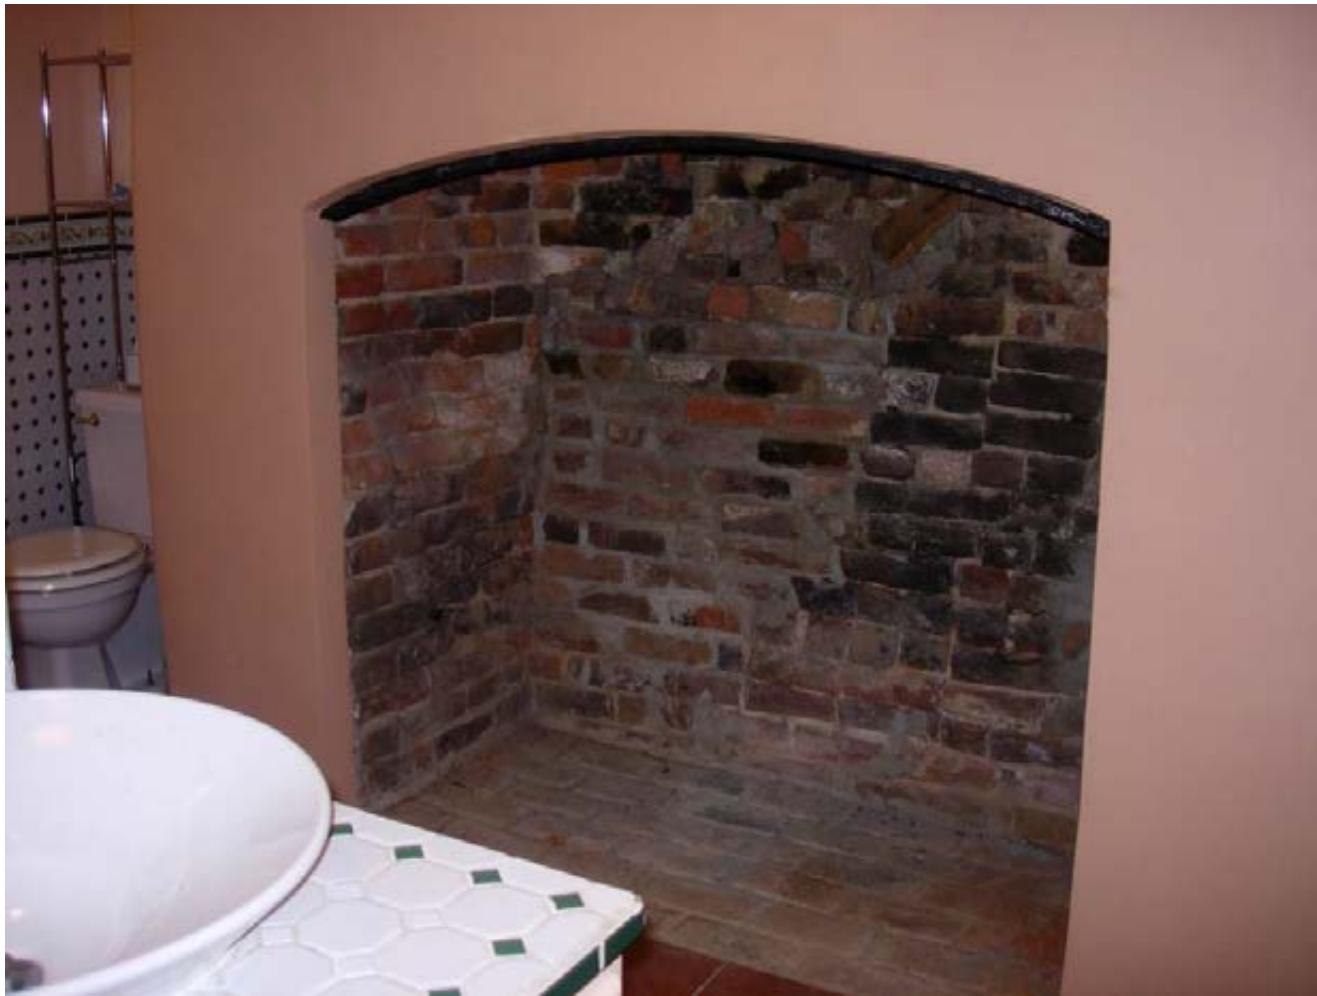
Figure 8-9. The fireplace in the Stoddert addition. Note the poor condition of the brick. Photograph by Kathleen Manicke.

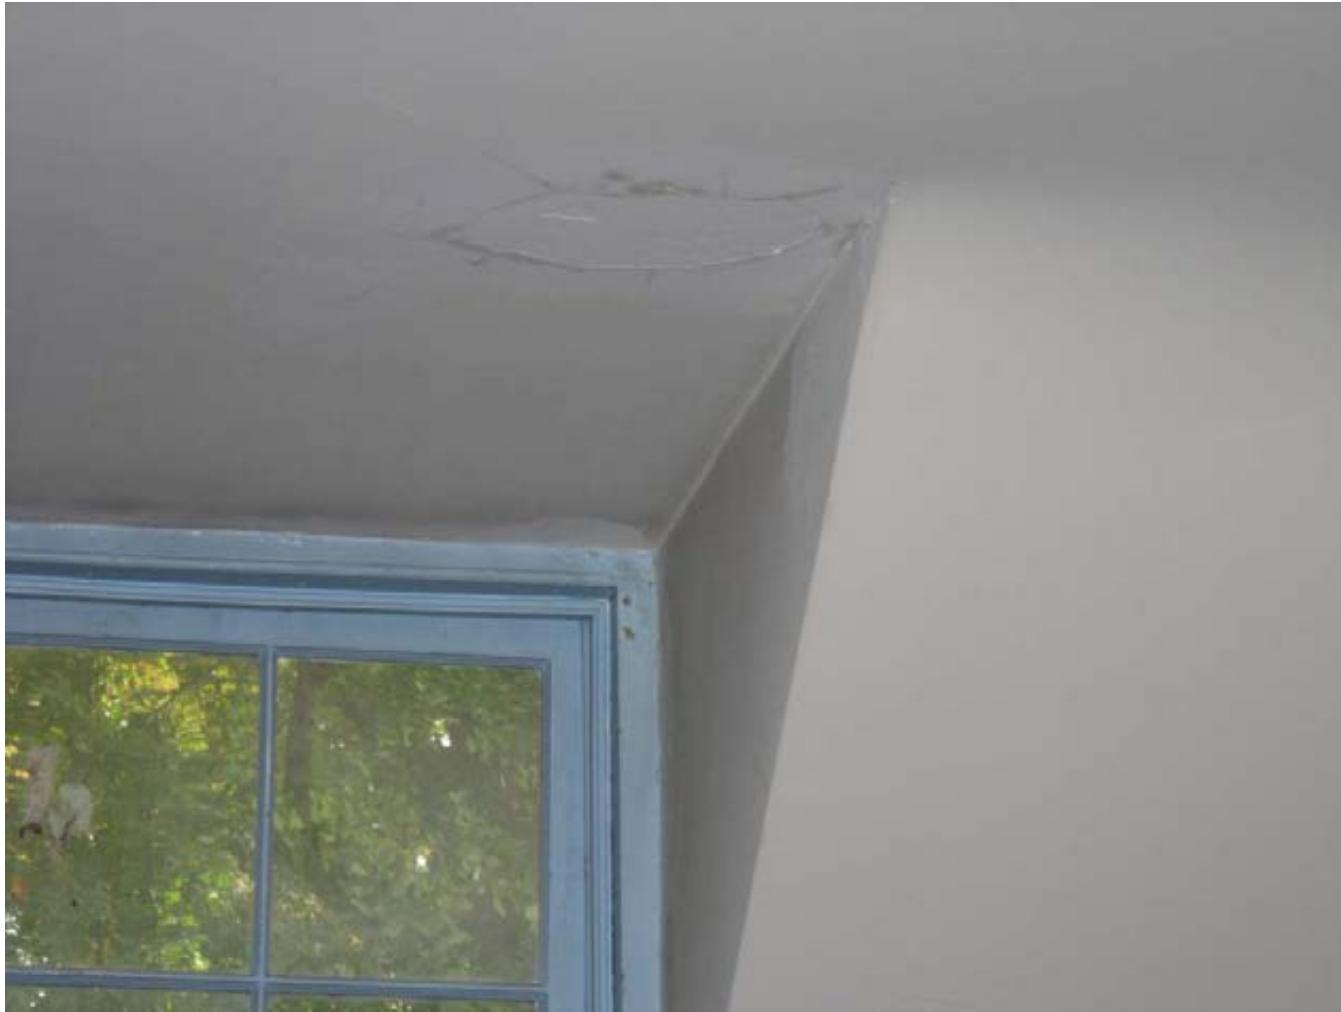
Figure 8-11. The leaking dormer on the east wall of the south room on the second floor of the Stoddert addition. Photograph by Kathleen Manicke.

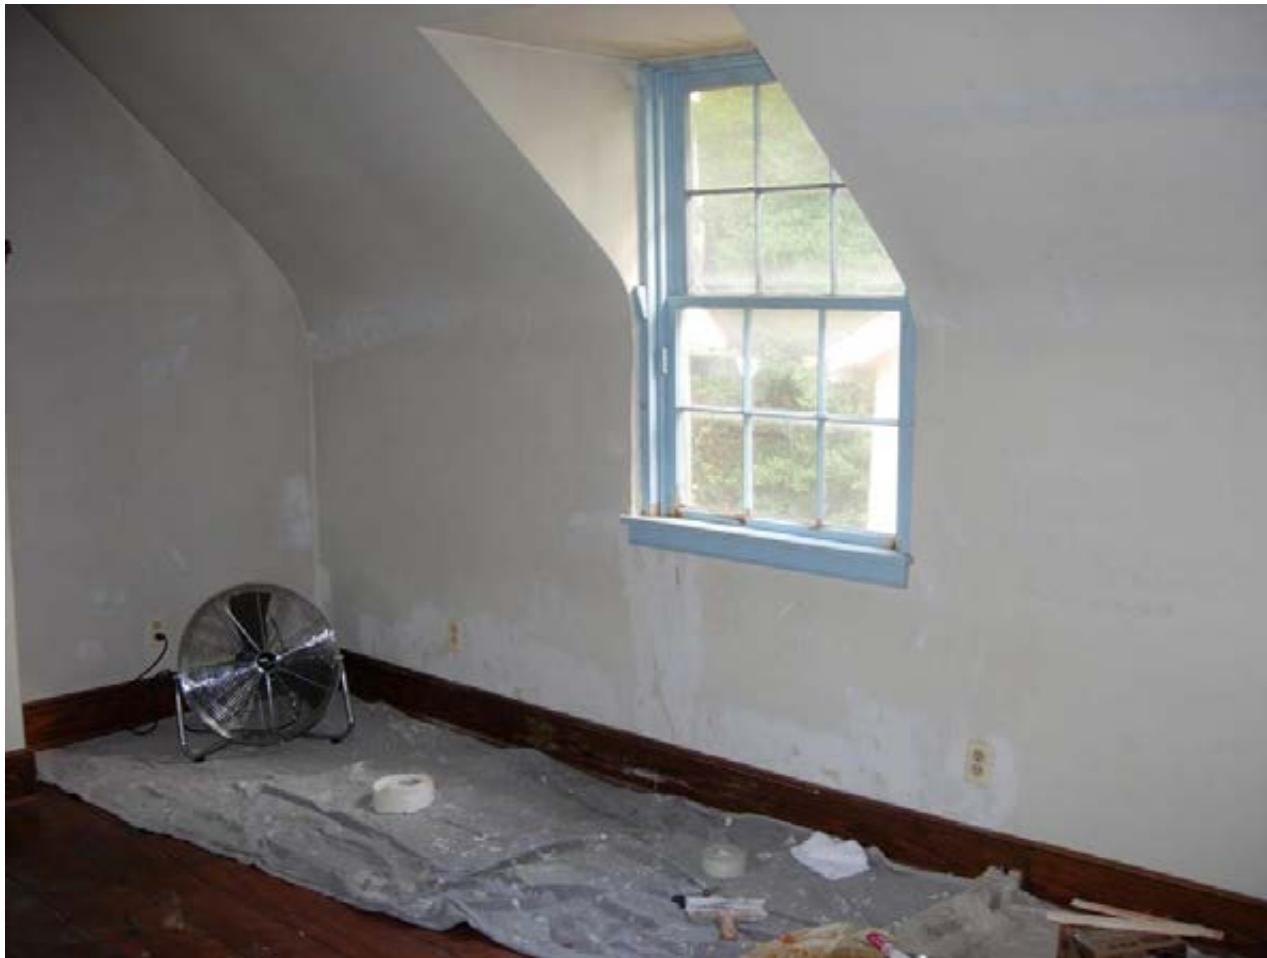
Figure 8-13. The east window in the larger of the two upstairs rooms in the Stoddert addition. Notice the repairs to the plaster brought about by the leaks in the dormer area. Photograph by Kathleen Manicke.

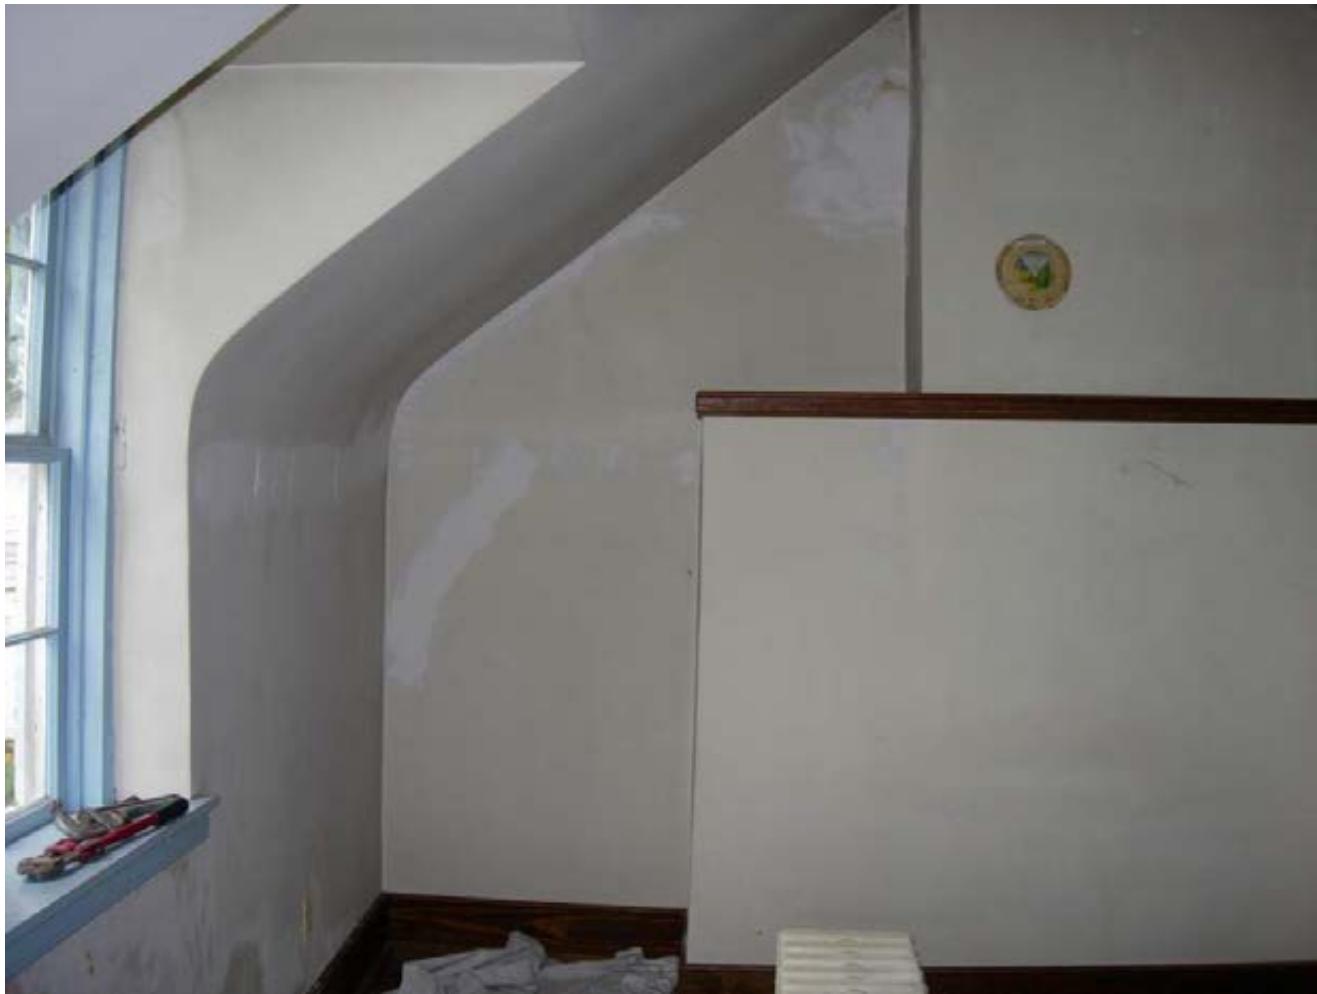
Figure 8-14. The chimney area upstairs in the Stoddert addition. Repairs to the plaster were necessitated by moisture infiltration around the chimney and the dormer. Photograph by Kathleen Manicke.
