FEASIBILITY STUDY FOR THE ADAPTIVE USE OF THE BOSTWICK HOUSE AND PROPERTY

Final Report

December 2002

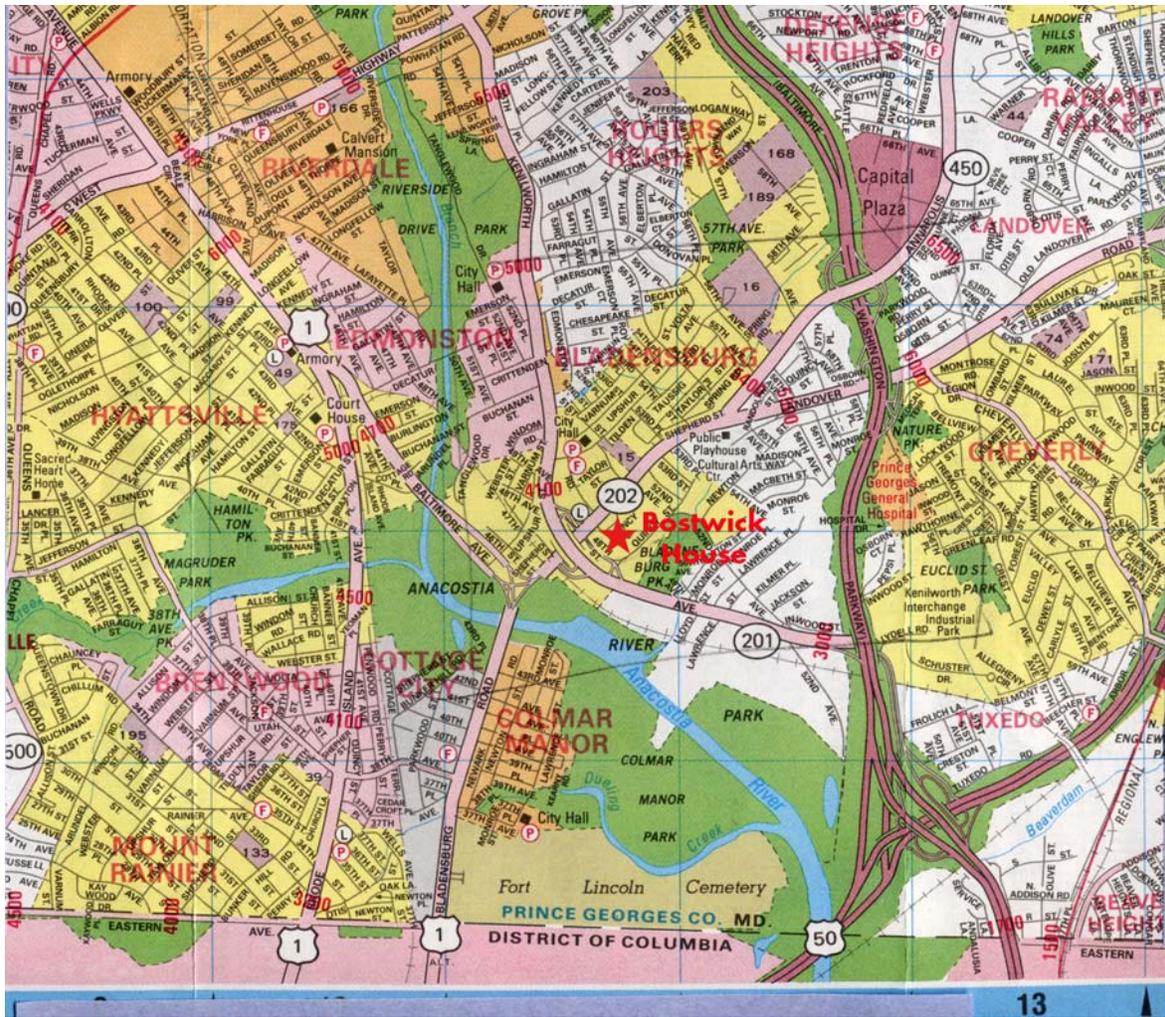
Figure 1. Location and context for Bostwick Property

Also significant to the property, and highlighted on Figure 1, is the driveway that leads visitors from the main gate at 48th Street up to the south side of the house and terminates at the farm building complex. While this drive provides a wonderful sense of arrival and a picturesque approach to the house, it may not be a sufficient means of access for large numbers of

visitors. In addition, the gate and the entrance to the driveway are located at the [potentially] dangerous intersection of 48th and Quincy Streets. Pedestrian paths are also noted on Figure 2, and include the significant front walk leading from 48th Street to the front porch of the house, and the diagonal path leading from the back (east) side of the house to the farm complex.

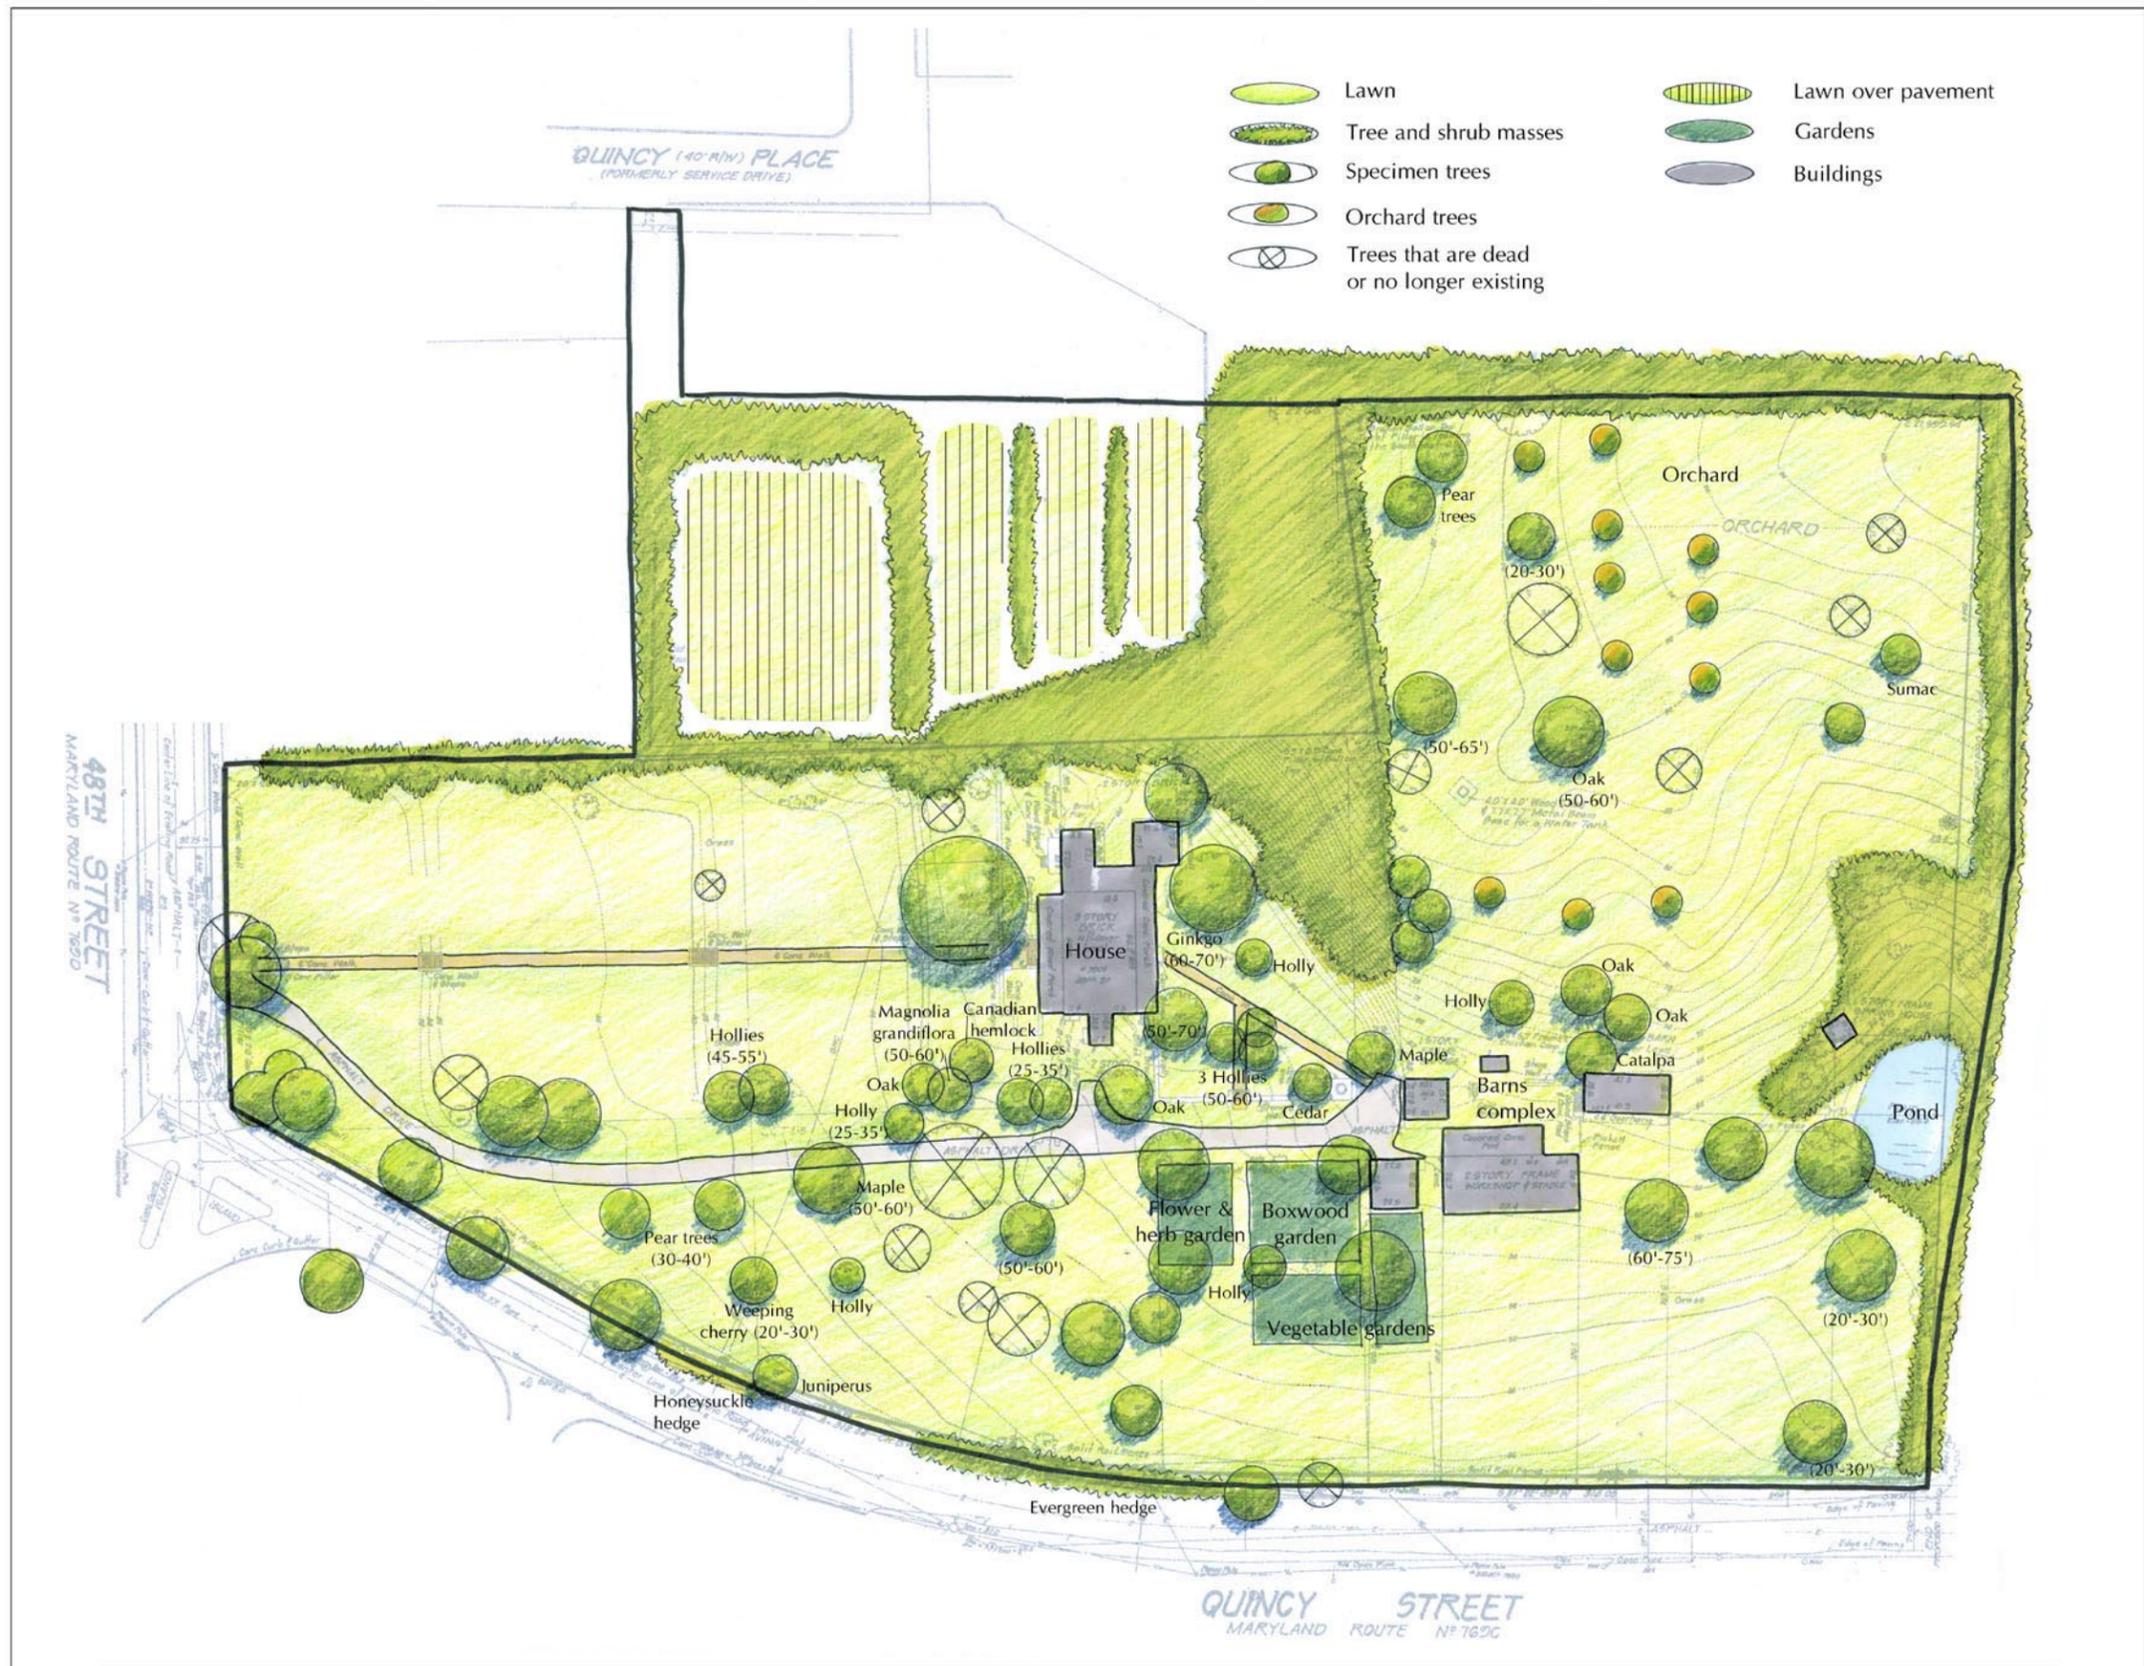
Vegetation
Figure 4
June 2002

Figure 4 illustrates the location and main types of vegetation found on the property. The majority of the property is lawn, which is either completely open (in the case of the front lawn) or exists underneath individual trees or groupings of trees (in the area around the house, bordering the driveway, and in the orchard, for example). Because of its former use as a commercial property, the additional Bostwick property (to the north) is mostly grassy, but is underlain with a layer of pavement that was never removed. Although a carpet of grass is present, the pavement shows through in many areas.

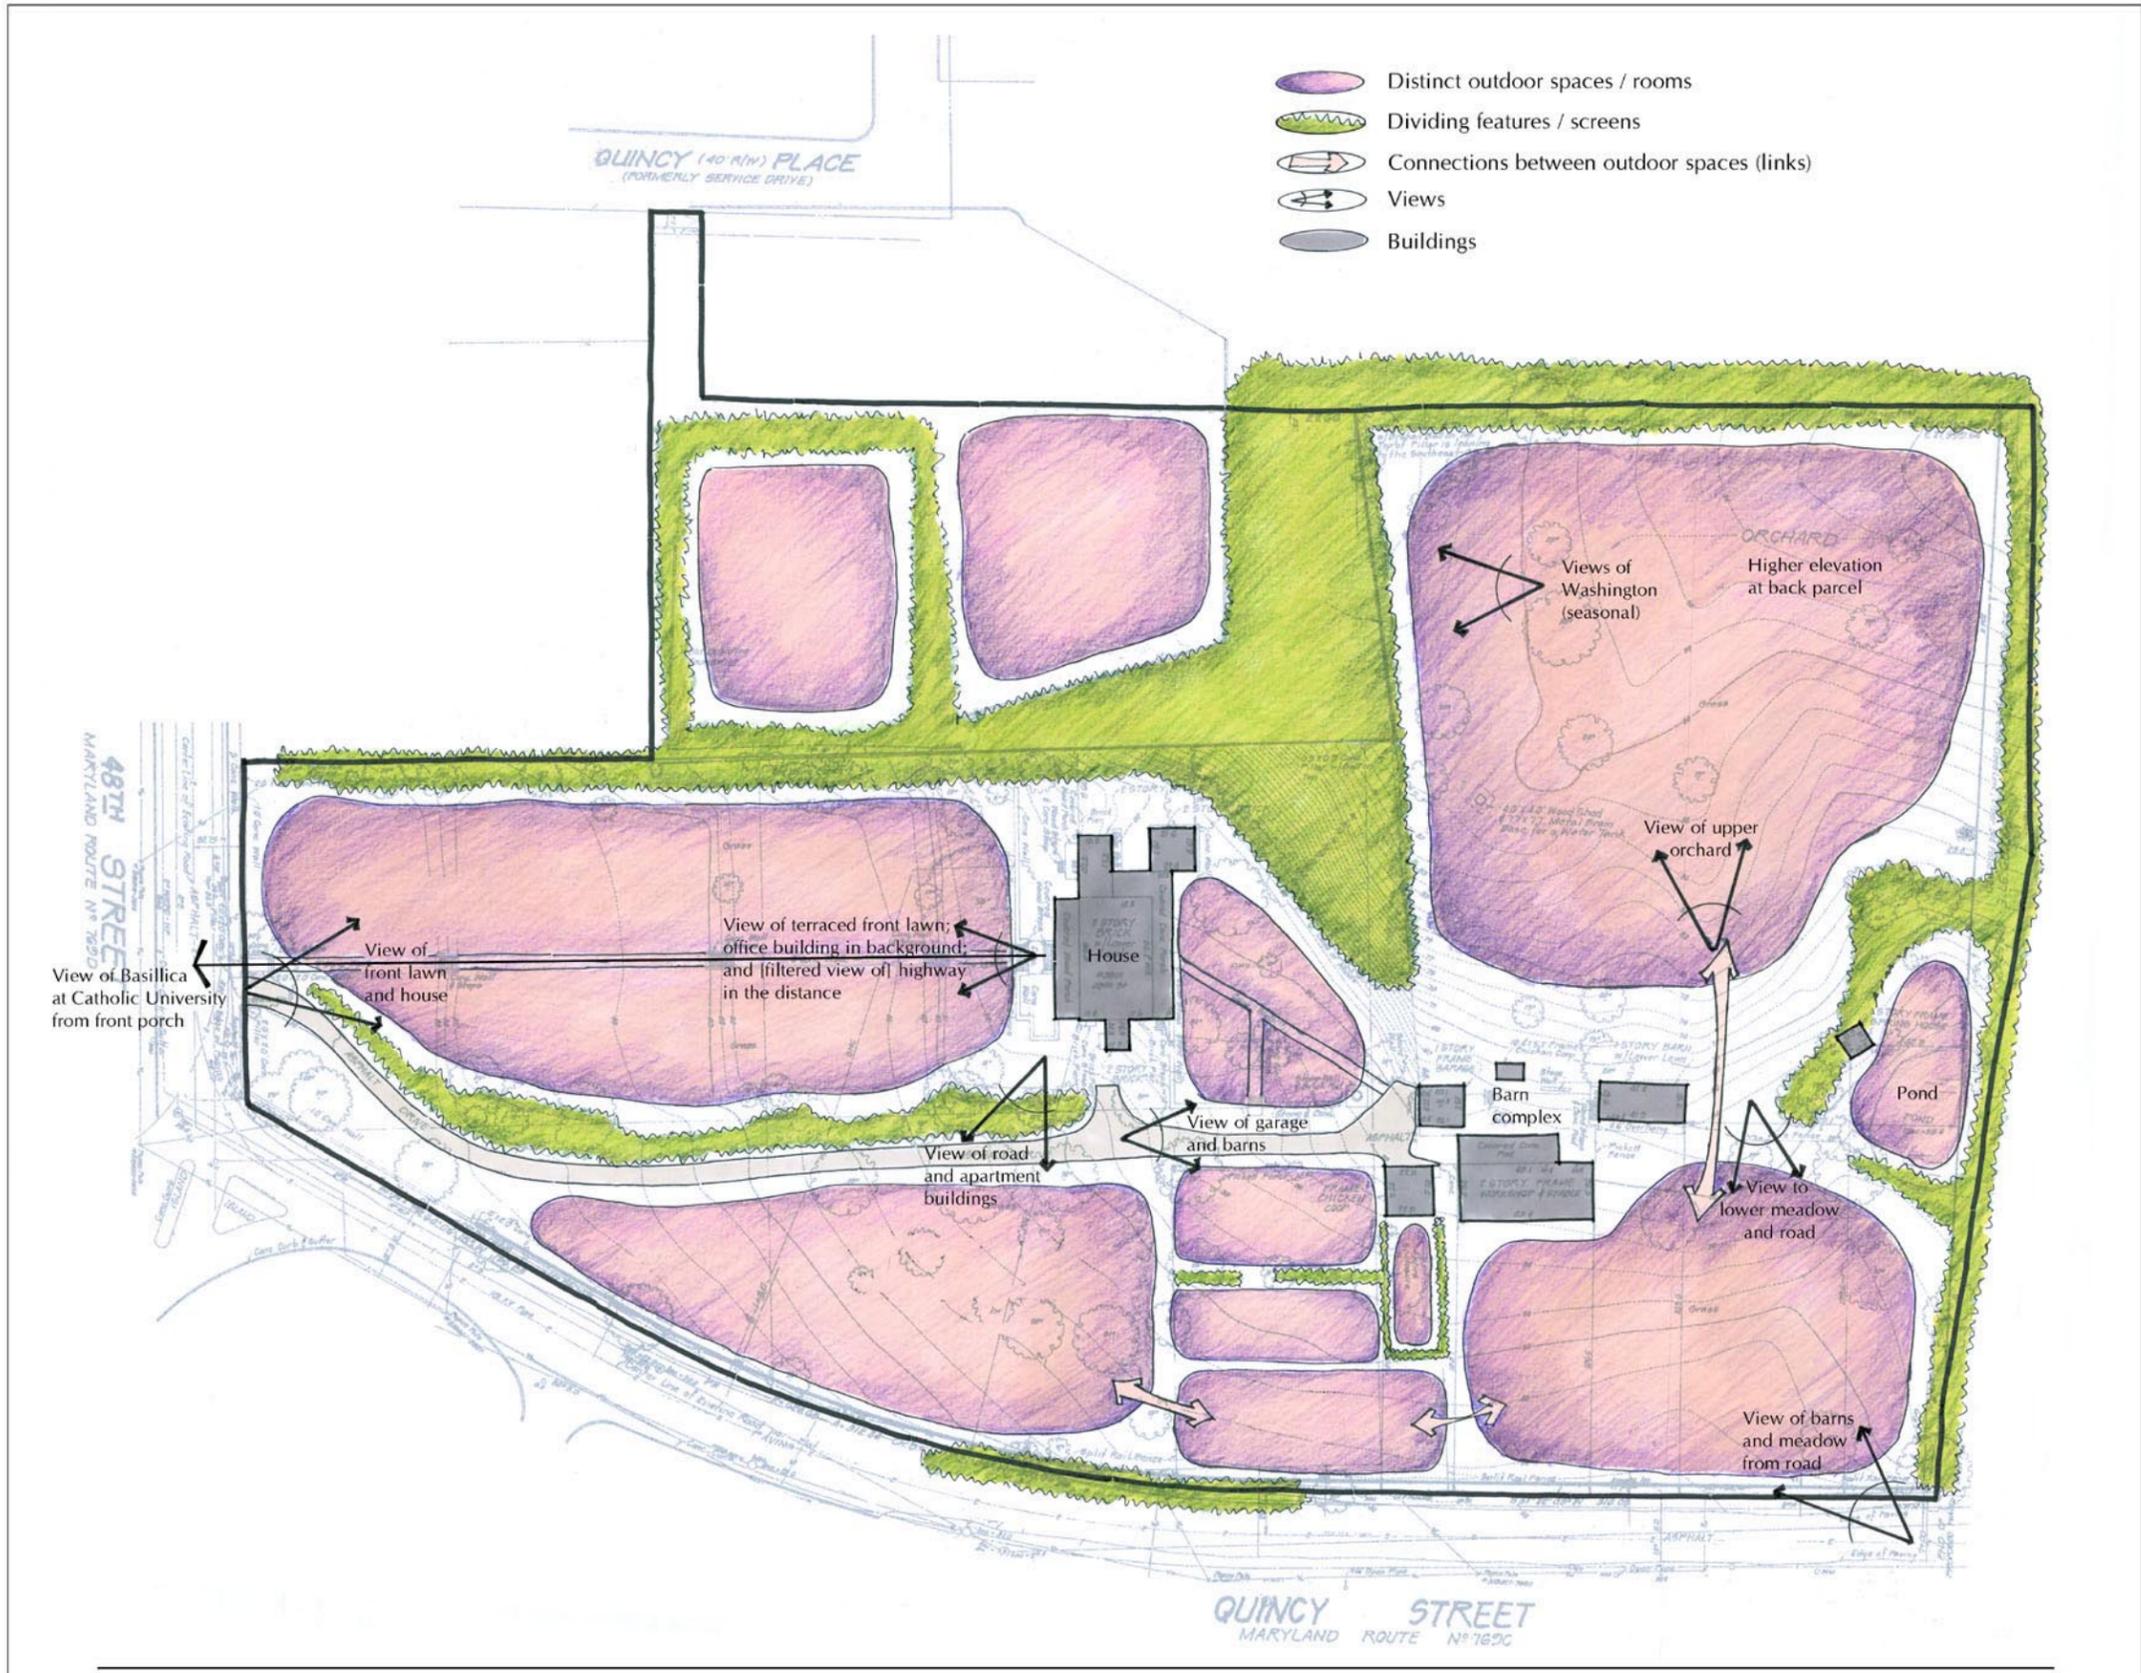
Visual and Spatial Analysis
Figure 5
June 2002

Figure 5, the Visual and Spatial Analysis, illustrates Bostwick as it is broken down into its essential spatial components, and how the site is actually perceived by viewers as a series of linked separate spaces. The map also shows important views within, into, and out of the property; these views are labeled in Figure 5.

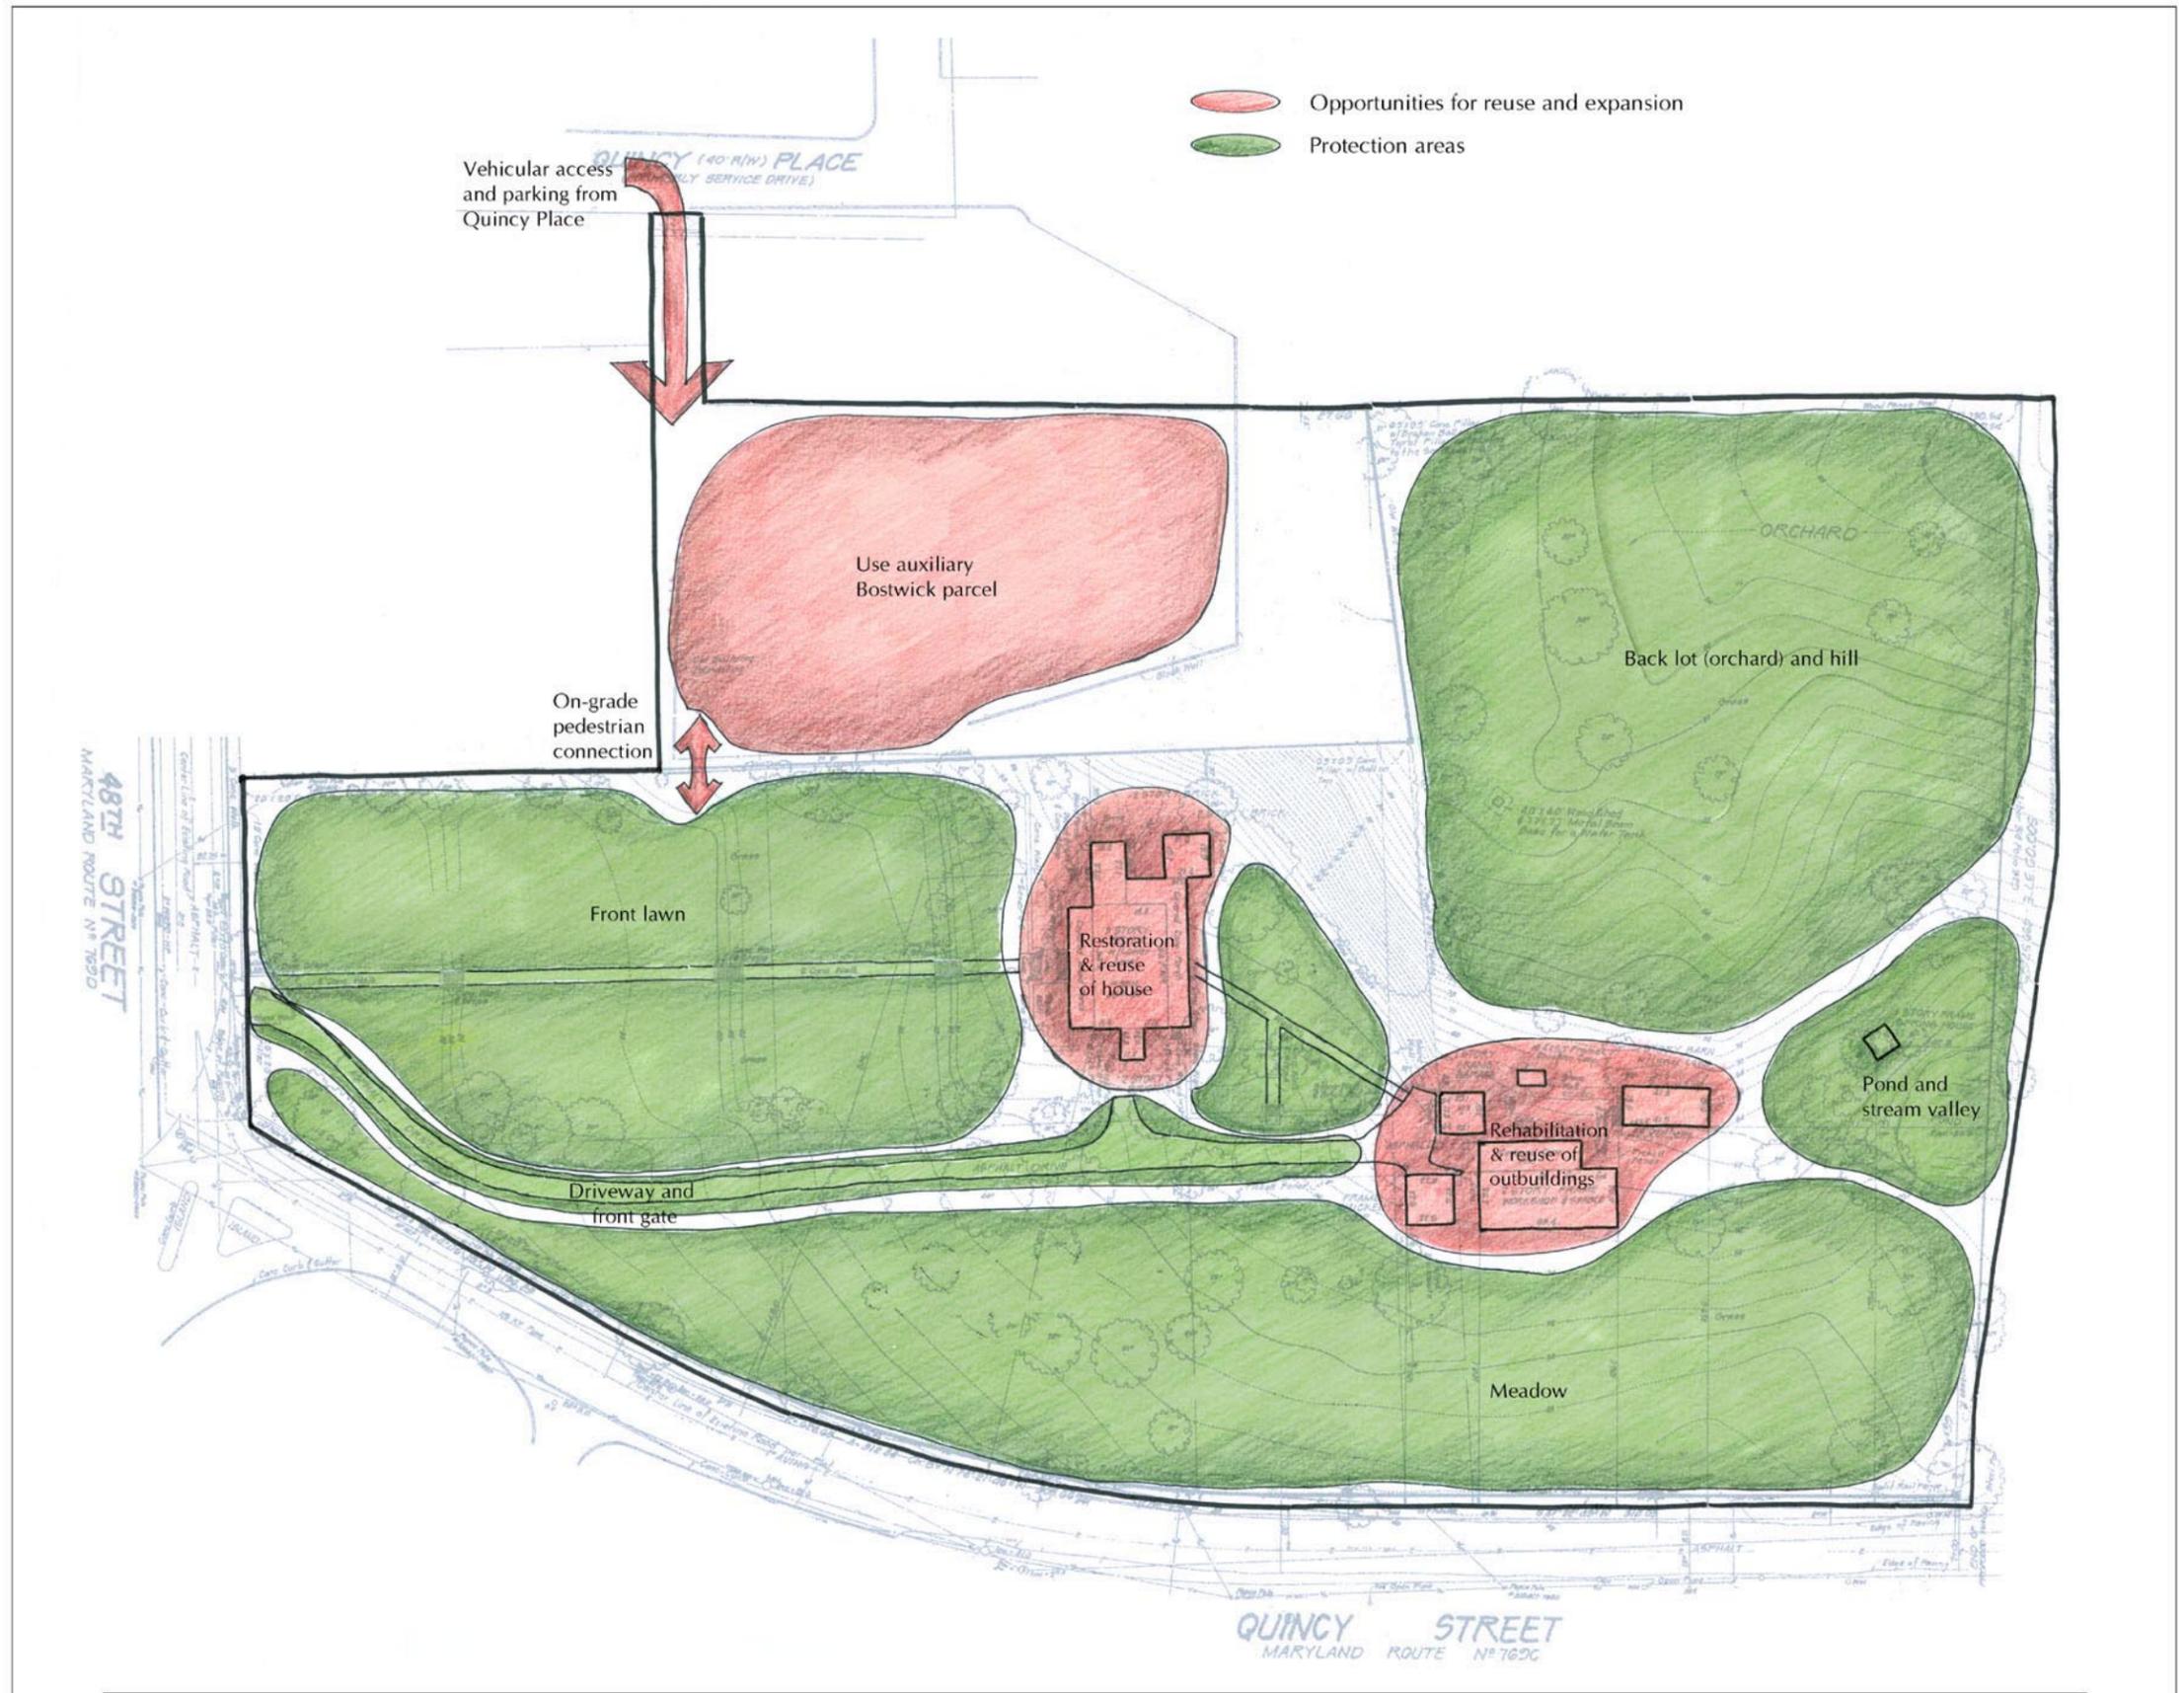
Figure 7 is the culmination of all of the previous existing conditions maps, and shows which areas of the site are appropriate for future development and which areas should be protected from any new construction.

As can be seen, a large proportion of the remaining open [unbuilt] land at Bostwick (in green) has been suggested as a protection area (divided into the various landscape components). All of the various pieces of the existing conditions analysis – from Built Features to Landforms to the Visual and Spatial Analysis – point to the fact that these areas are far too important to jeopardize through new construction. For instance, any new structures or roads on the front

lawn would compromise not only the approach to the house, but also the views and the spatial quality of that unique space. The same holds true for the meadow and the entire portion of land between the driveway and Quincy Street. These regions are critical to maintaining the historical and aesthetic character of the property, as well as maintaining the views and approach to the property from Quincy Street and Kenilworth Avenue. The existing driveway is another area that should be maintained in its existing condition/alignment. Because this is most likely the historic alignment of the drive, and because the turn-off into the front gate at 48th Street is too dangerous to handle a large number of visitors, it should not be significantly modified. Instead, a new method of access and parking for visitors should be developed.

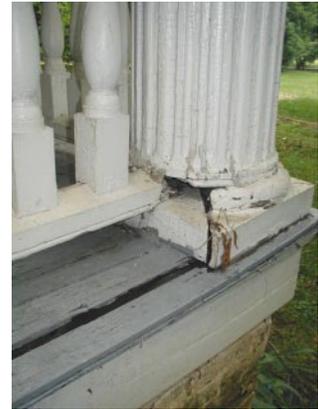
Photo 6

The condition of the roofing, the roof framing, the beaded wood ceiling, and the balusters of the porch is good. The sheet metal gutters and downspouts have deteriorated and need replacement. The fluted wood columns are also in good condition except for the components of the base (torus and plinth) that show evidence of rot (see Photo 6). The wood flooring is beginning to show signs of wear although it is still adequate for use in the short term. There are isolated areas of rot at the exposed edges of the flooring (see Photo 6).

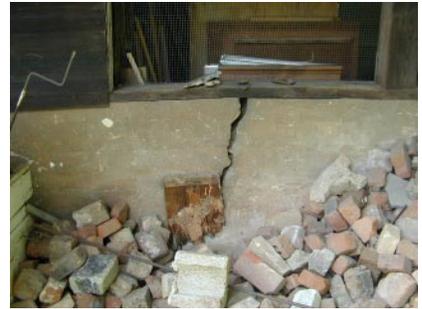
Photo 12

The most significant structural damage to any of the outbuildings occurs at the bank barn. The unbalanced soil condition has caused the building to tilt away from the grade. This has caused the wood post and beam framing at the grade side of the building to tilt approximately 6-inches out of plumb (see Photo 10). At the cantilevered ends of the upper floor joists, shear cracks have developed at the ends of the second floor joists (see Photo 11). Additionally, two shear cracks were observed in the exterior perimeter concrete foundation walls (see Photo 12). This condition will eventually cause the collapse of the building.

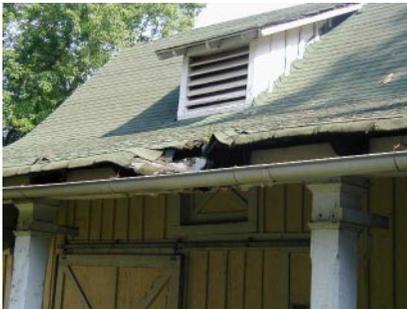
Photo 13

At the stable, minor structural defects were evident. A small portion of the existing porte cochere roof has rotted and collapsed and many of the existing rafter tails have rotted off due to the failure of the gutter (see Photo 13). Deformation is evident at several locations in the main roof. It appears that this deflection is due to either lateral movement of the balloon framed studs which extend several feet above the loft level or by the absence of mechanical connection between the ends of the rafters and wood top plate.

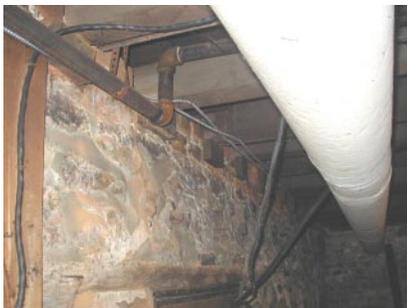
Photo 16

Wood shims have been added to the bearing condition of the first floor joists at the southwest side of the basement where the condition of the brick has deteriorated (see Photo 16). One of the central joists at the east side of the joists has split in half (see Photo 17). A similar condition was observed at the joist located adjacent to the interior masonry wall at the northeast side of the house where the joist has been supplemented by the addition of a W6 steel beam and 2 adjustable steel columns (see Photo 18).

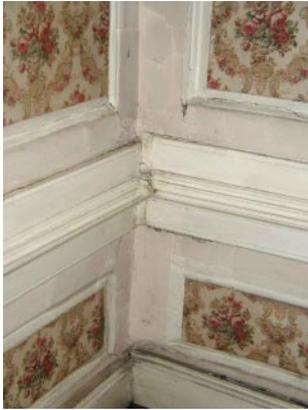
Photo 19

In the parlor, the wall plaster is badly cracked at the exterior walls and has settled in the southwest corner (see Photo 19). The decorative cornice is badly damaged due to horizontal cracking (see Photo 20). All of this appears to be the result of wall movement that relates to our concern over the issue of wall stability and the need for monitoring. The plaster ceiling is sagging due to deflection of the floor above and has already been repaired at least once.

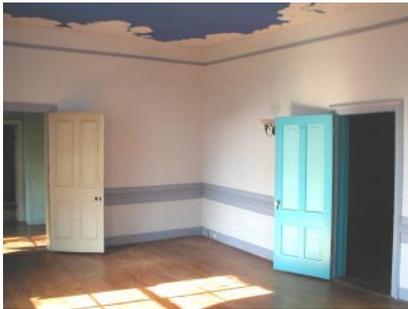
Photo 22

There is a severe sag in the floor of the two rooms above the parlor with the bottom of the sag located in the doorway between the two rooms (see Photo 22). Repairs to the plaster ceiling in the parlor are a result of this excessive deflection. It appears that the floor framing is structurally inadequate at this location and the installation of the dividing partition with no

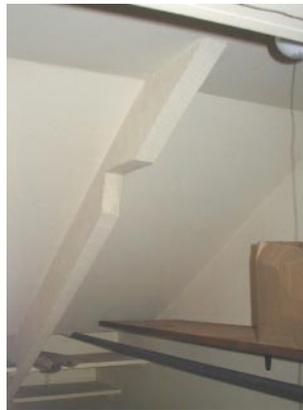
Photo 23

At the two rooms on the north side of the center hall, the sag is much less severe due the presence of a partition below that assists in supporting the weight of the one on the second floor. The stair stringer located between the first floor and the first to second floor landing has been notched at mid-span (see Photo 23).

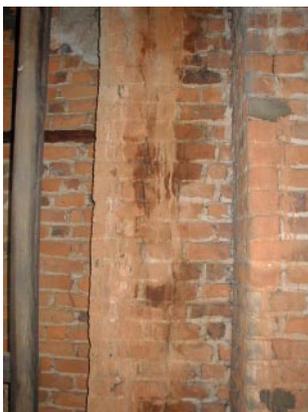
Photo 25

Masonry cracks are visible on the interior face of the south chimney at the east side of the flue (see Photo 25). It appears that the masonry in this area has undergone several previous repairs. A large gap has developed between the edge of the attic floor sheathing and the exterior brick wall at the south side of the house. The width of the gap varies between 5/8-inch at the southeast side of the wall to 1 3/8-inch just east of the chimney to 4-inches at the west side of the chimney (see Photo 26). Three star anchors with tie rods are visible on the exterior face of the south wall at this location.

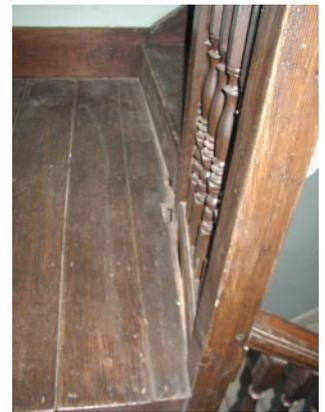
Photo 27

At the stair landing between the 2nd and 3rd floors, the header appears to be pulling away from the sheathing and floor boarding (see Photo 27). Some minor plaster cracks were observed in the wall adjacent to this location.

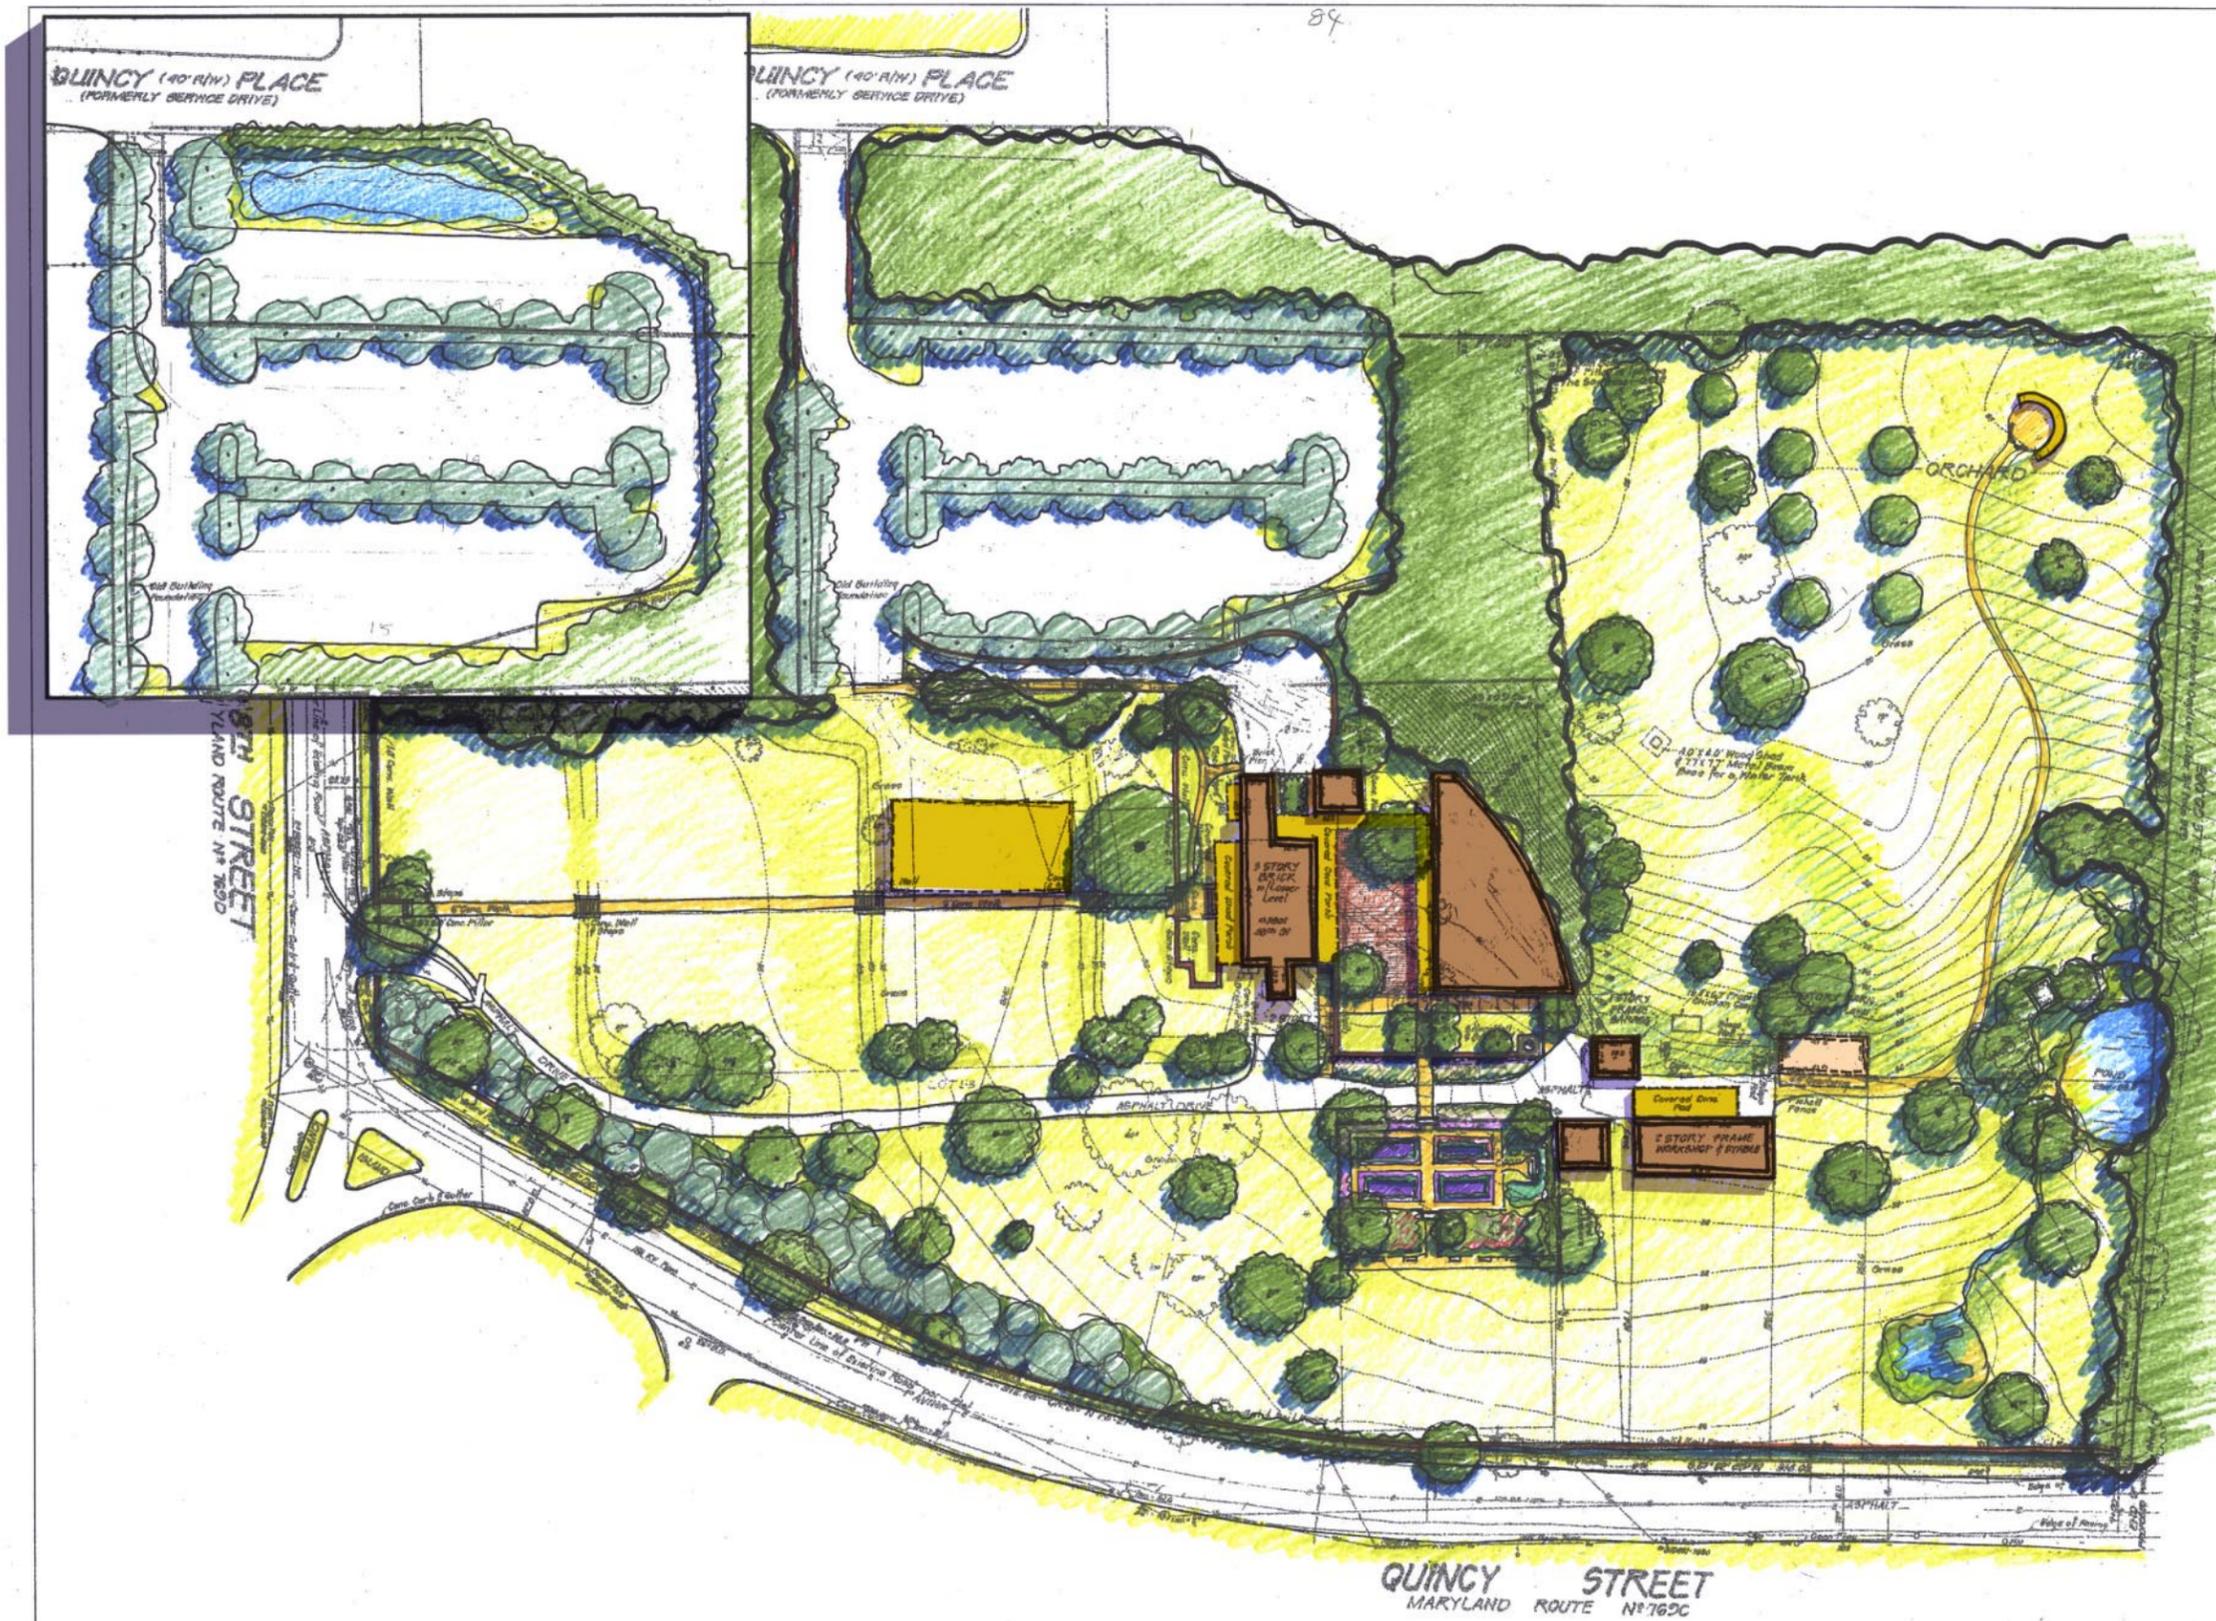
Conference Center and Events Venue
Figure 8
September 2002

- **Alternative 1: The Bostwick Conference Center and Events Venue (Figure 8)**

The property's landscaped grounds would include construction of a semi-permanent tent (approx. 2,500 – 3,000 s.f.); restoration of the mansion's formal gardens (perhaps in the period of significance of the property); the planting of additional trees to buffer noise from, and views to, Kenilworth Avenue; and a replanting/restoration of the orchard.

Parking under this option would be provided on the former bowling alley site to accommodate 80-90 vehicles. This should be sufficient for the uses proposed in this option. In addition, **service and emergency vehicle access** would be through the existing entry gate, which would be widened to accommodate these functions. Finally, **a pedestrian/ADA accessible walkway** to be provided from the parking lot to the house.

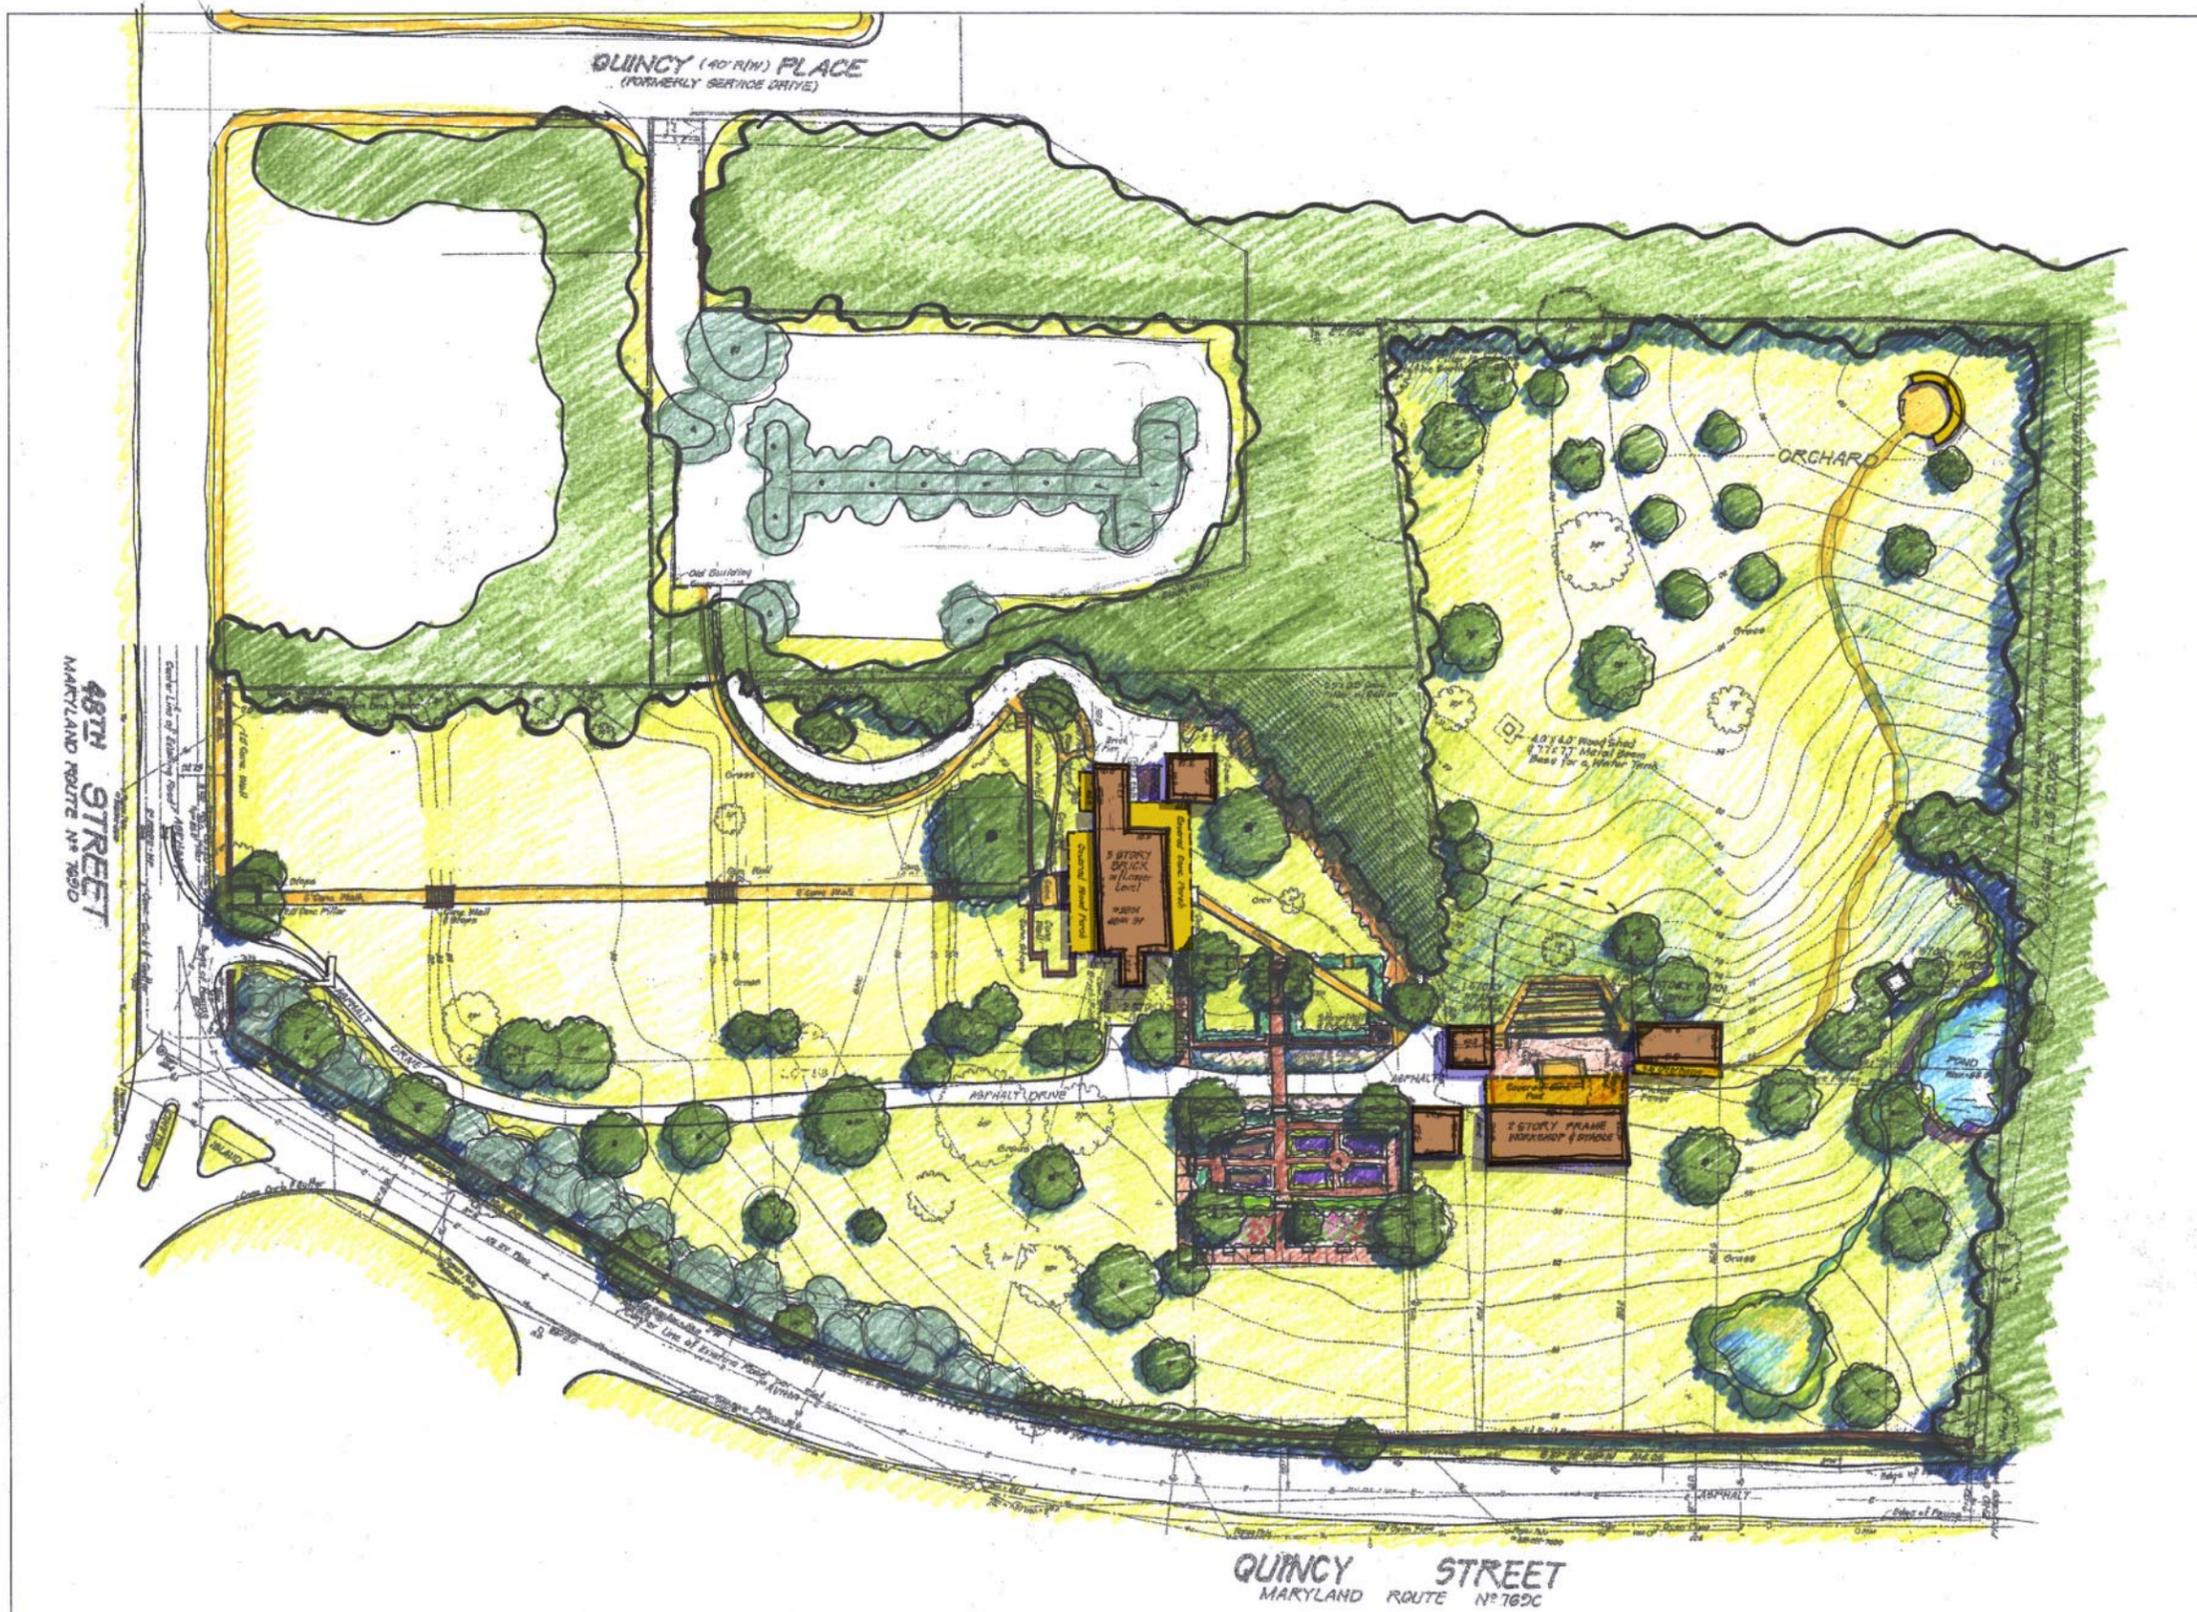
Figure 9
September 2002

- **Alternative 2: The Bostwick Center for the Arts (Figure 9)**

Arts Center, Cafe and Outdoor Theater
