FEASIBILITY STUDY FOR THE ADAPTIVE USE OF THE BOSTWICK HOUSE AND PROPERTY

Final Report

December 2002

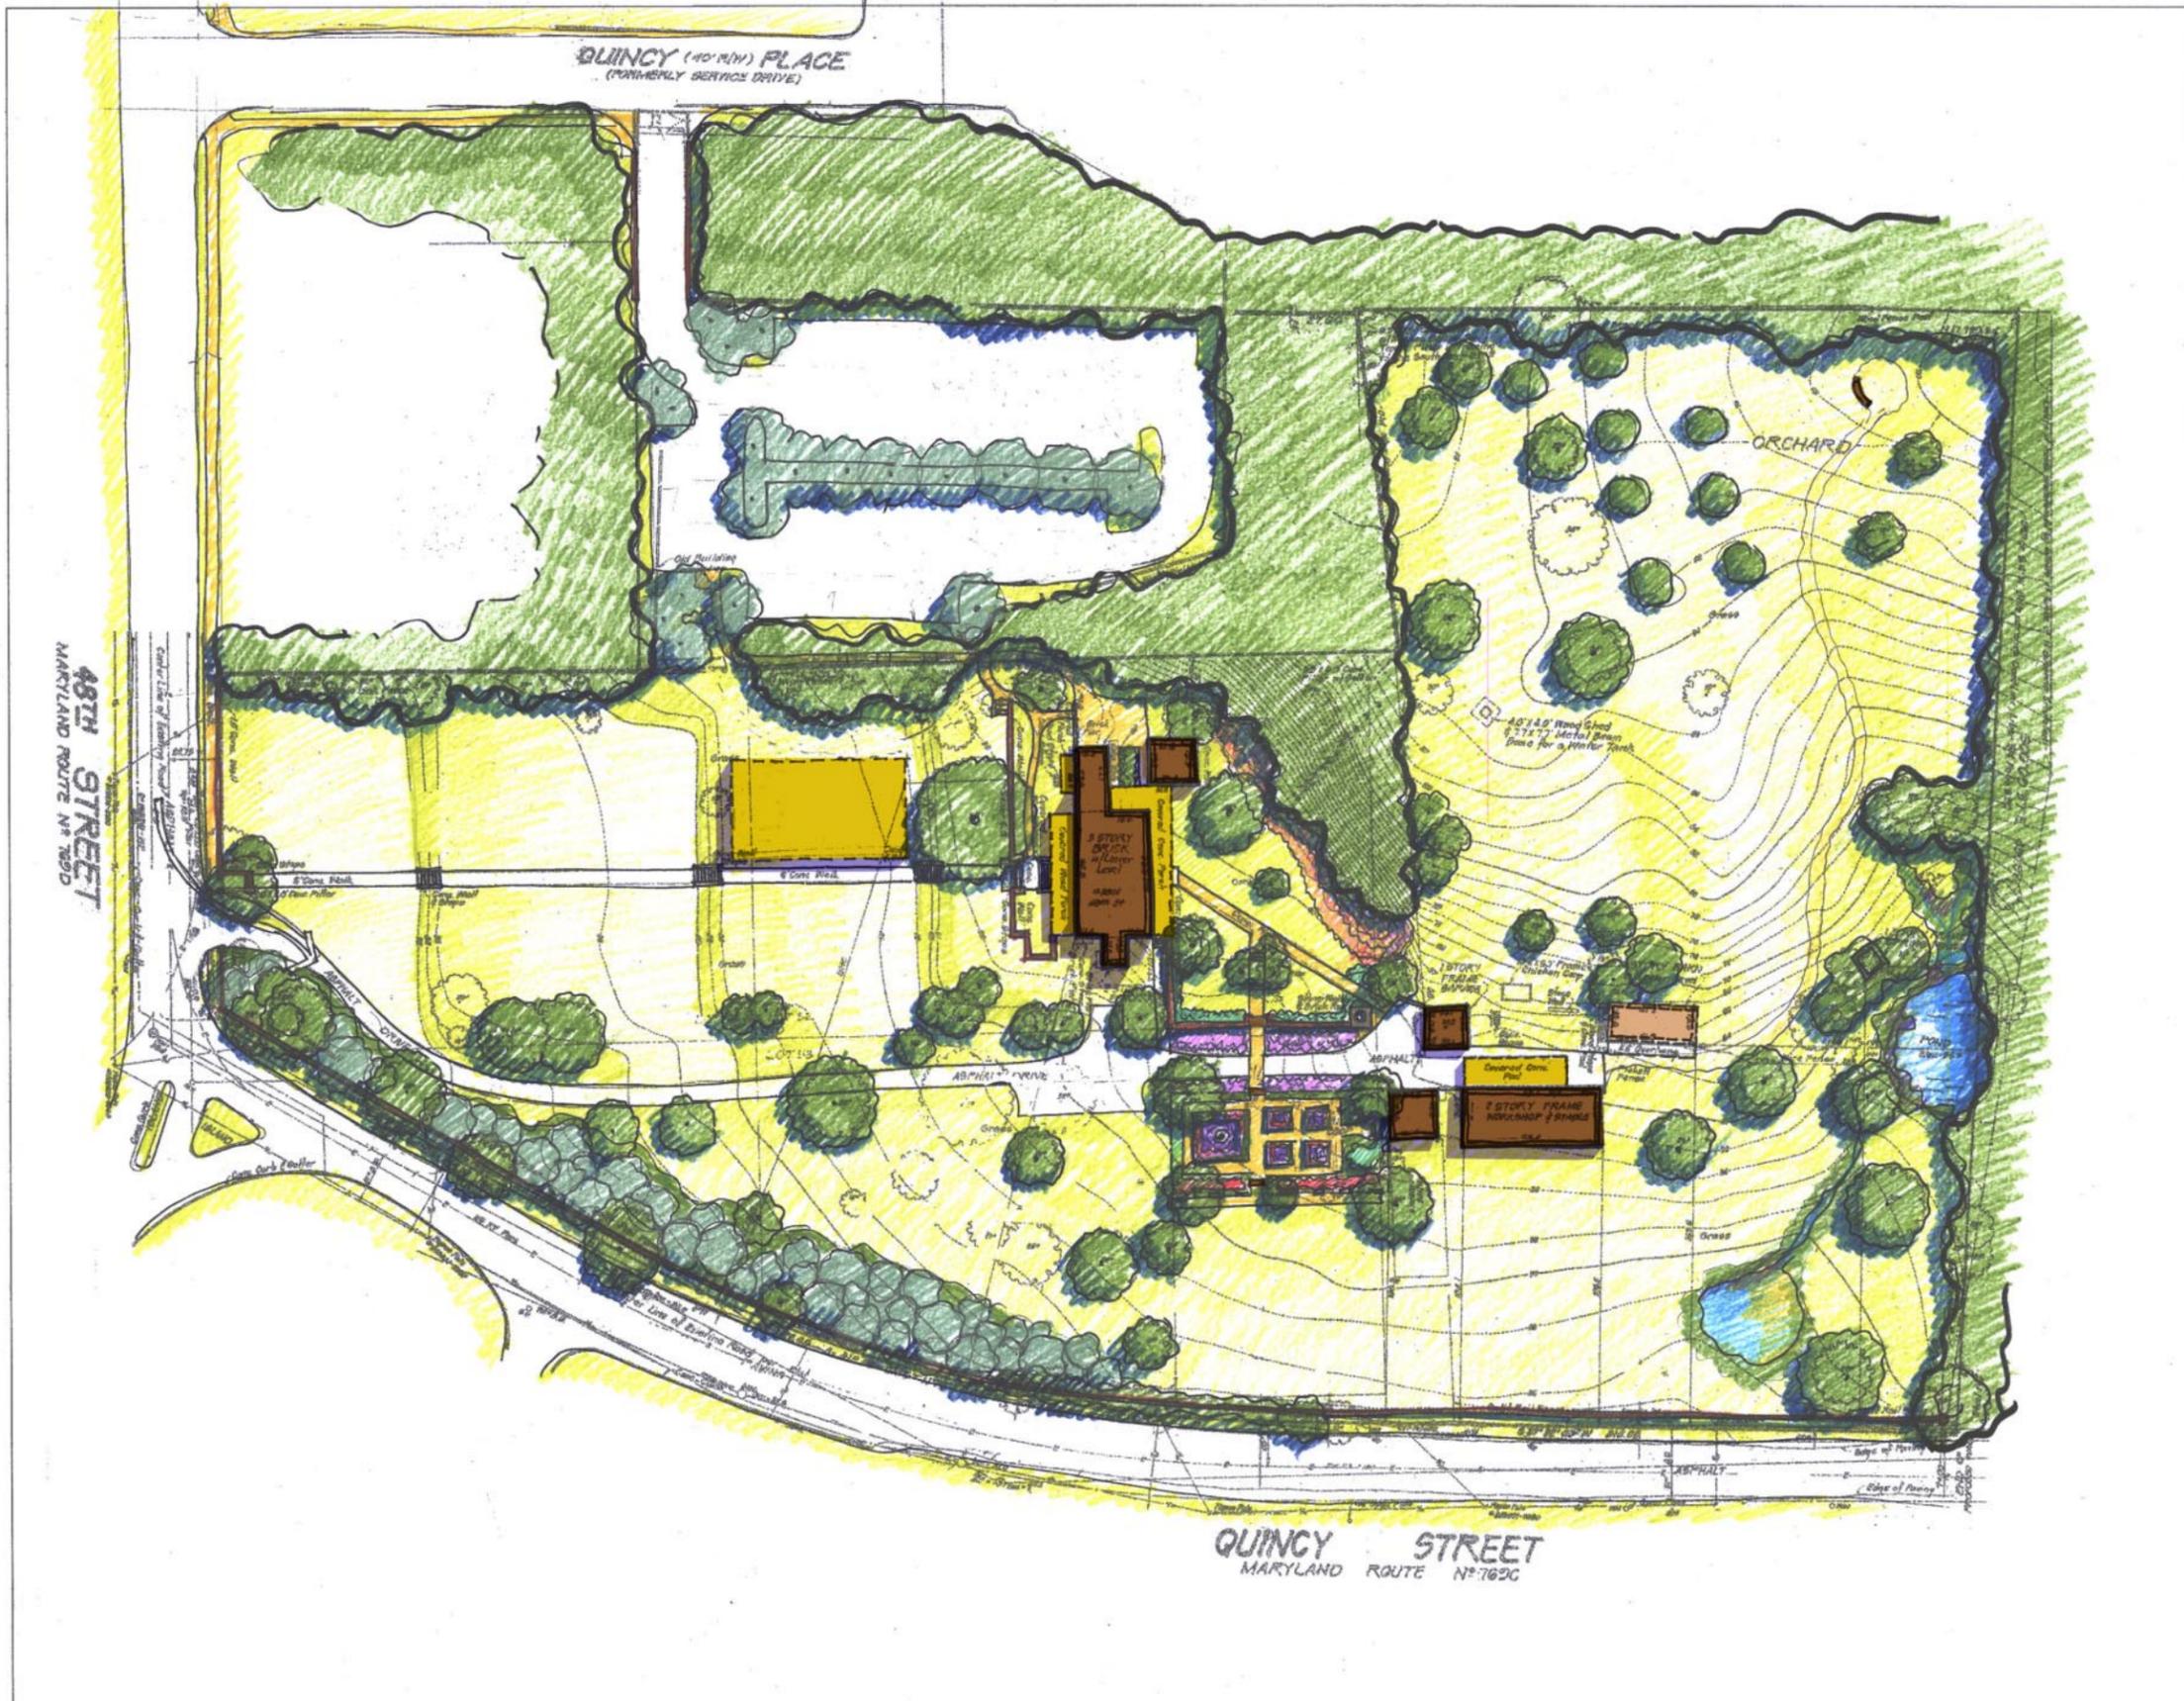
Private Office with Museum
 Figure 10
 September 2002

- **Alternative 3. The Bostwick Office/Museum Complex (Figure 10)**
