Building at Risk:

A Historic Structure Report for Bostwick in Bladensburg, MD

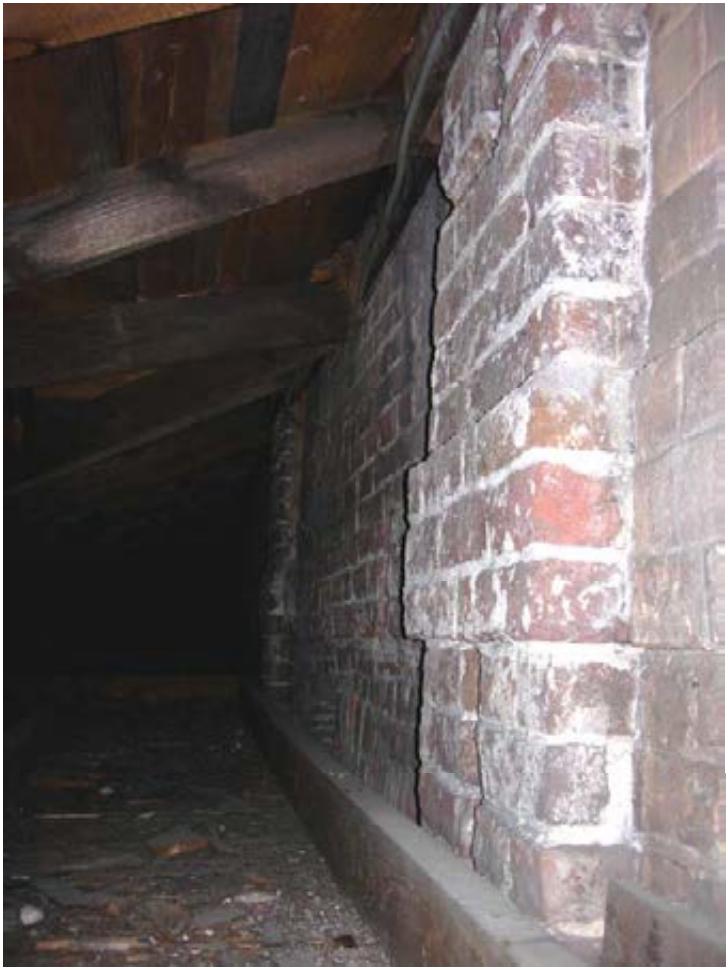
Figure 3-5. The main front porch hatch area. The original brick pilasters and quoins can still be seen in this area. Photograph by Kathleen Manicke.

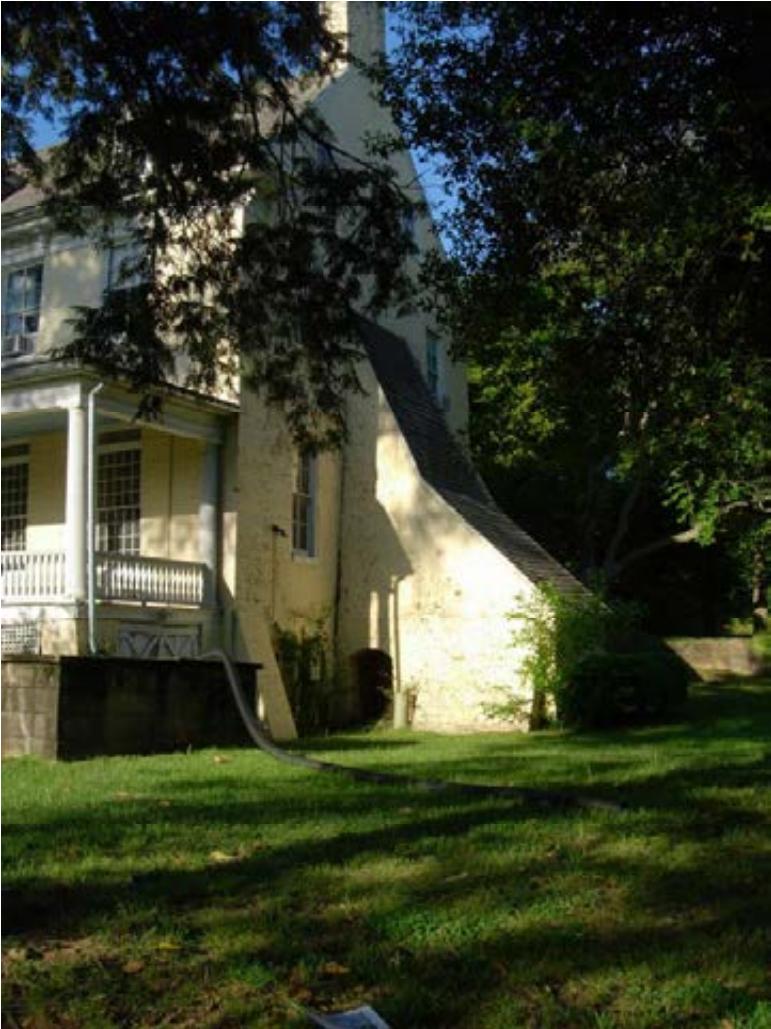
The south façade is dominated by a large brick buttress built during the Stoddert residency to halt the slippage of the house to that side (figure 3-4). The steep shed roof of the buttress is covered with the same roofing material as the house. The east wall of the main buttress is bowed and considerably out of plumb. This buttress wall is punctuated by a single small rectangular opening near the ground. The short south wall of the main buttress has no openings and shows a definite tilt to the southwest corner. The front of the buttress is supported by another smaller buttress at the south end. The north end of this buttress façade has a doorway. Inside the buttress are two small chambers from which the brick vaulting that strengthens the buttress can be seen.

Figure 3-6. Bostwick's south façade. The large buttress was added during the Stoddert period. Photograph by Kathleen Manicke.

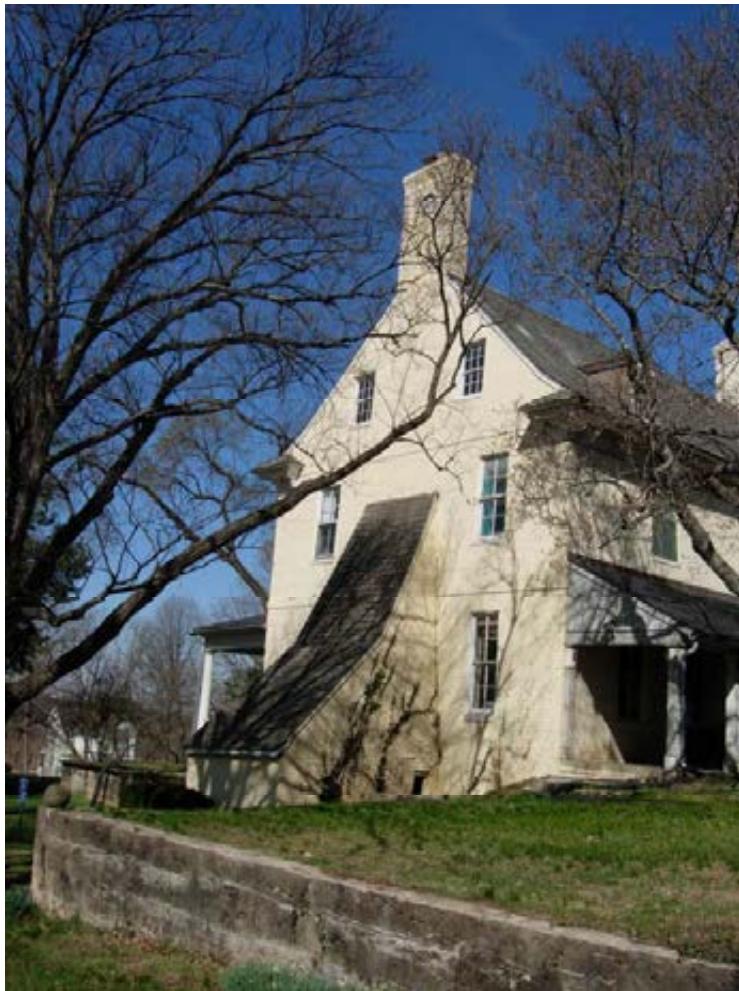
Figure 3-7. Bostwick's southern façade and large central buttress. Photograph by Kathleen Manicke.

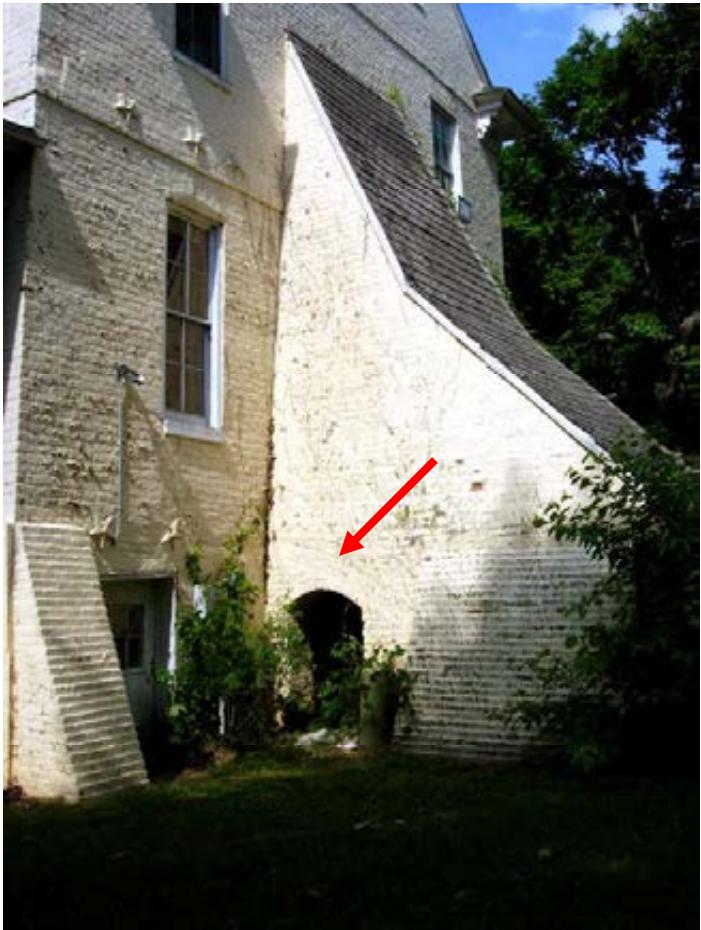
Figure 3-9. Entrance to the large central buttress. Line of ceiling vaulting is visible over the door (red arrow). Photograph by Kathleen Manicke.

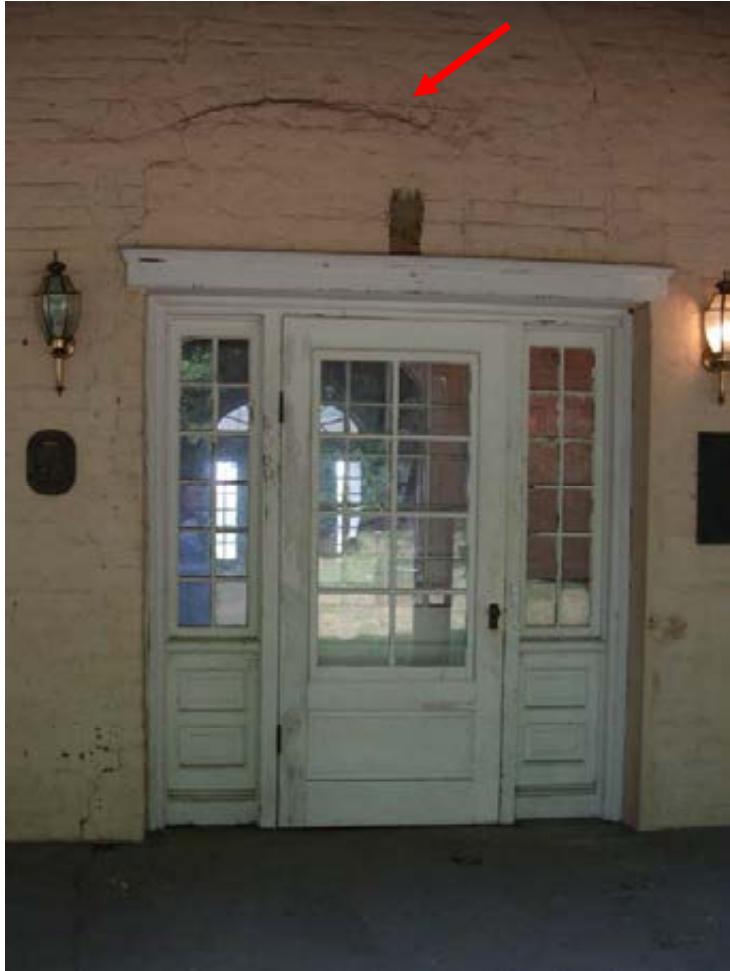
Figure 3-15. The rear entry. A red arrow marks the shadow arch above. Photograph by Kathleen Manicke.

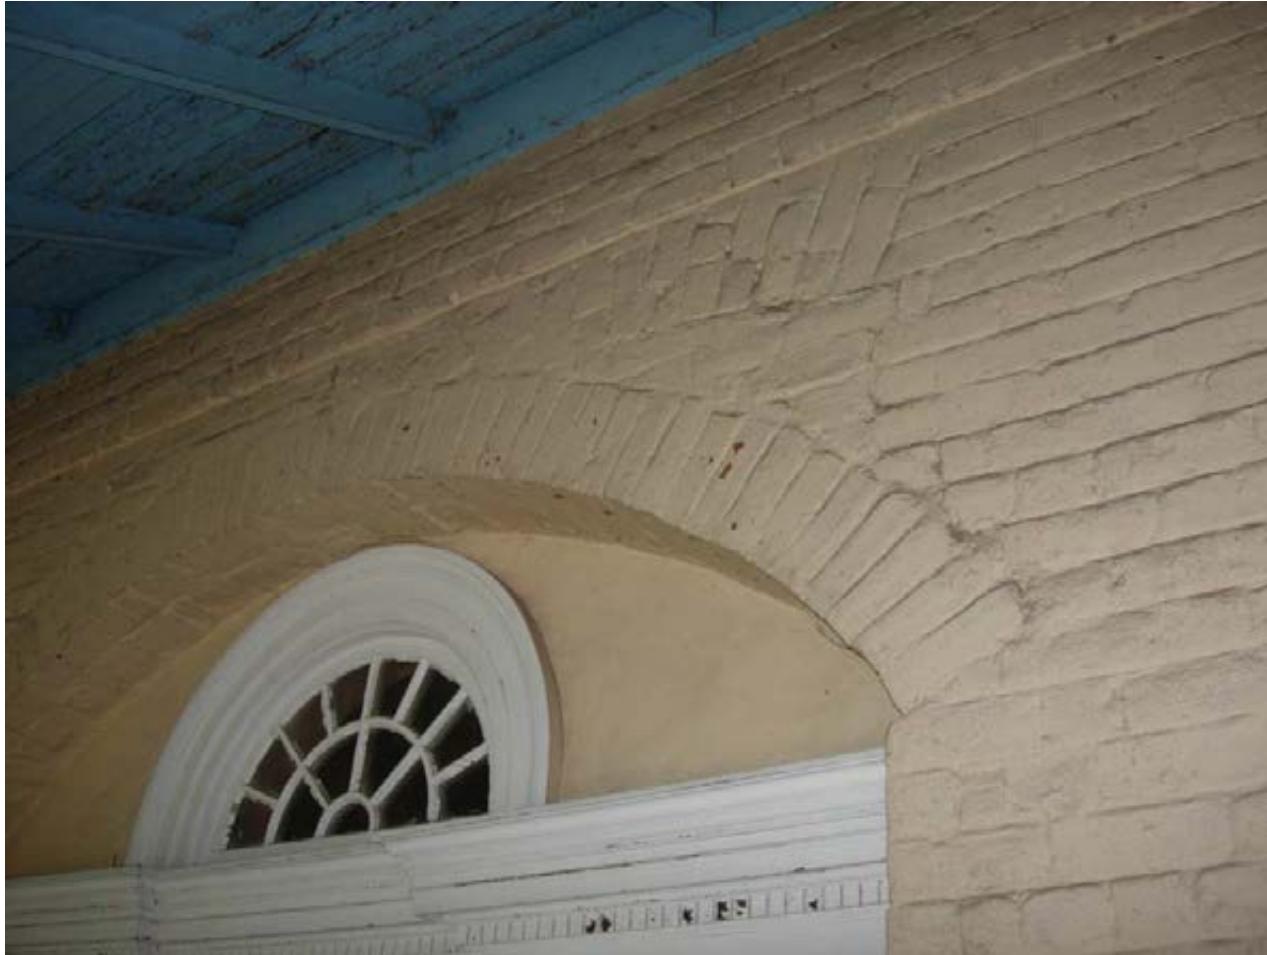
Figure 3-16. Shadow of a former window arch over the Palladian window. Photograph by Kathleen Manicke.

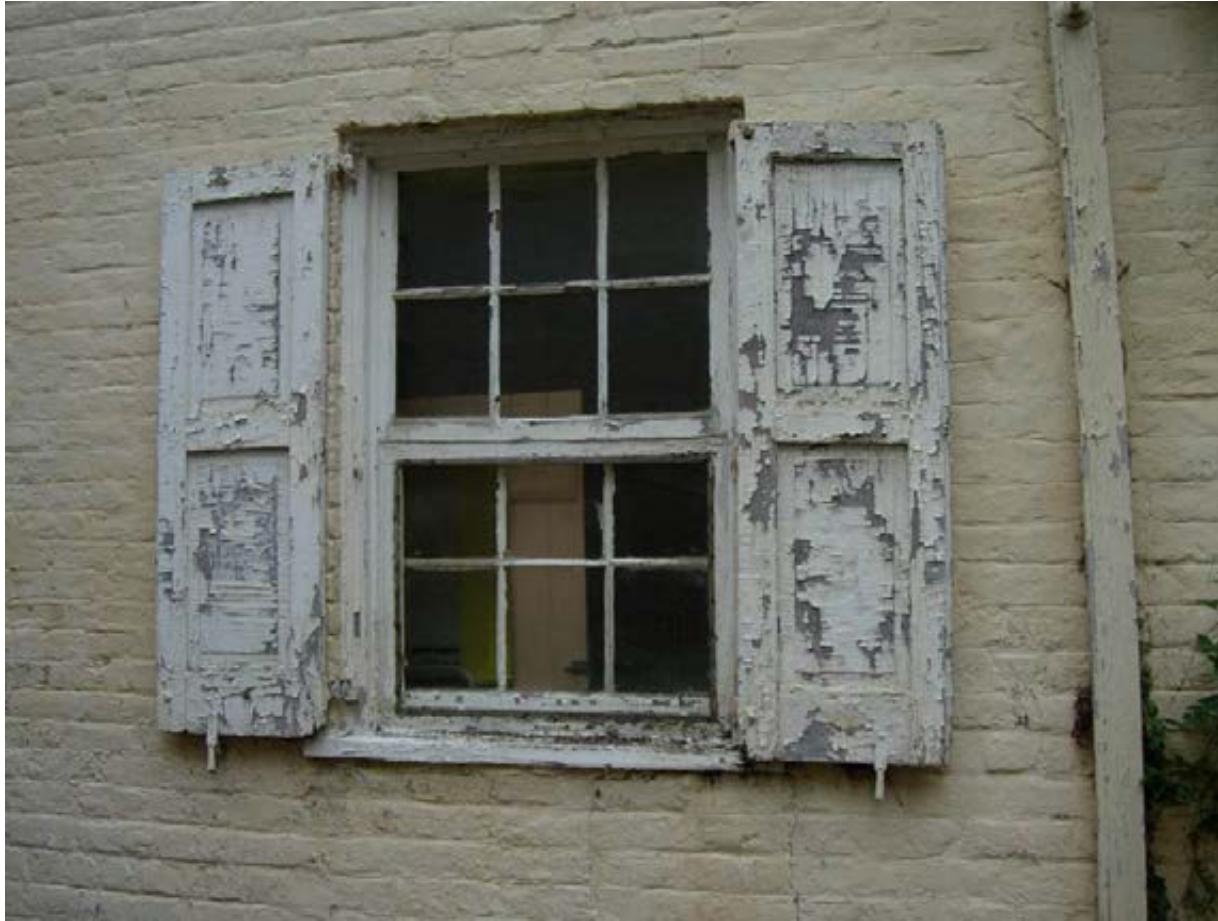
Figure 3-19. The northern window of the Stoddert addition's east façade. Photograph by Kathleen Manicke.

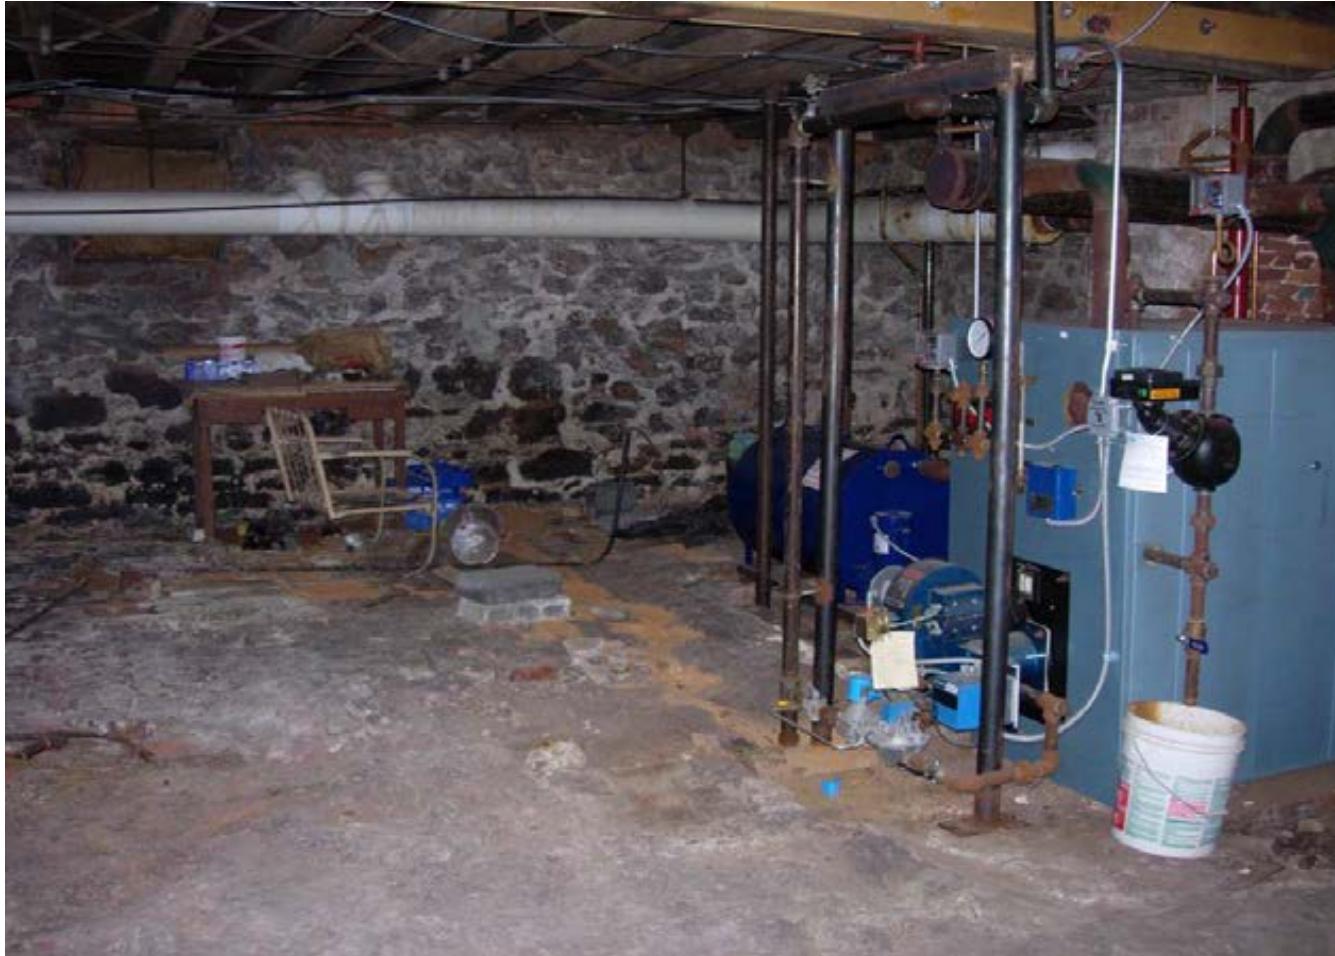
Figure 4-2. The south bay of Bostwick's basement looking toward the east wall. Photograph by Kathleen Manicke.

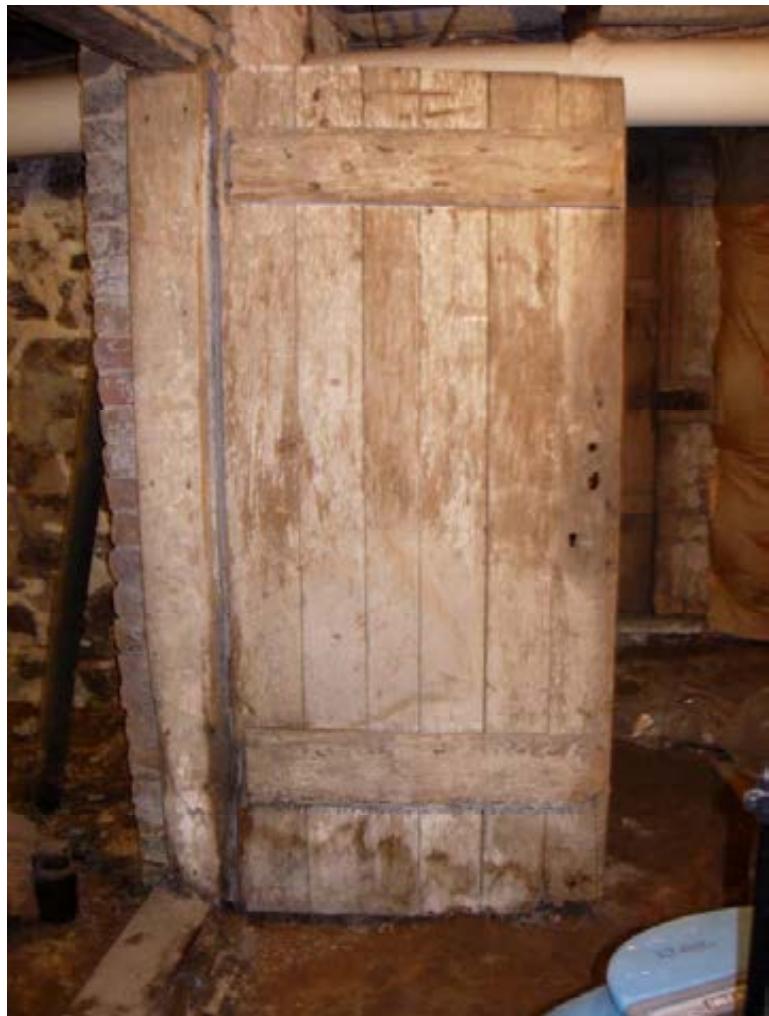
Figure 4-5. The west panel of the double door leading from the south bay to the central bay of the basement. Photograph by Kathleen Manicke.

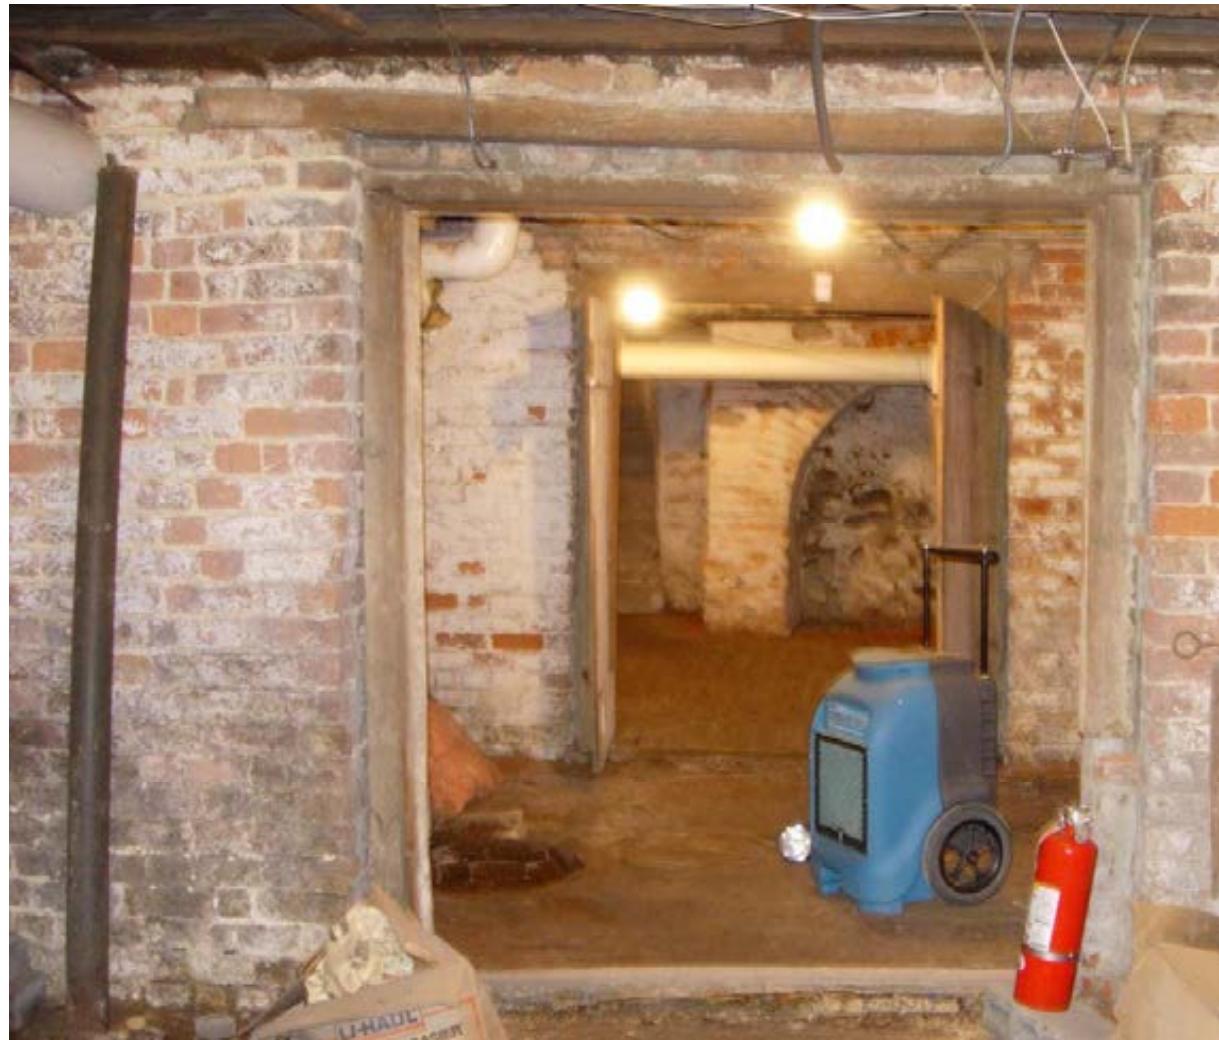
Figure 4-6. The double door on the north wall of the south bay through the central bay into the north bay of the basement. Notice the frame and lintel of the double door. Photograph by Kathleen Manicke.

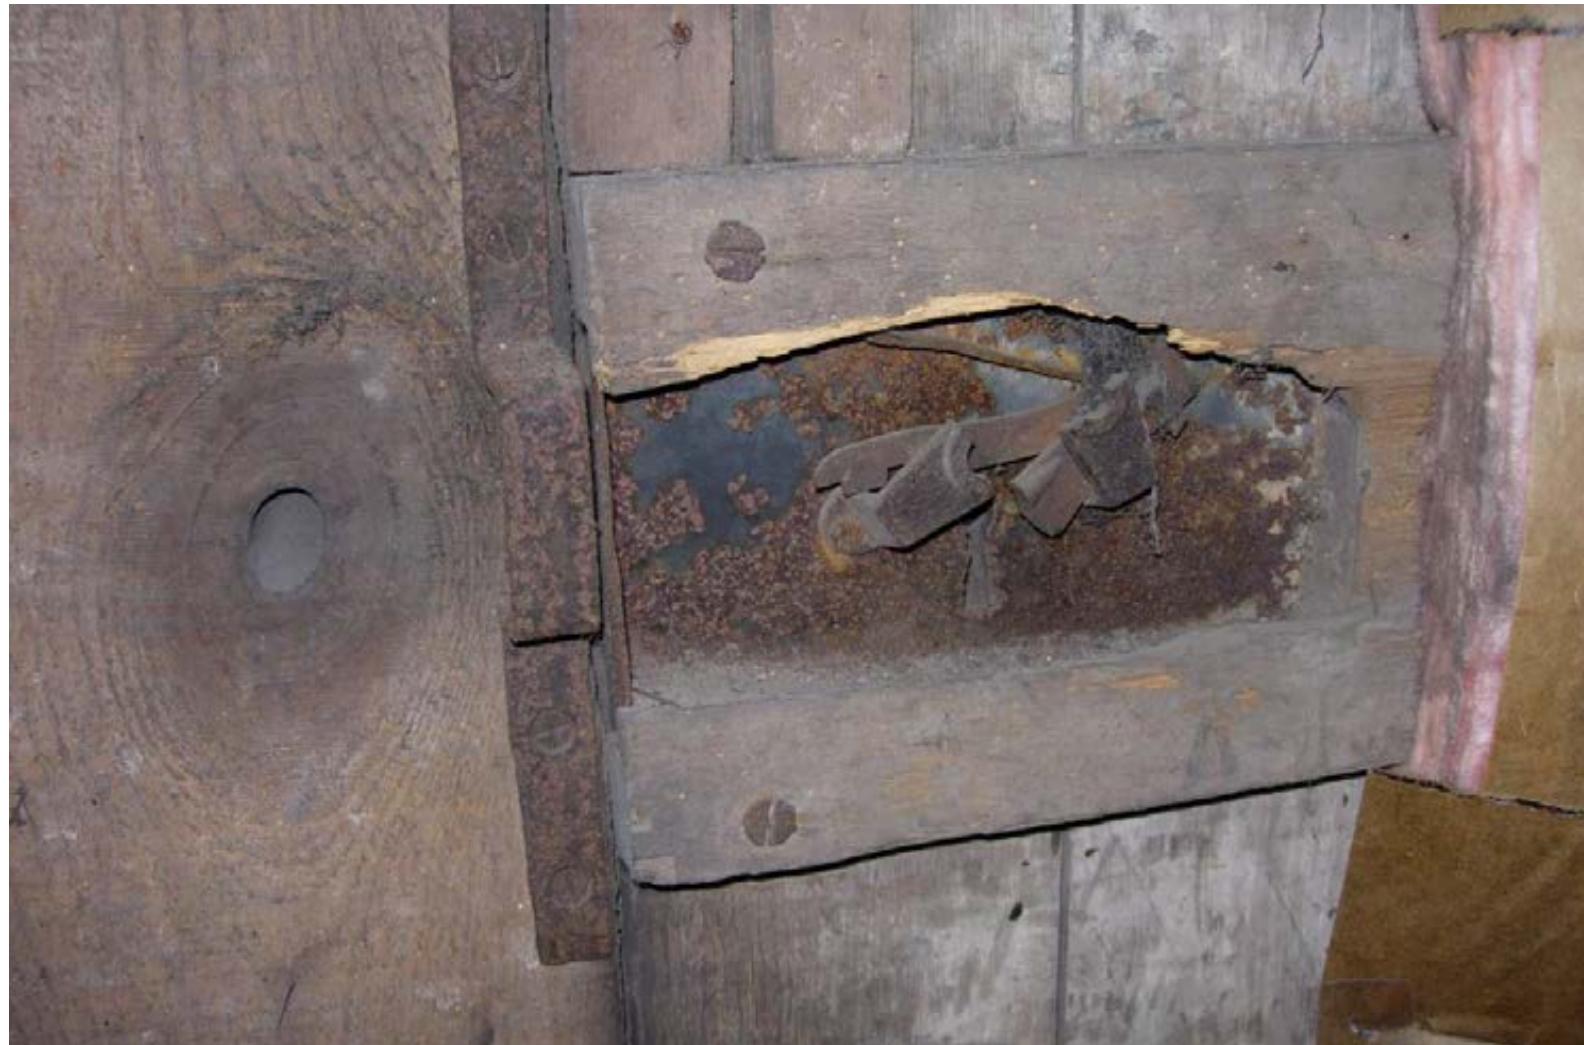
Figure 4-15. The steel lockset on the exterior door in the west wall of the basement's central bay. The light weight steel used in this lockset indicates a late nineteenth or early twentieth century date of manufacture. Photograph by Kathleen Manicke.

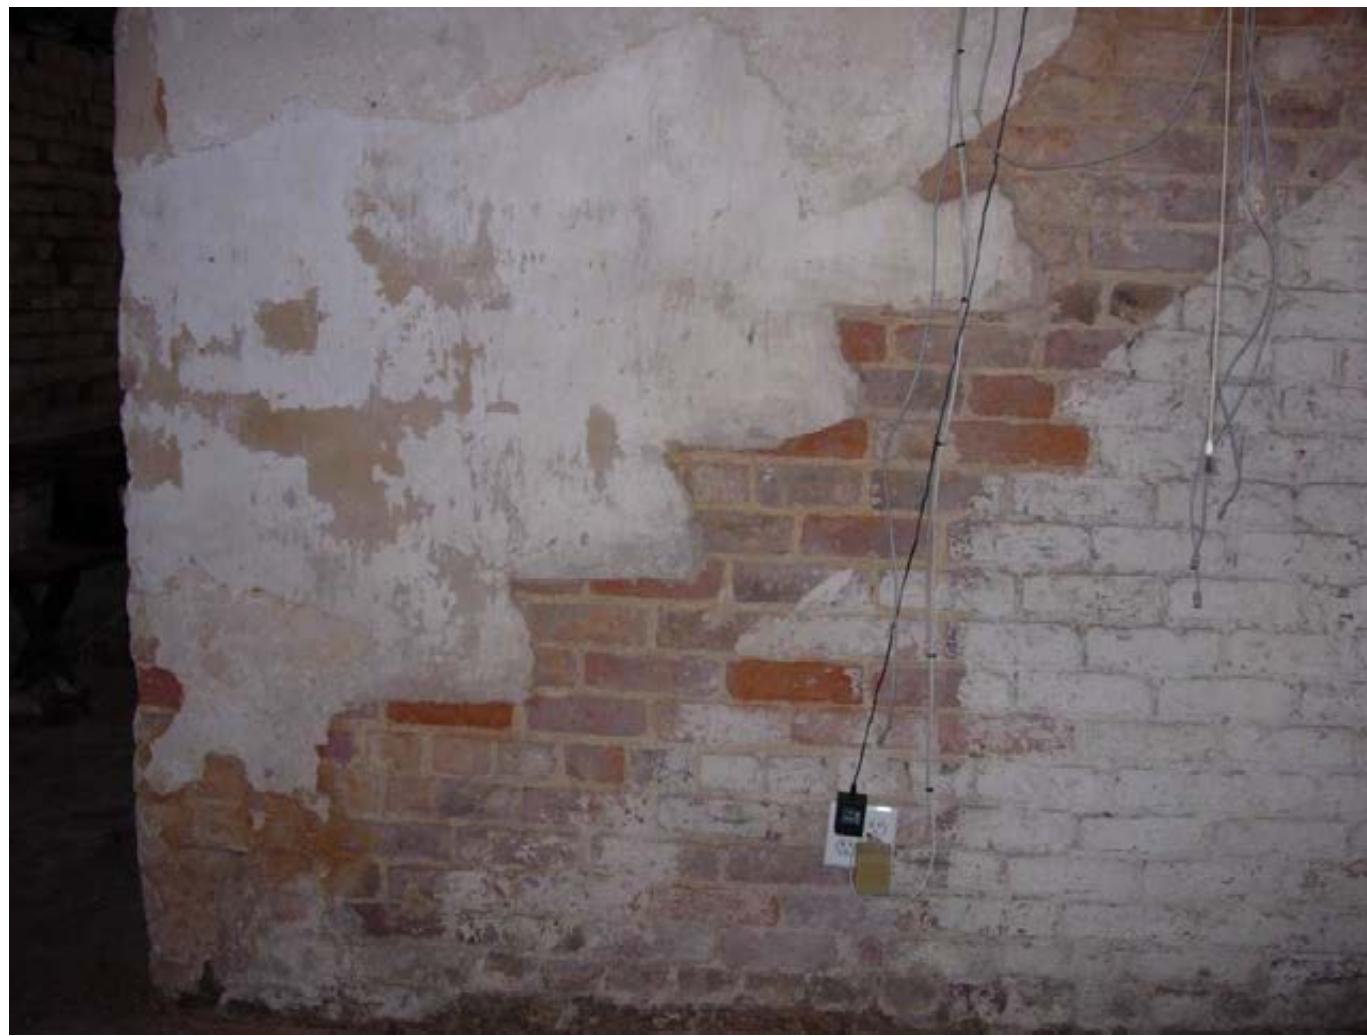
Figure 4-16. The ghost of a former stairway along the central bay's north wall. Photograph by Kathleen Manicke.

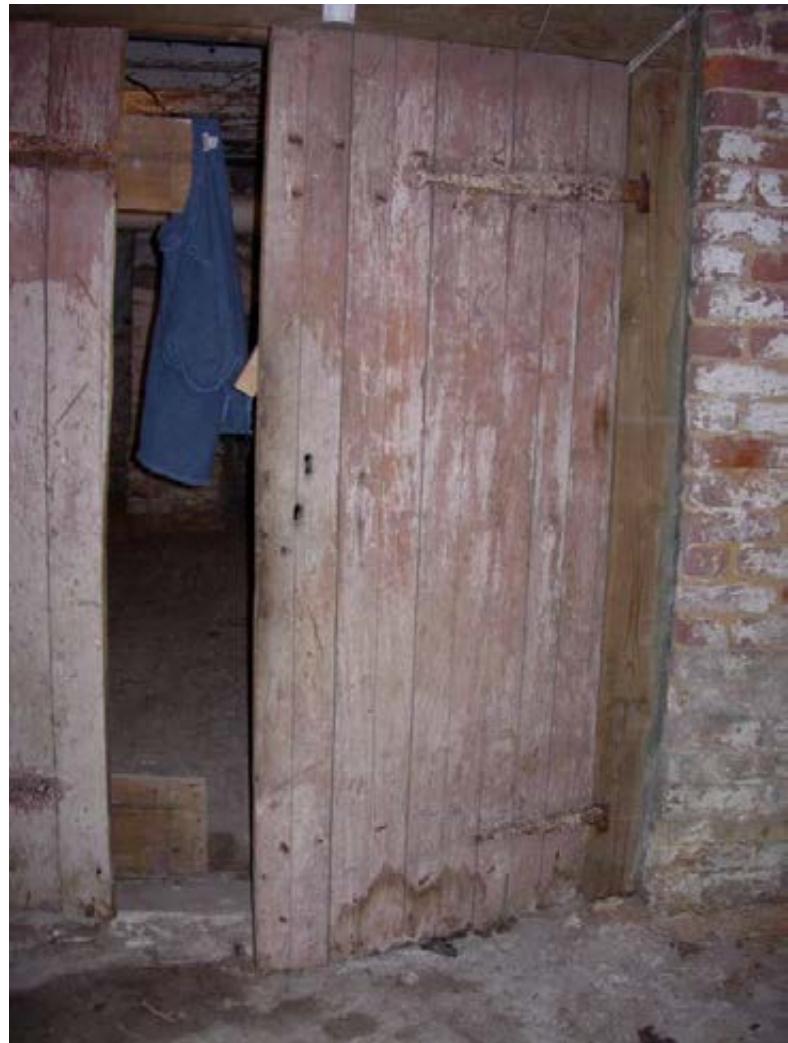
Figure 4-17. The door leading from the central bay to the west room of the north bay. Note the large strap hinge's square nails, and water damage on the bottom of the planks.

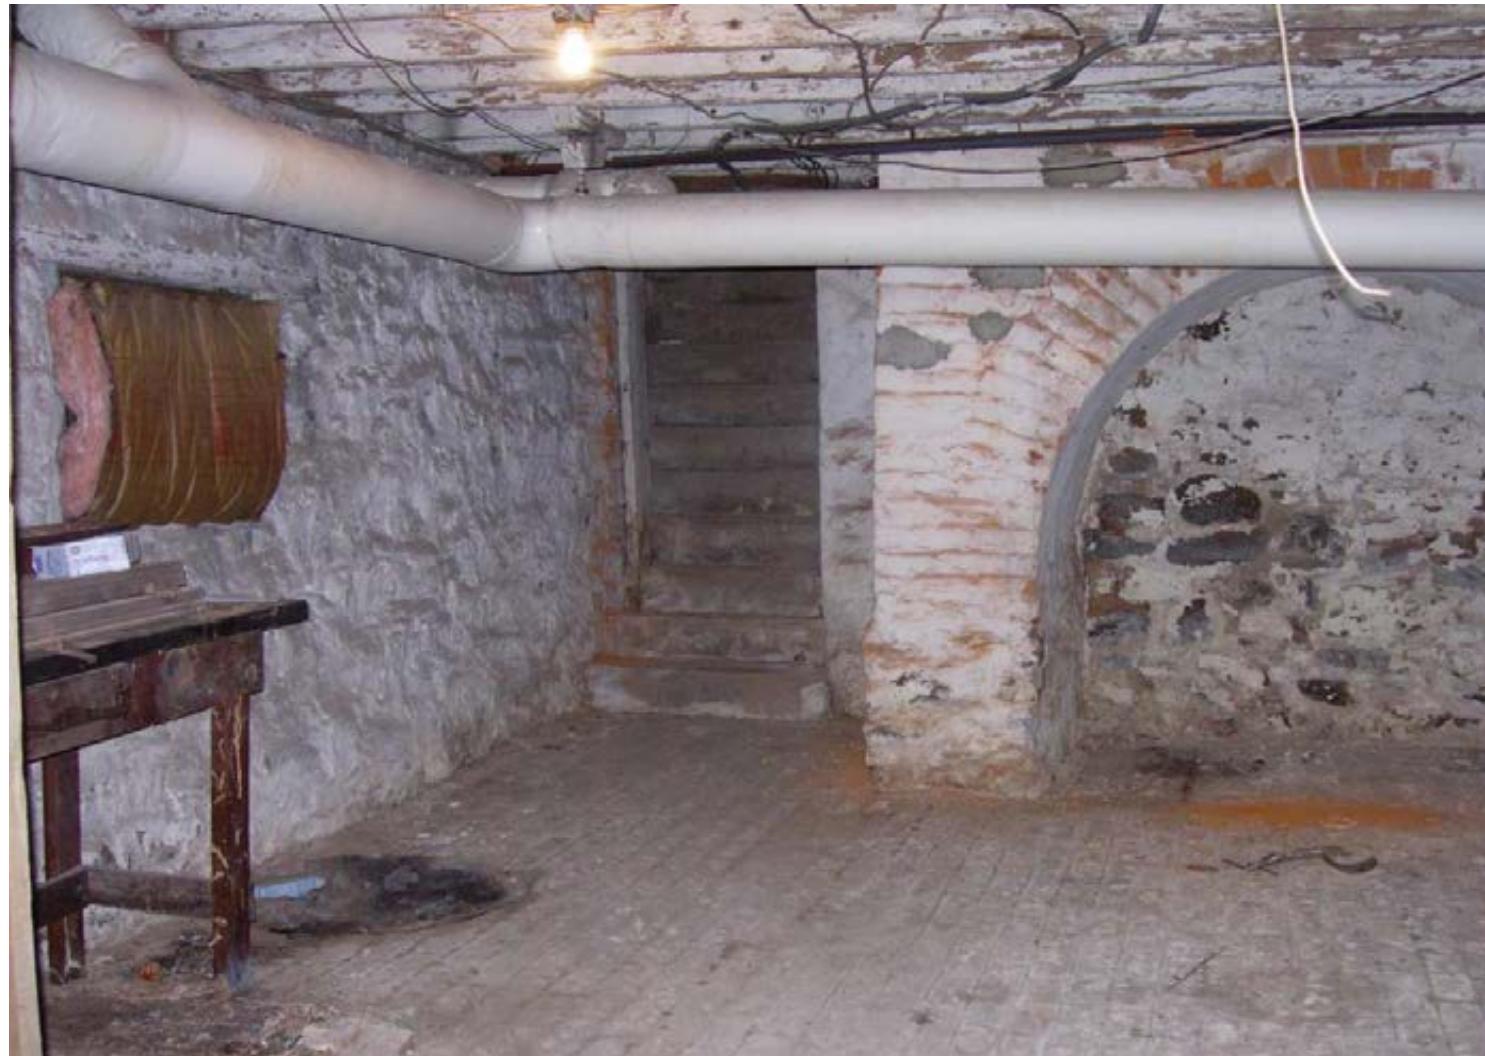
Location: Basement North Bay~Ceiling and Floor of the West Room					
Item	Date	Size	Description	Condition	Figure #
Joists	1746	3"to 4" W x 8" to 9" H	Joists in the this bay run east-west and are of an undetermined variety of wood; some are sistered with smaller flat lumber apparently to level the floors above--others have nailing blocks; although some frassing is evident, joists in this room appear sound upon probing.	Fair to good condition.	4-25
Subflooring	18th to 19th century	2½"W	Constructed of tongue-in-groove flooring with a routed bead down the center.	Good condition.	4-25
Flooring	18th to 19th century		Floor seems to be made of a more modern type of pressed brick, likely dating to the Kyner restoration; the floor is more even than floors in other parts of the basement; floor has been painted.	Good condition; with some tree roots causing small uneven areas.	4-20

Figure 4-20. The west room of the north bay in Bostwick's basement showing the west stone wall as well as the stairs and relieving arch on the north wall. The large pipes are for the steam heating system. Photograph by Kathleen Manicke.

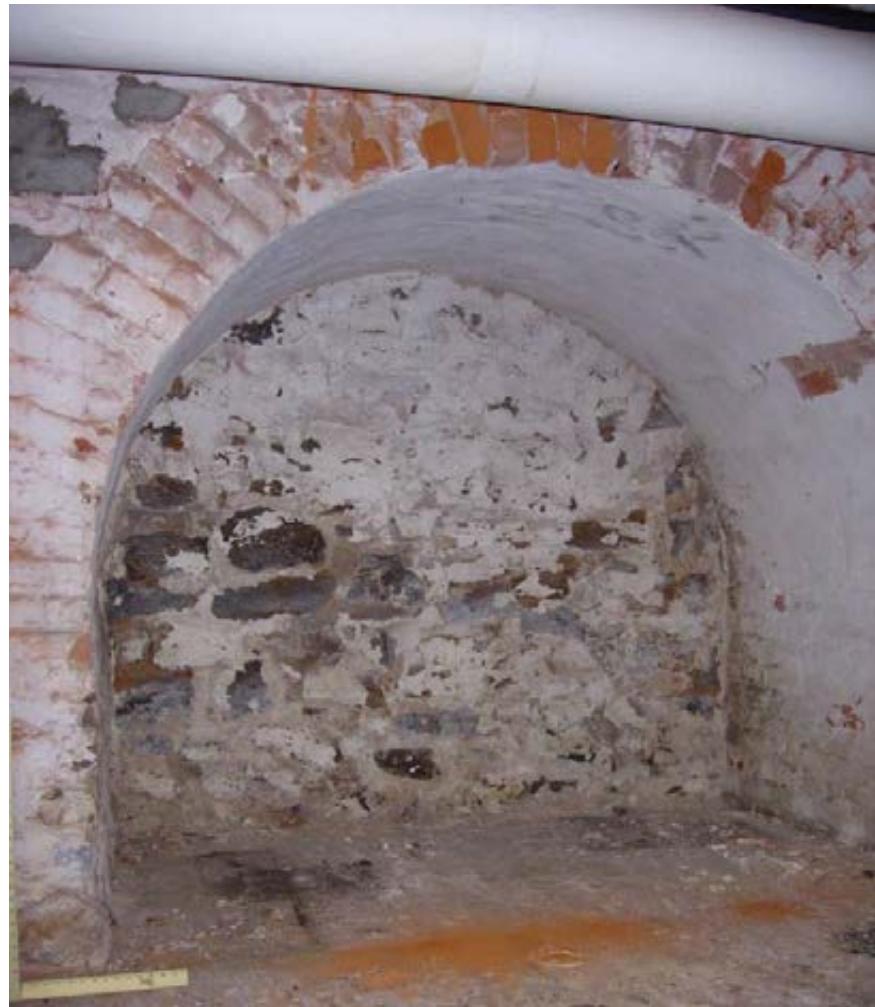
Relieving arch	1746	73" H x 85" W by 4' deep	Stone and brick relieving arch that supports the chimneys and fireplaces above; the back wall of the arch is part of the stone foundation wall; brick Roman arch; inappropriate parging above and inside the arch makes it difficult to determine the type of mortar and its condition; some spalling of the brick, particularly at the top of the arch; moisture infiltration has washed away the mortar and brick at the rear of the arch.	Fair to good condition.	4-20 4-21
----------------	------	-----------------------------------	--	-------------------------	--------------

Figure 4-21. The relieving arch in the west room of the basement's north bay. The northern stone wall of the basement forms the back wall of the arch. Notice the spalling brick at the top of the arch. Photograph by Kathleen Manicke.

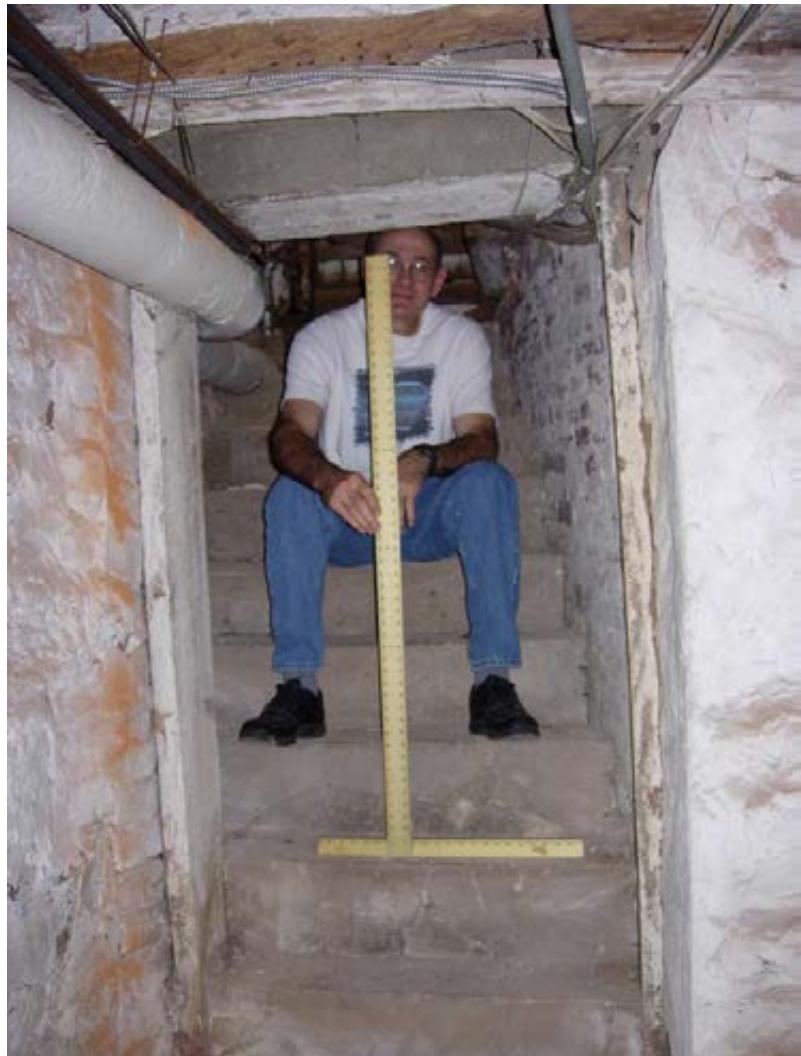
Location: Basement North Bay~North Wall of the West Room					
Item	Date	Size	Description	Condition	Figure #
Stone wall	1746	7'4' H	Irregularly sized, uncoursed, undressed stone of undetermined variety; large areas of inappropriate repointing at two different times--once with what appears to be a lime-based product and once with a cement-based mortar; mortar joints were not properly struck after repointing and obscure the stone in some places; the stone on this wall is further indication that this was once the north end wall of the house.	Fair to good condition.	
Stairs	Late 19th-20th century		Concrete stairs in the northwest corner lead to the Stoddert kitchen wing and most likely date to the Kyner renovation in 1904 or later; stairs are steep with inconsistent tread depths and rises; lack handrail; as stairs pass under the house's sill plate, there is only 4' of headroom.	Fair to good condition.	4-24

Figure 4-24. There is very little headroom, approximately four feet, in the existing stairs to Bostwick's basement. Photograph by Kathleen Manicke.

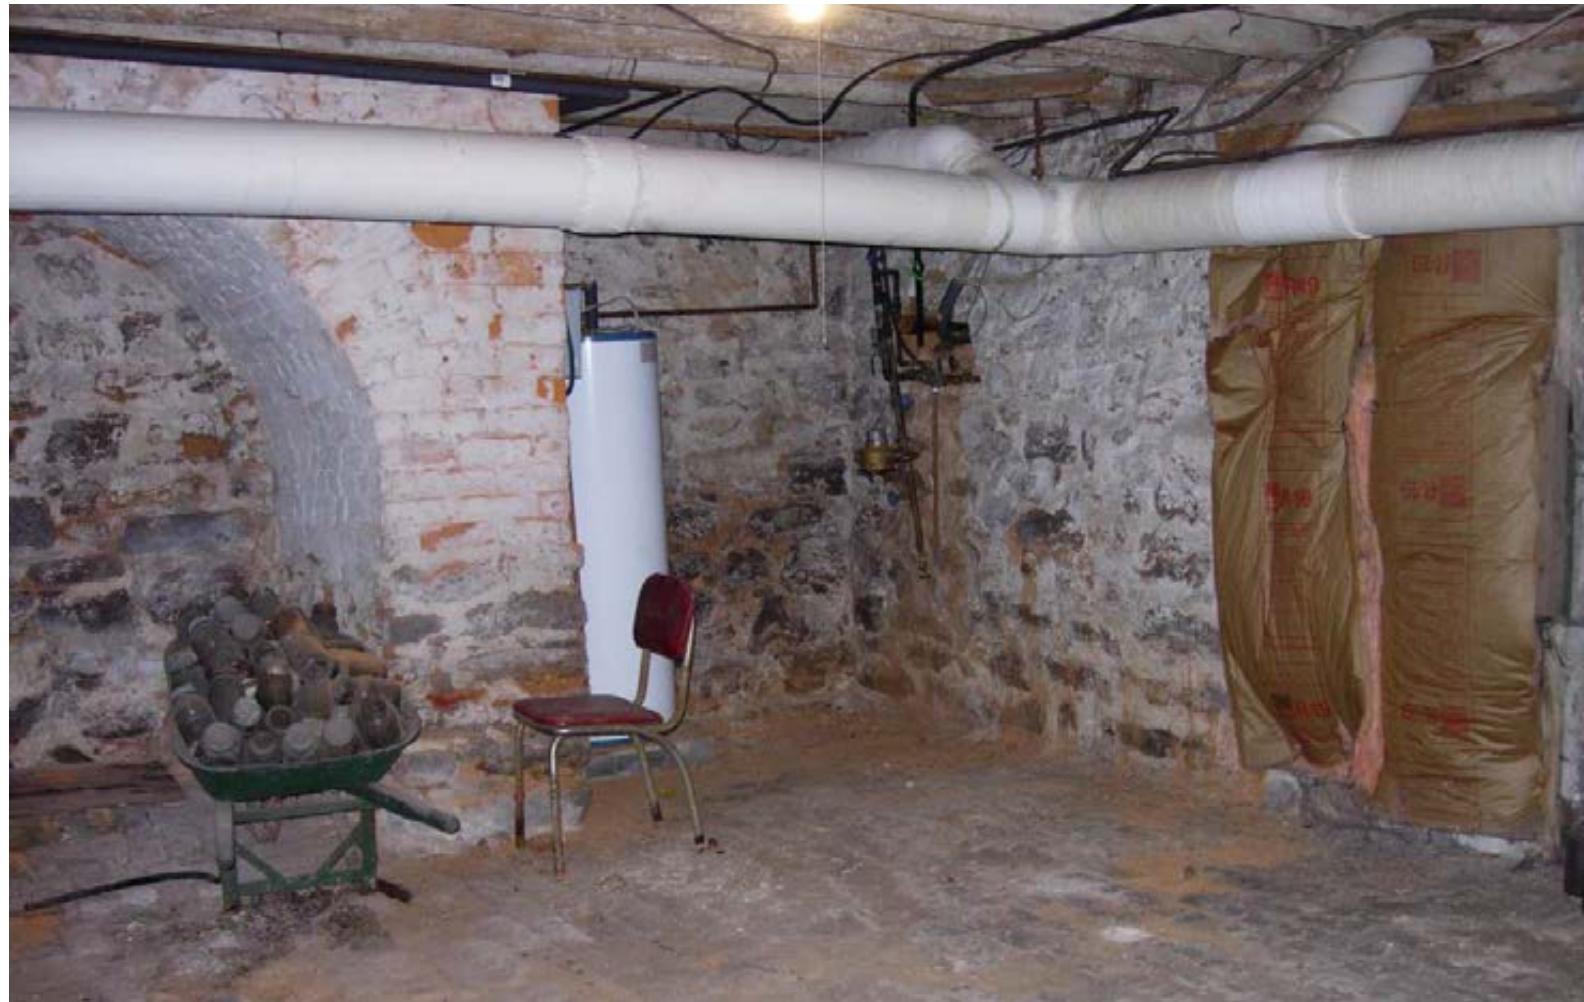
Location: Basement North Bay~West Wall of the East Room					
Item	Date	Size	Description	Condition	Figure #
Brick wall	18th to 19th century		Interior wall built of soft, hand-made brick laid in an irregular pattern; inappropriate repointing with cement-based mortar; northern corner of this wall joins with the relieving arches in both the east and west rooms of this bay; ceiling joists pass through this wall.	Good condition.	4-26

Location: Basement North Bay~North Wall of the East Room					
Item	Date	Size	Description	Condition	Figure #
Stone wall	1746	7'4' H	Irregularly sized, uncoursed, undressed stone of undetermined variety; large areas of inappropriate repointing at two different times--once with what appears to be a lime-based product and once with a cement-based mortar; mortar joints were not properly struck after repointing and obscure the stone in some places; the stone on this wall is further indication that this was once the north end wall of the house.	Fair to good condition.	4-26
Relieving arch	1746	73" H x 85" W by 4' deep	Stone and brick relieving arch that supports the chimneys and fireplaces above; the back wall of the arch is part of the stone foundation wall; brick Roman arch; inappropriate parging/painting above and inside the arch makes it difficult to determine the condition and type of mortar.	Fair to good condition.	4-26

Location: Basement North Bay~East Wall of the East Room					
Item	Date	Size	Description	Condition	Figure #
Stone wall	1746	7'4" H	Irregularly sized, uncoursed, undressed stone of undetermined variety; large areas of inappropriate repointing at two different times--once with what appears to be a lime-based product and once with a cement-based mortar; mortar joints were not properly struck after repointing and obscure the stone in some places.	Fair to good condition.	4-26 4-27
Door to outside stairs	1746	32" W by 6' H	Door is nailed shut and covered with six inches of fiberglass batt insulation with a Kraft paper backing.	Undetermined.	4-26

Figure 4-26. The east room of the basement's north bay looking at the northeast corner. The relieving arch and door to the exterior stairs are visible in the photograph. Photograph by Kathleen Manicke.

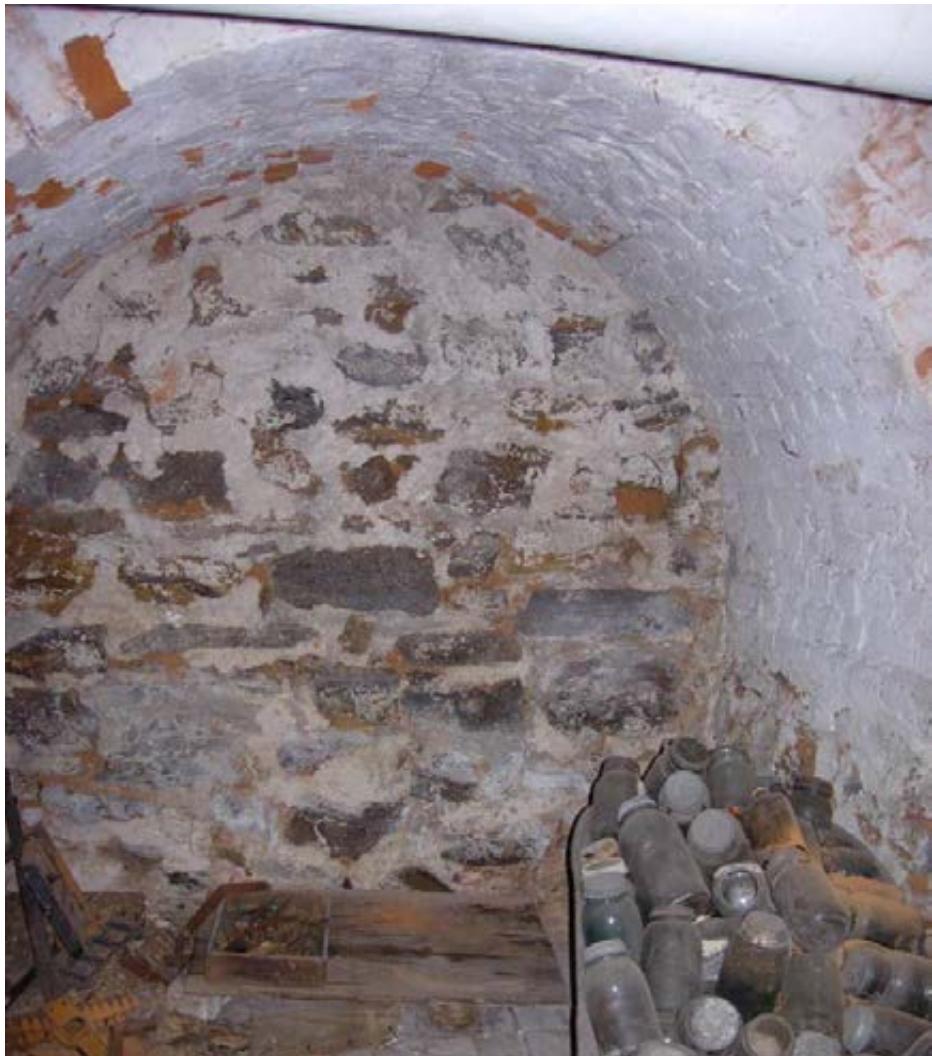
Figure 4-27. The relieving arch in the east room of the basement's north bay. Photograph by Kathleen Manicke.

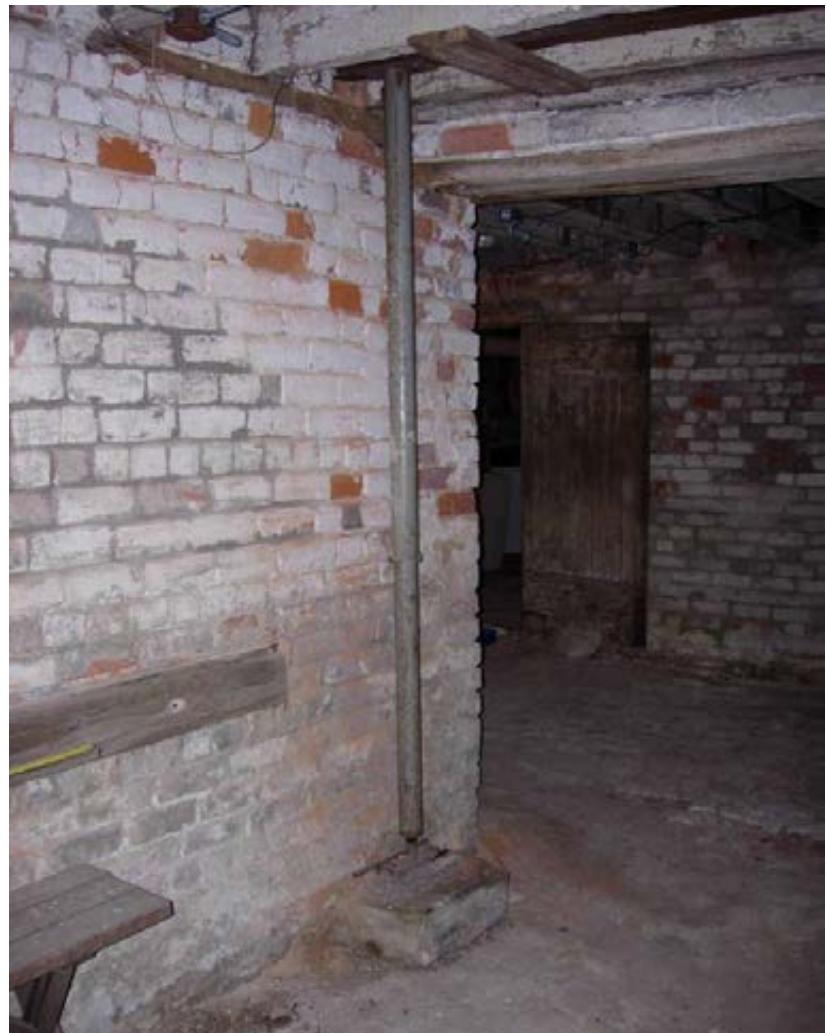
Figure 4-28. This pipe structure supports the floor above. It located near the passage opening in the south wall of the east room.
Photograph by Kathleen Manicke.
