Building at Risk:

A Historic Structure Report for Bostwick in Bladensburg, MD

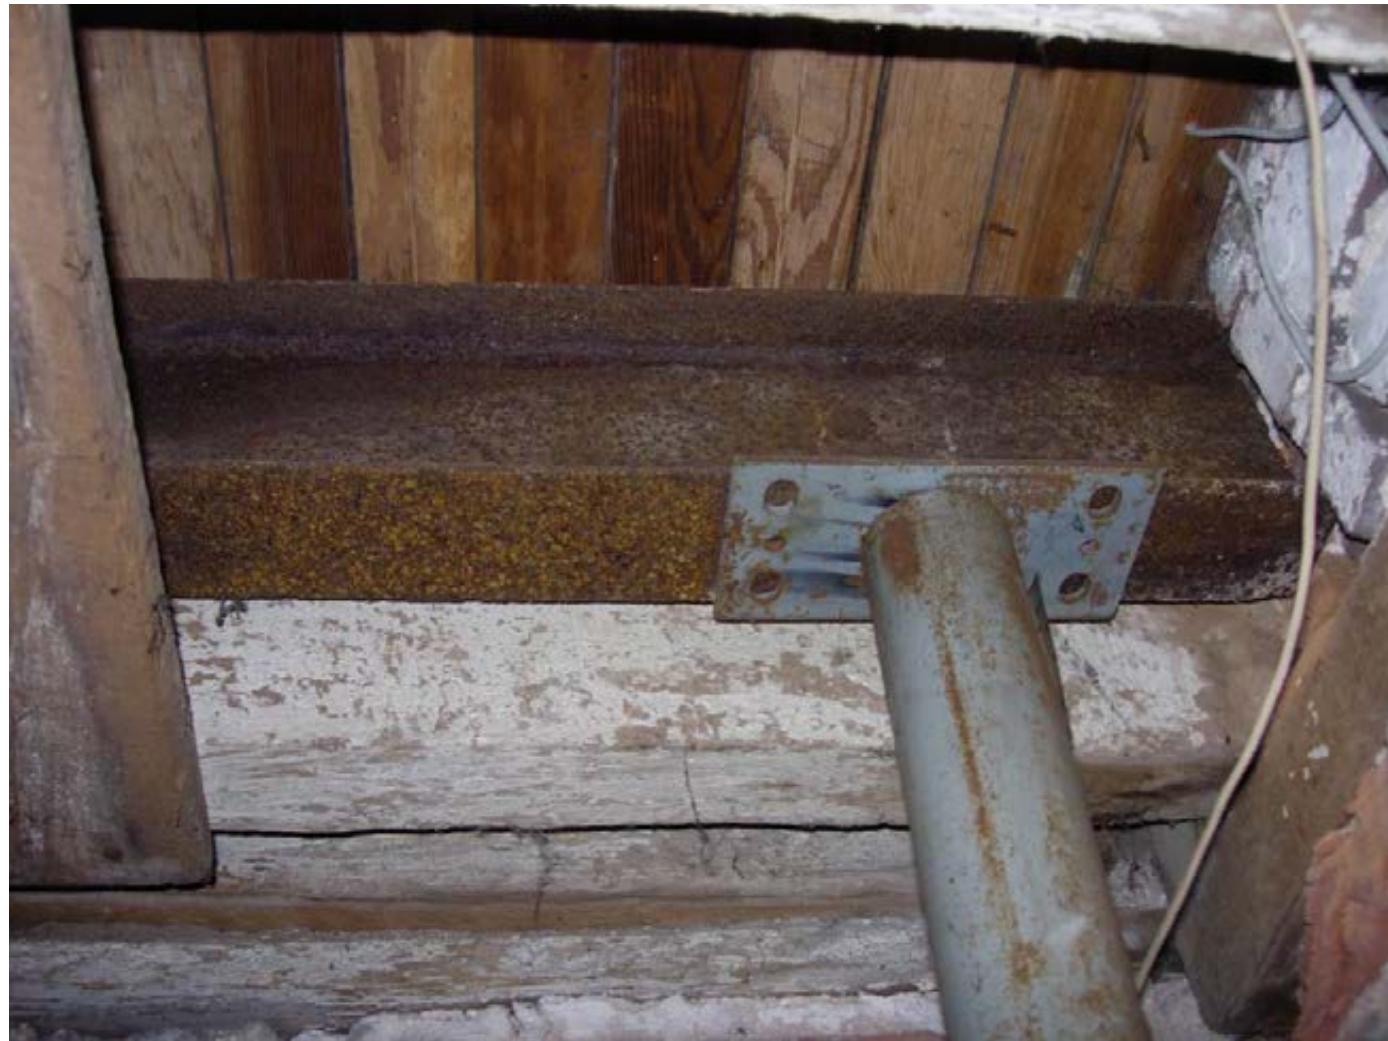
Figure 4-29. Pipe structure supporting the floor above. It provides a nailing surface for the floor above. Photograph by Kathleen Manicke.

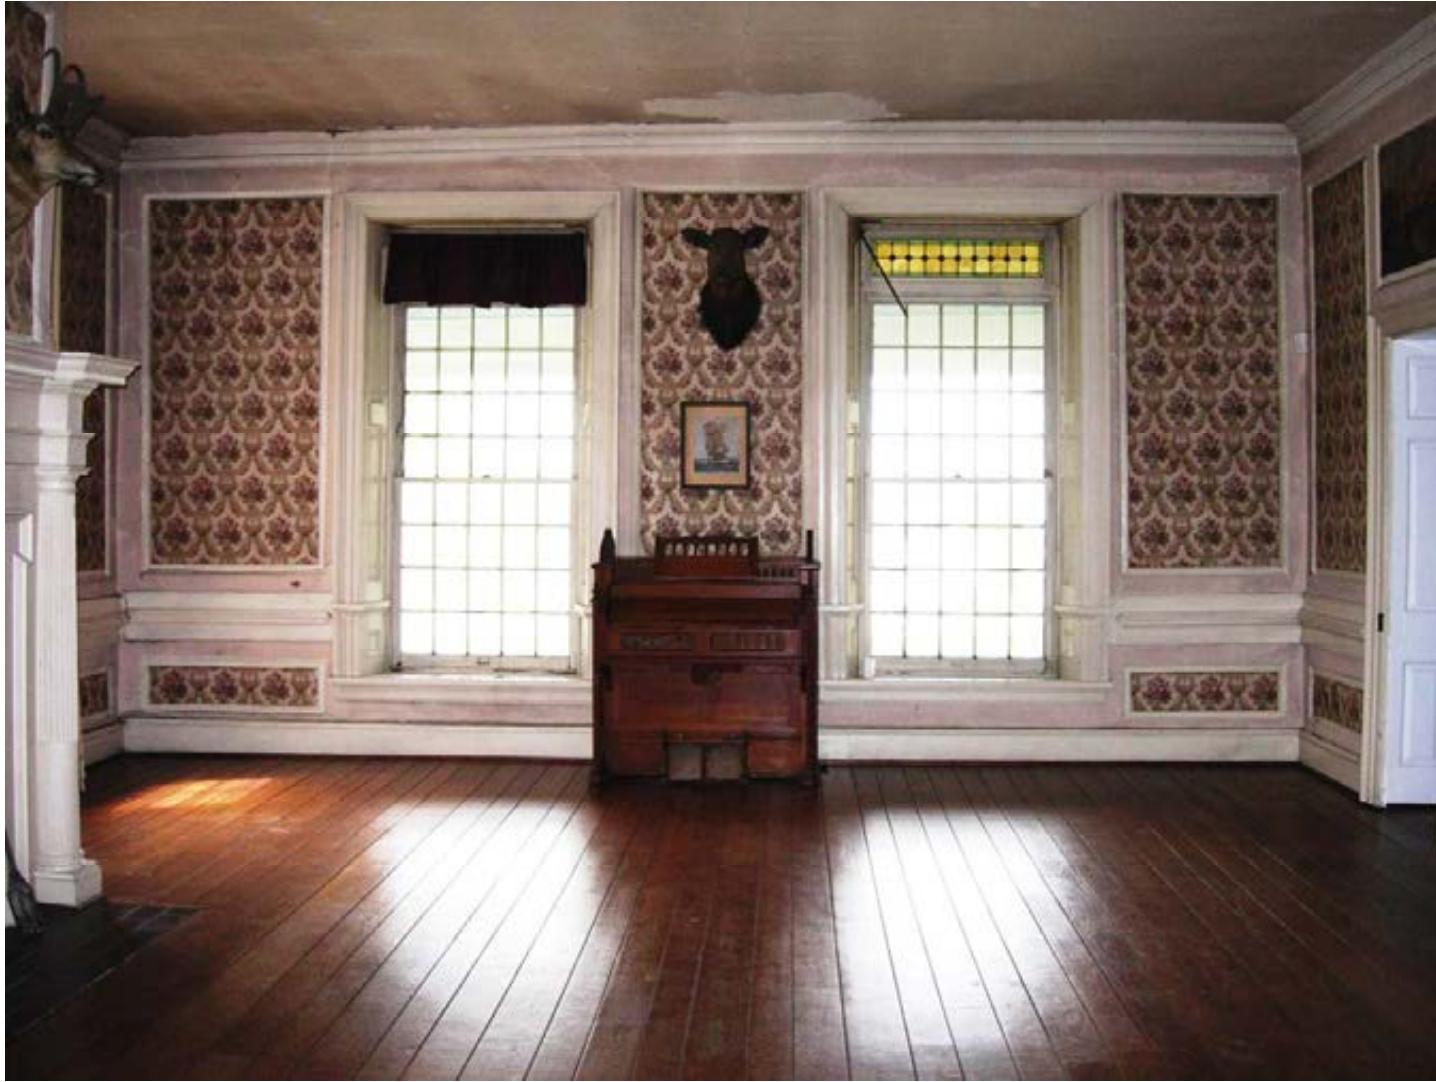
Location: South Parlor~West Wall					
Item	Date	Size	Description	Condition	Figure #
Windows	Early 20th century— circa 1904 Kyner restoration	44"W x 103"H	20-over-20; wooden; double-hung sash with stained glass transom above.	Fair to good.	5-3 5-4
Window hardware (2 sets)	Early 20th century	N/A	Latches and pulls typical for time period; pulley system uses ½-inch steel strap instead of rope or chain.	All latches and pulls present and working; steel straps for pulleys are broken.	
Window Framing	18th to 19th century		Wooden; paneled.	Excellent to good; some have excised areas for shutter hinges (shutters not currently on windows).	5-3 5-4
Window casing	18th to 19th century	6" wide	Typical of the Georgian period. "Double" casing planed into two distinct fasciae. The inner plane is lower in level than the outer plane and separated from the outer plane by a narrow ogee molding.	Good condition	5-3 5-4

Plaster walls	18th century	N/A	Red-mud base coat over masonry exterior walls; white skim coat; rare incised paneling likely original to the house; total of 6 panels (3 upper and 3 lower); upper panels 7' high; lower panels 1' high; widths vary.	Fair to good; some cracking at both corners; panels presently covered with mid-20th century floral wallpaper.	5-3
Cove molding	18th century	8" high	Cove molding separates ceiling and wall; double bead along top and bottom edges.	Generally fair; poor at southwest corner due to severe cracking.	5-3
Chair-rail Molding	18th century	12" high	12 inch wide; 1 inch thick; single bead along both top and bottom edges; wide bolection molding in center; similar piece found in attic shows pit-saw marks and wrought, spade-tipped nails indicating 18th century date.	Excellent.	5-3
Baseboard	18th to 19th century	10" high	Comprised of a flat board 8" high topped by a 2" piece of ogee molding.	Good condition; has pulled away from wall due to settling/movement of the house; inappropriate fill causes it to sit over 1 inch away from the wall in places.	5-3

Figure 5-3. The west wall in the south parlor. Photograph by Kathleen Manicke.

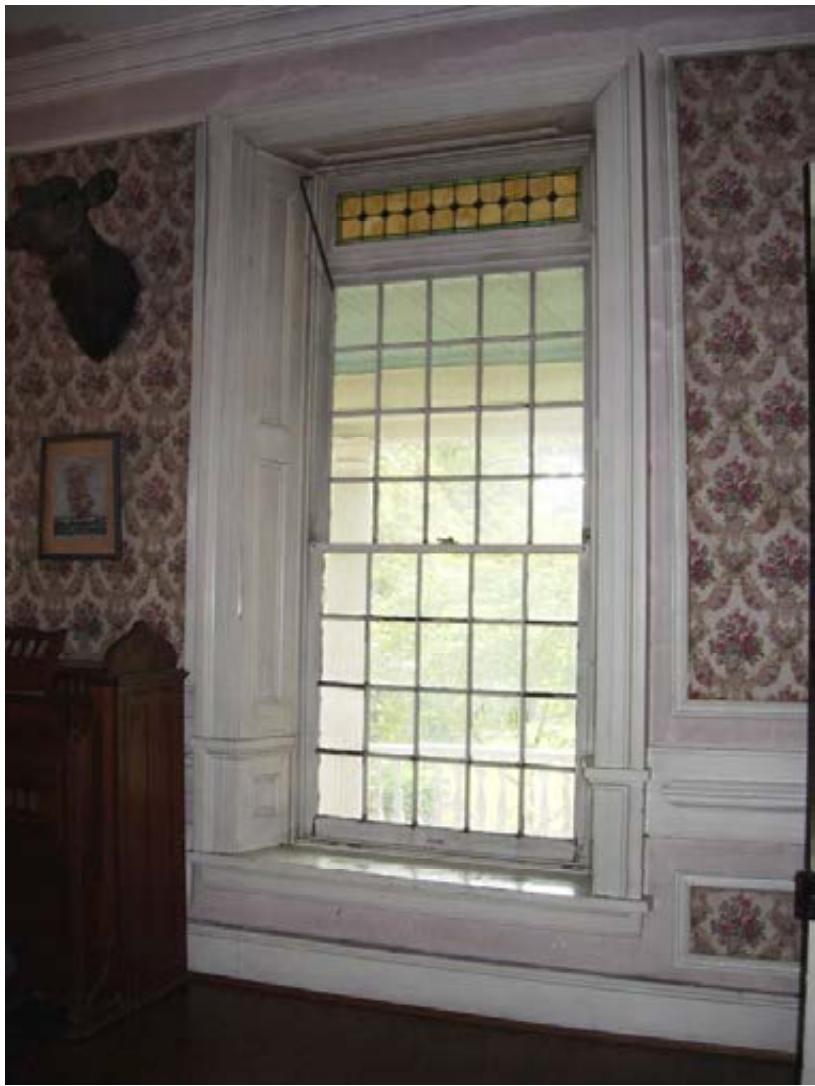
Figure 5-4. West wall window. Photograph by Kathleen Manicke.

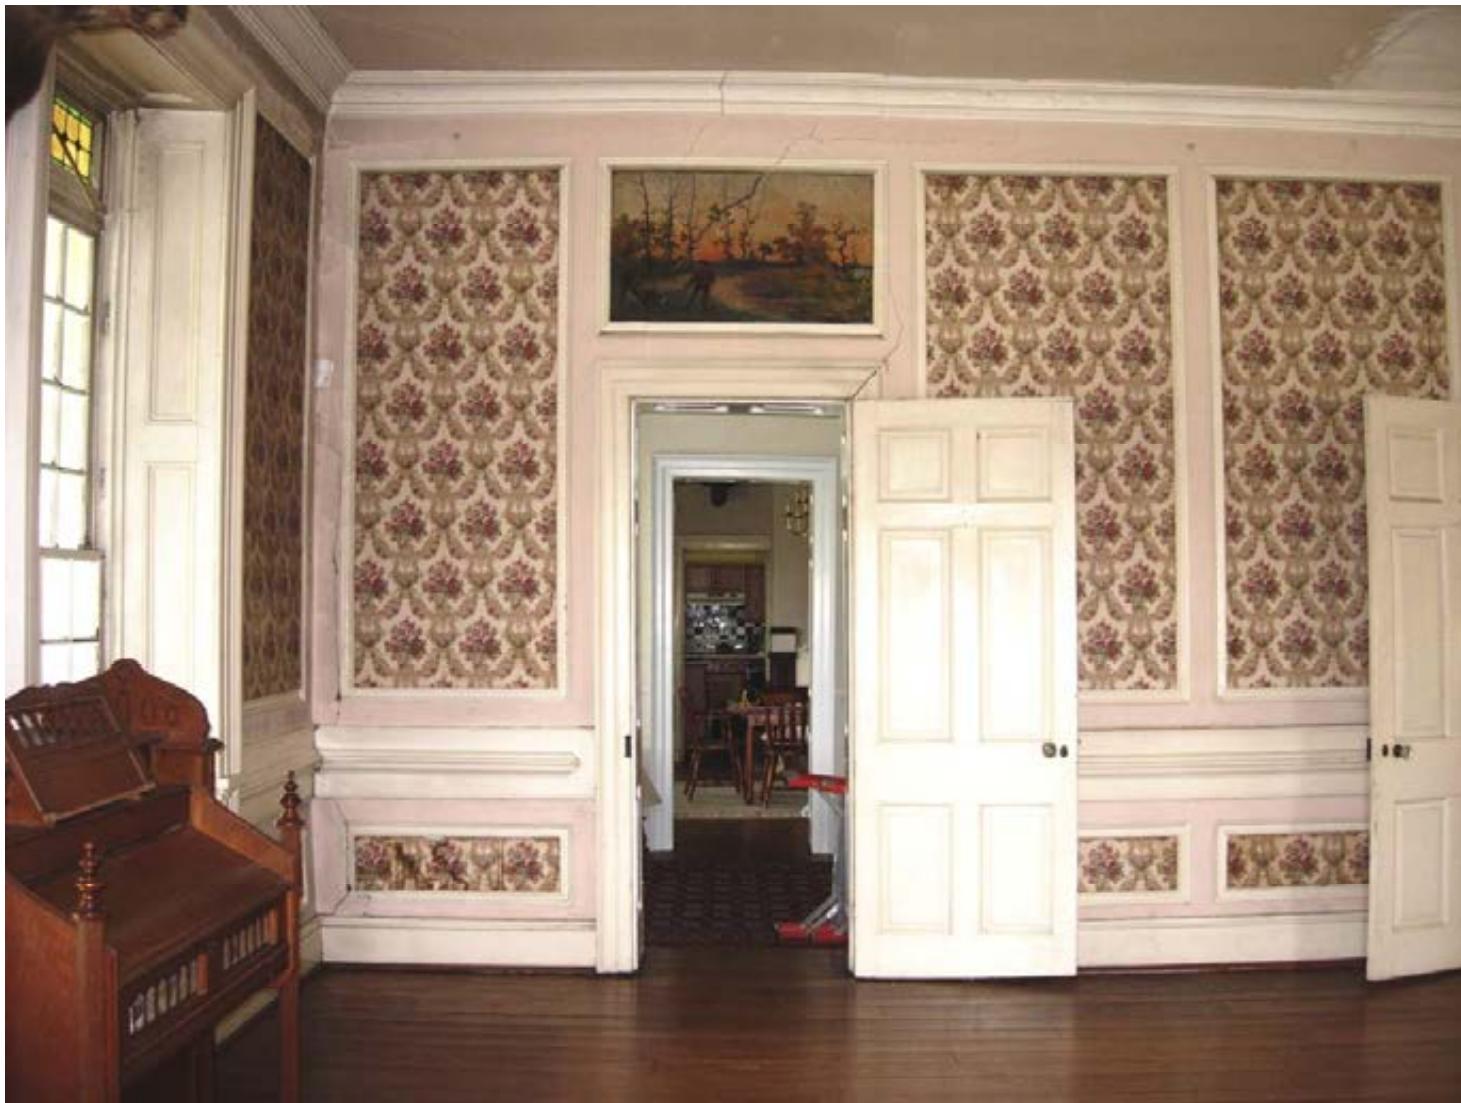
Chair rail molding	18th century	12" high	12" wide; 1" thick; single bead long both top and bottom edges; wide bolection molding in center; similar piece found in attic shows pit-saw marks and wrought, spade-tipped nails indicating 18th century date.	Excellent condition.	5-5
Baseboard	18th to19th century	10" high	Comprised of a flat board 8" high topped by a 2" piece of ogee molding.	Good condition; has pulled away from wall due to settling/movement of the house; inappropriate fill causes it to sit over 1 inch away from the wall in places.	5-5

Figure 5-5. The north wall in the south parlor. Photograph by Kathleen Manicke.

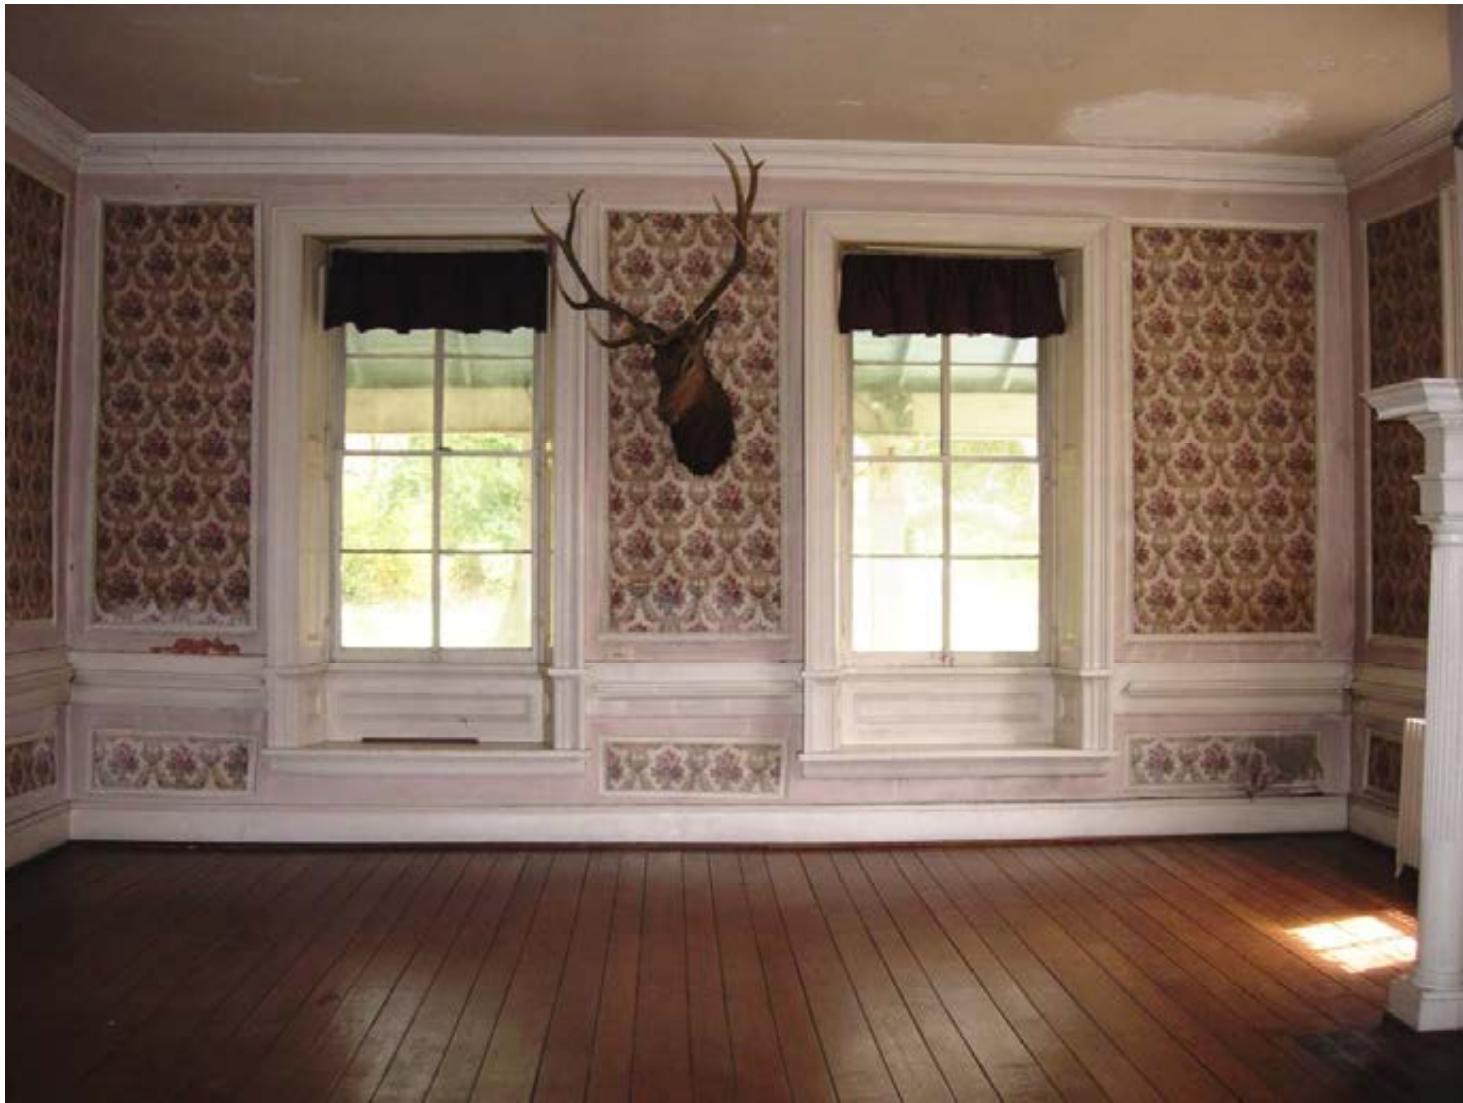
Plaster	18th century	N/A	Red-mud base coat over masonry walls; white skim coat; rare incised paneling likely original to the house; upper panels are 7' high; lower panels are 1' high; panels vary in width.	Severe cracking and plaster spalling caused by dampness prior to the installation of gutters in 2006; wallpaper exhibits waterline; lower plaster panels likely not original since they are not aligned with the upper panels and not plumb; severe bowing in the upper northeast corner which is 2"-3" out of plumb; large area in NE corner where plaster has crumbled from the wall.	5-9 5-12
Chair rail molding	18th century	12" H	12" wide; 1" thick; single bead along both top and bottom edges; wide bolection molding in center; similar piece found in attic shows pit-saw marks and wrought, spade-tipped nails indicating 18th-century date.	Excellent condition.	
Baseboard	18th to 19th century	10" H	Comprised of a flat board 8" H topped by a 2" piece of ogee molding.	Good condition; has pulled away from wall due to settling/movement of the house; inappropriate fill causes it to sit over 1 inch away from the wall in places.	5-8 5-14

Figure 5-8. The east wall in the south parlor. Photograph by Kathleen Manicke.

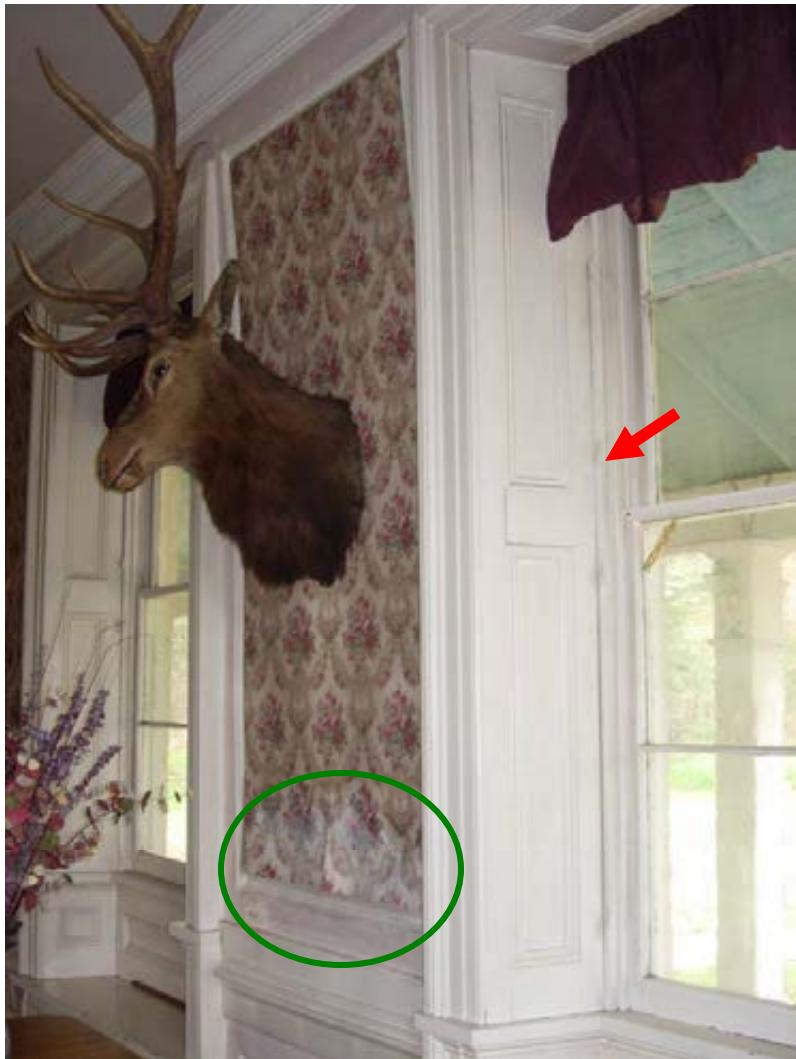
Figure 5-12. Paneled window frame on the east wall of the south parlor. The red arrow points to where the shutters were once hinged. Also note the damage to the wallpaper caused by moisture wicking up from the foundation (green circle). Photograph by Kathleen Manicke.

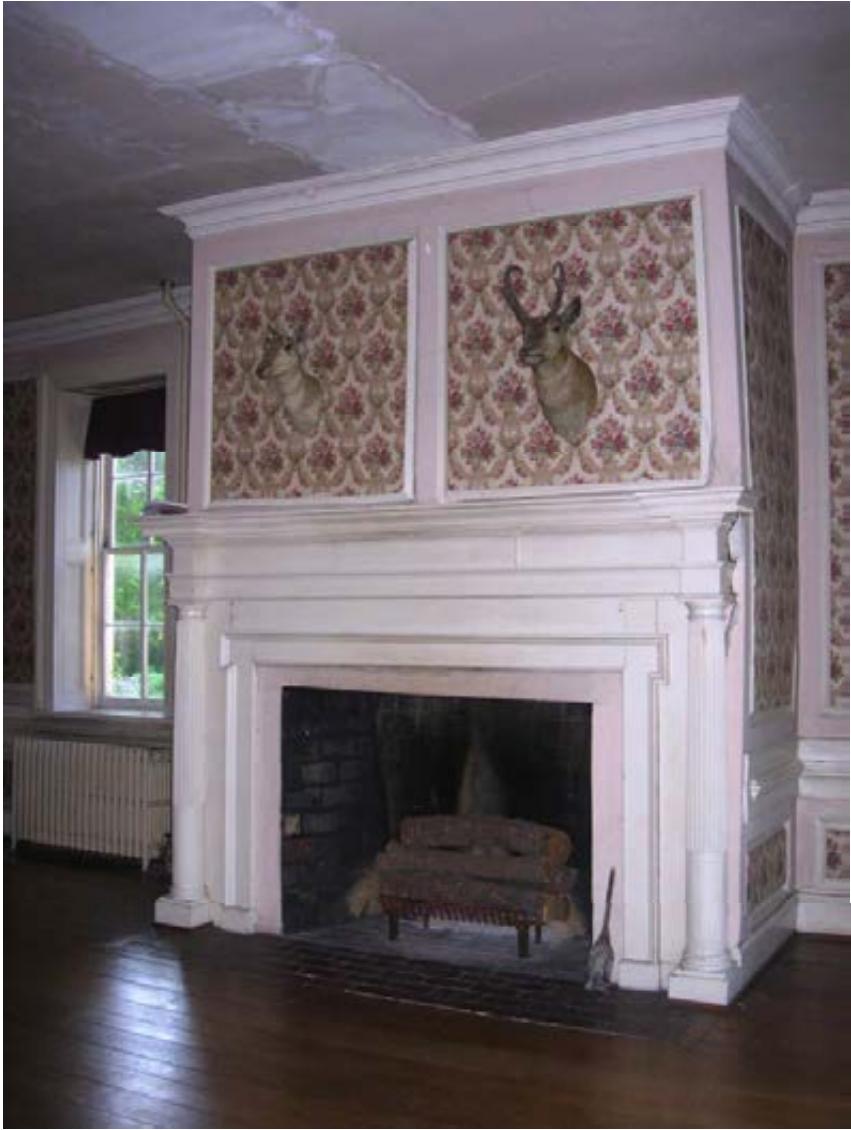
Plaster	18th century; repairs vary	N/A	Red-mud base coat over masonry exterior walls; white skim coat; rare incised paneling likely original to the house; 8 upper panels and 6 lower panels; upper panels vary in both width and height; lower panels are 1' high and of varied widths.	Plaster in fair to poor condition overall; some moderate cracking; inappropriate repairs to plaster around the fireplace have obscured panel profiles; faux painting attempted to mimic look of panels; cracking is generally moderate but severe in southwest corner; some plaster is loose and crumbling behind wallpaper.	5-19
Cove molding	18th century	8" H	Cove molding separates ceiling and wall; double bead along top and bottom edges.	Fair condition; cracking is generally moderate but severe at southwest corner.	5-17

Figure 5-17. The fireplace on the south wall of the south parlor. Photograph by Kathleen Manicke.

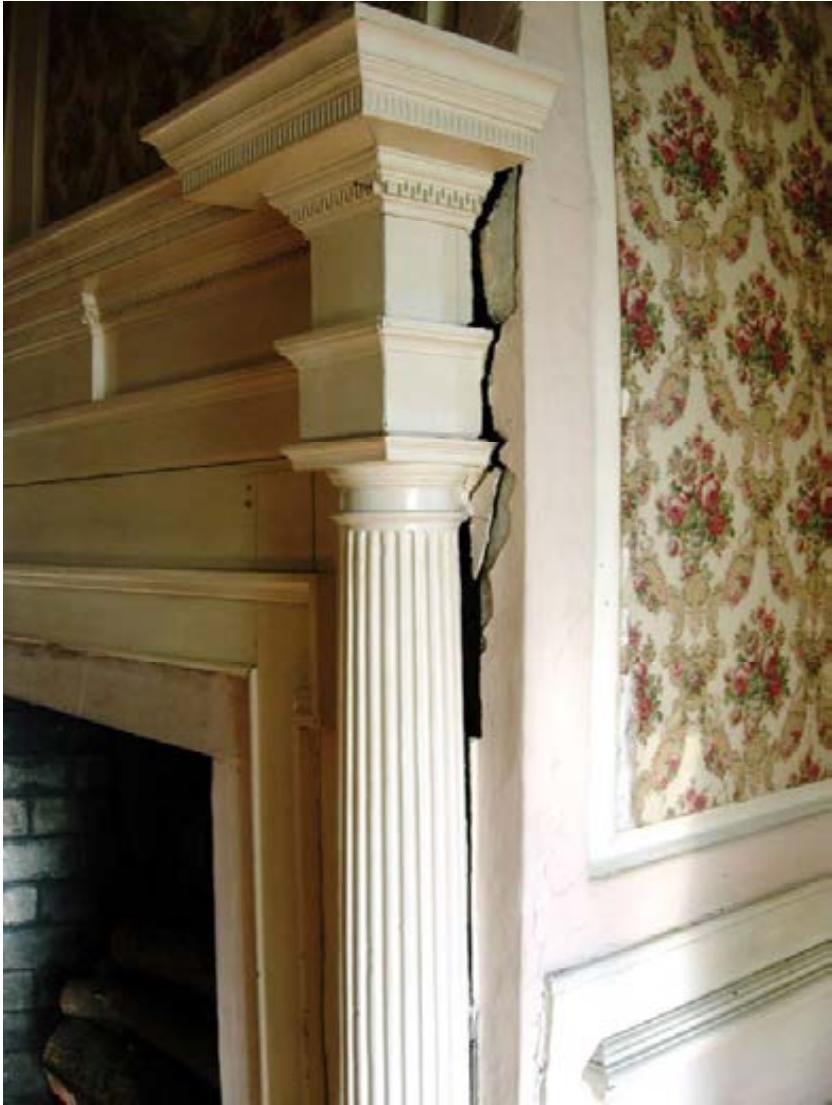
Figure 5-18. Fireplace detail in the south parlor. Damage is likely caused by the movement of the house at the southwest corner. Photograph by Kathleen Manicke.

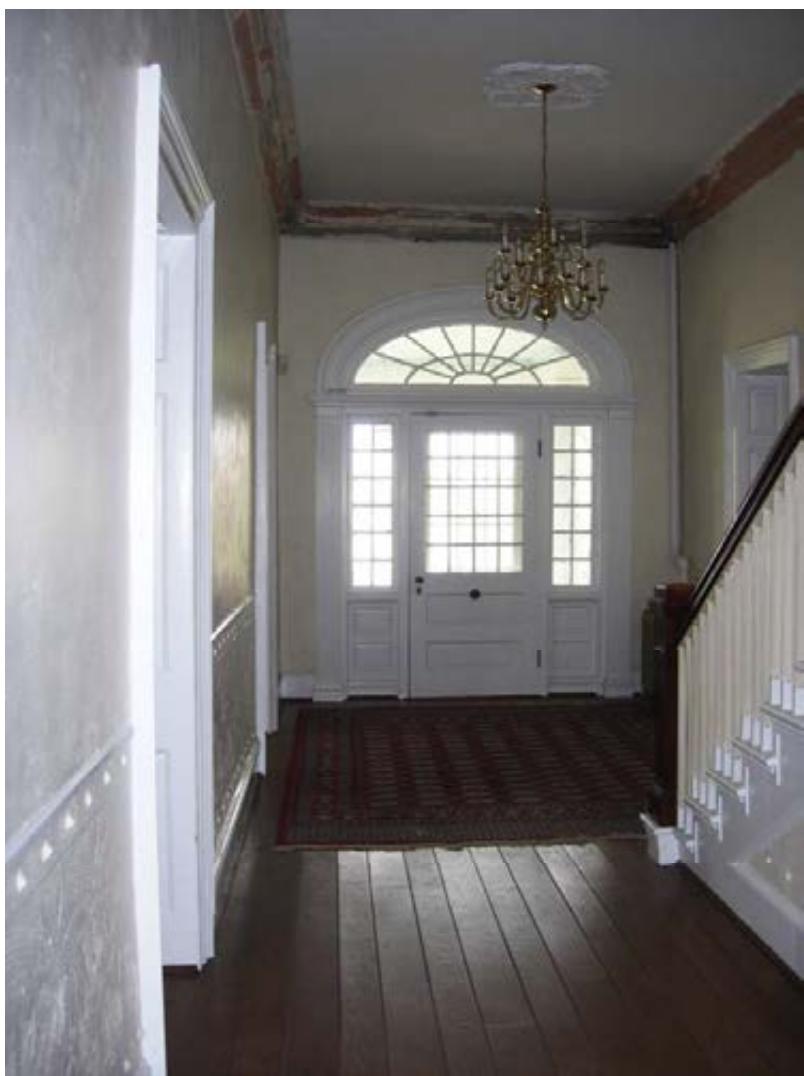
Pilasters (2)	Circa 1904 Kyner Restora-tion	7" W	Thee flank sidelights; fluted columns, unadorned architrave; capital is composed of cornice molding that extends across the door and sidelight openings; base composed of 3 types of machined molding.	Excellent condition; painted finish.	5-23 5-24
Fanlight casing	Circa 1904 Kyner Restora-tion	7" W	Curved.	Excellent condition; painted finish.	5-23
Flat plaster	Unknown		Flat plaster over masonry structural wall; textured finish	Good condition; textured finish shows some repairs giving it an uneven look; plaster, however, is sound.	
Crown molding	19th-20th century	13" H	Elaborate plaster crown molding made of red mud plaster with a white plaster finish coat.	Fair condition; hole through crown to allow for steam heating pipe has caused cracking and damage at the northwest corner; large hole approximately 6" in size near the center of this section of crown molding along its lower edge.	5-25

Figure 5-23. The front entry. Notice the door, fanlight, and sidelights. Photograph by Kathleen Manicke.

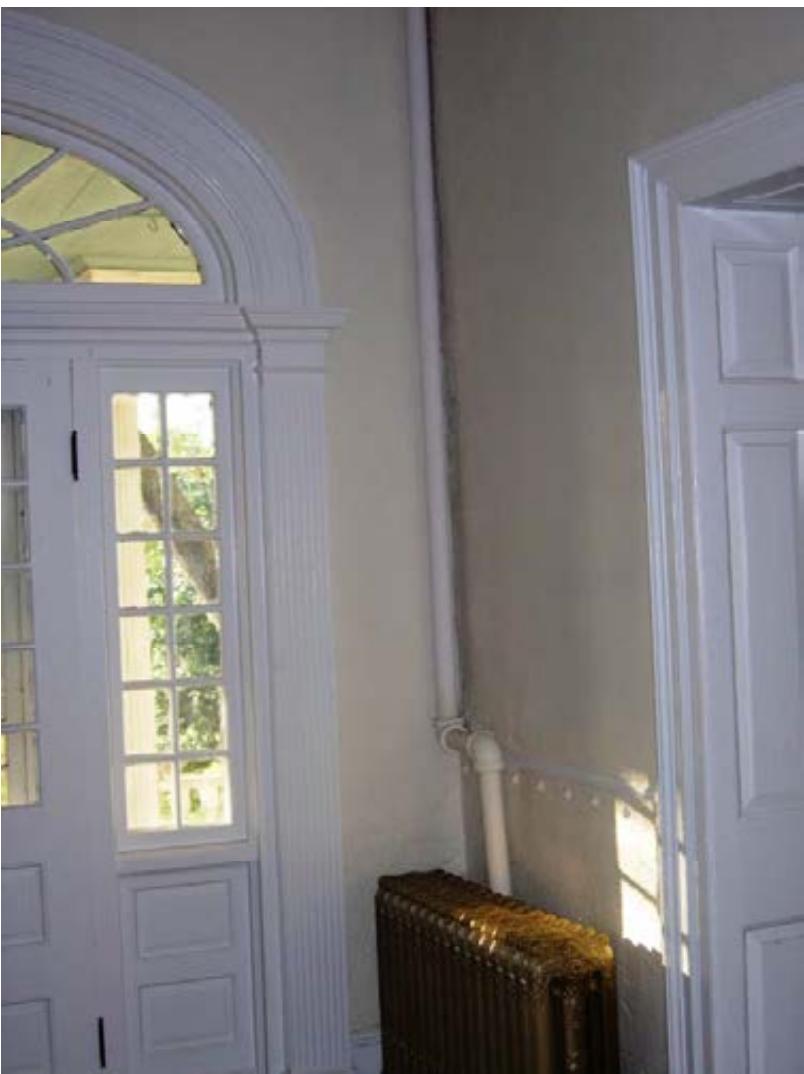
Figure 5-24. The trim, pilasters, and sidelights. Photograph by Kathleen Manicke.

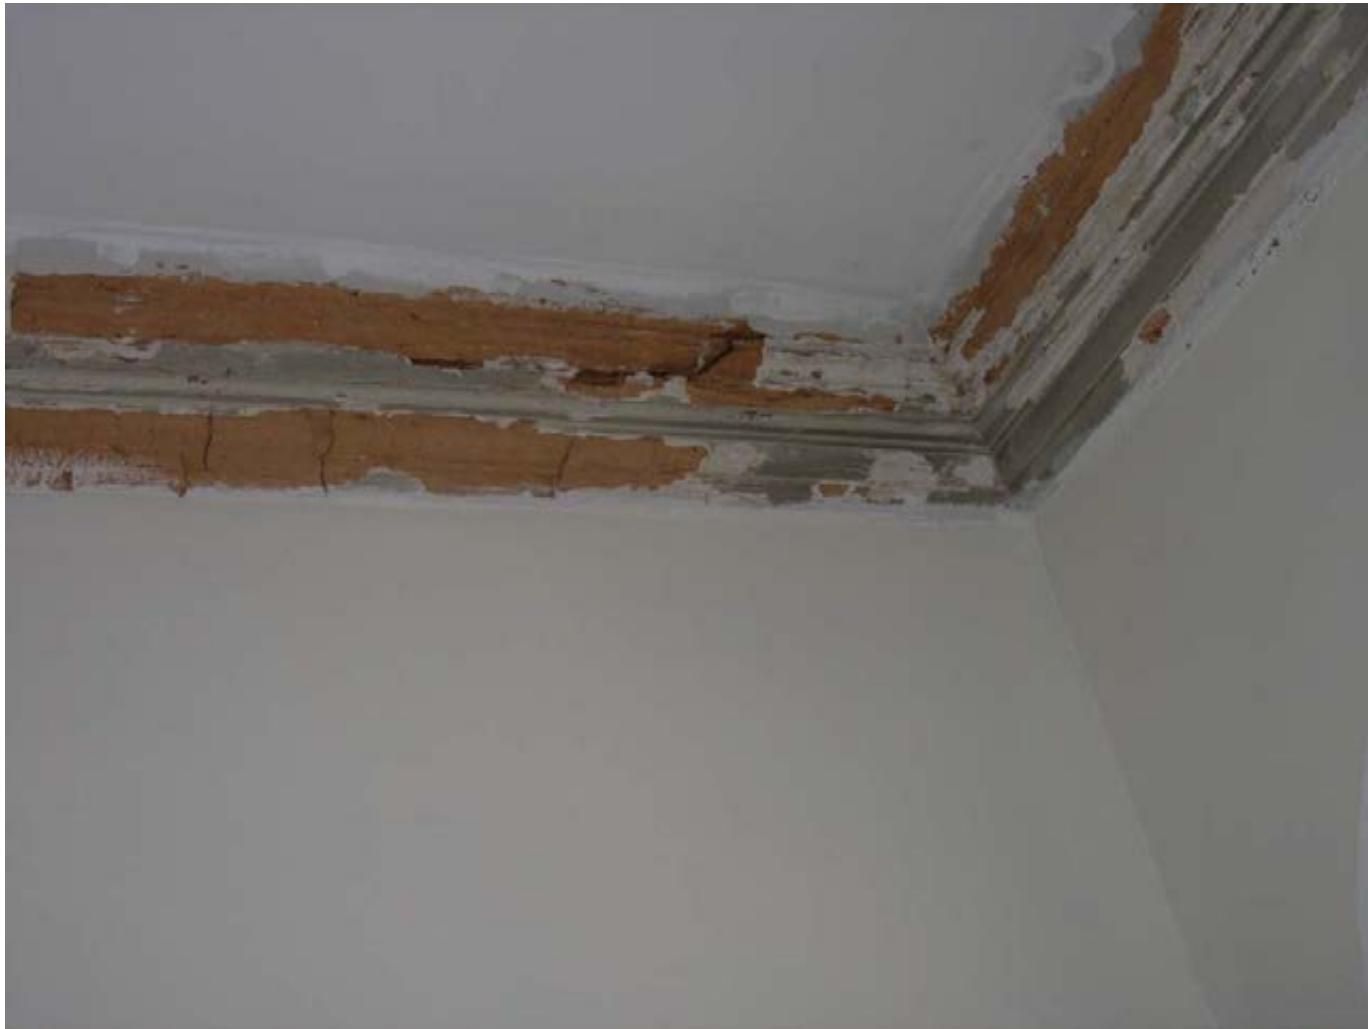
Figure 5-25. Crown molding at the corner of the west and south walls. Photograph by Kathleen Manicke.

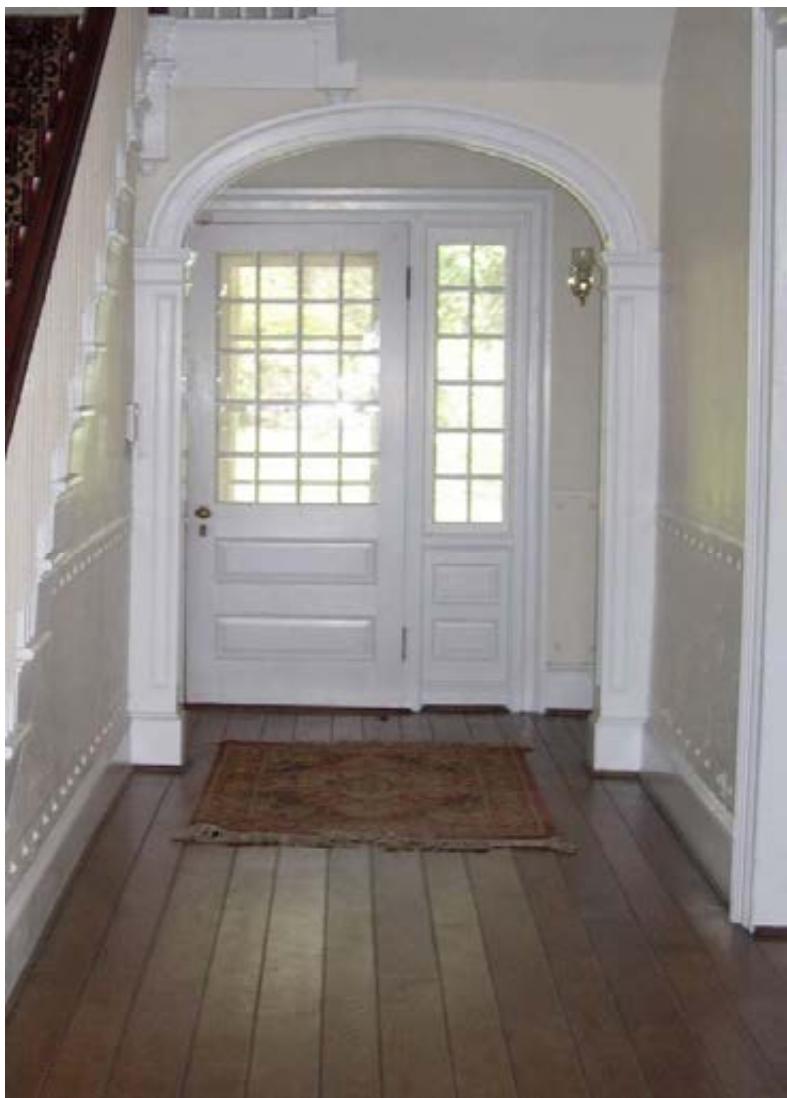
Location: Center Hall~East Wall					
Item	Date	Size	Description	Condition	Figure #
Archway	Circa 1904 Kyner Restora- tion	58" W x 91"H	Passageway to rear entry area with elliptical arched opening flanked by paneled pilasters in the classical style.	Excellent condition; painted finish.	5-29

Figure 5-29. The arch on the east wall that leads to the rear entry. Photograph by Kathleen Manicke.

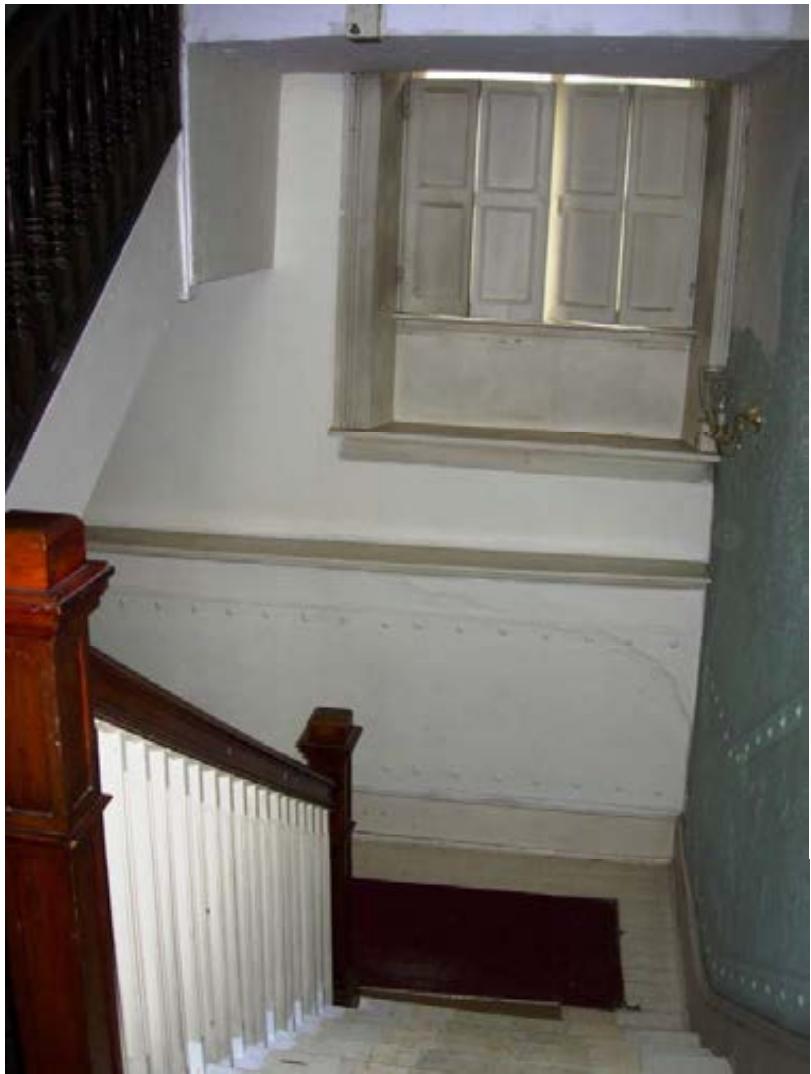
Figure 5-30. The landing between the first and second floors. Notice how the window is blocked by the ceiling. Photograph by Kathleen Manicke.

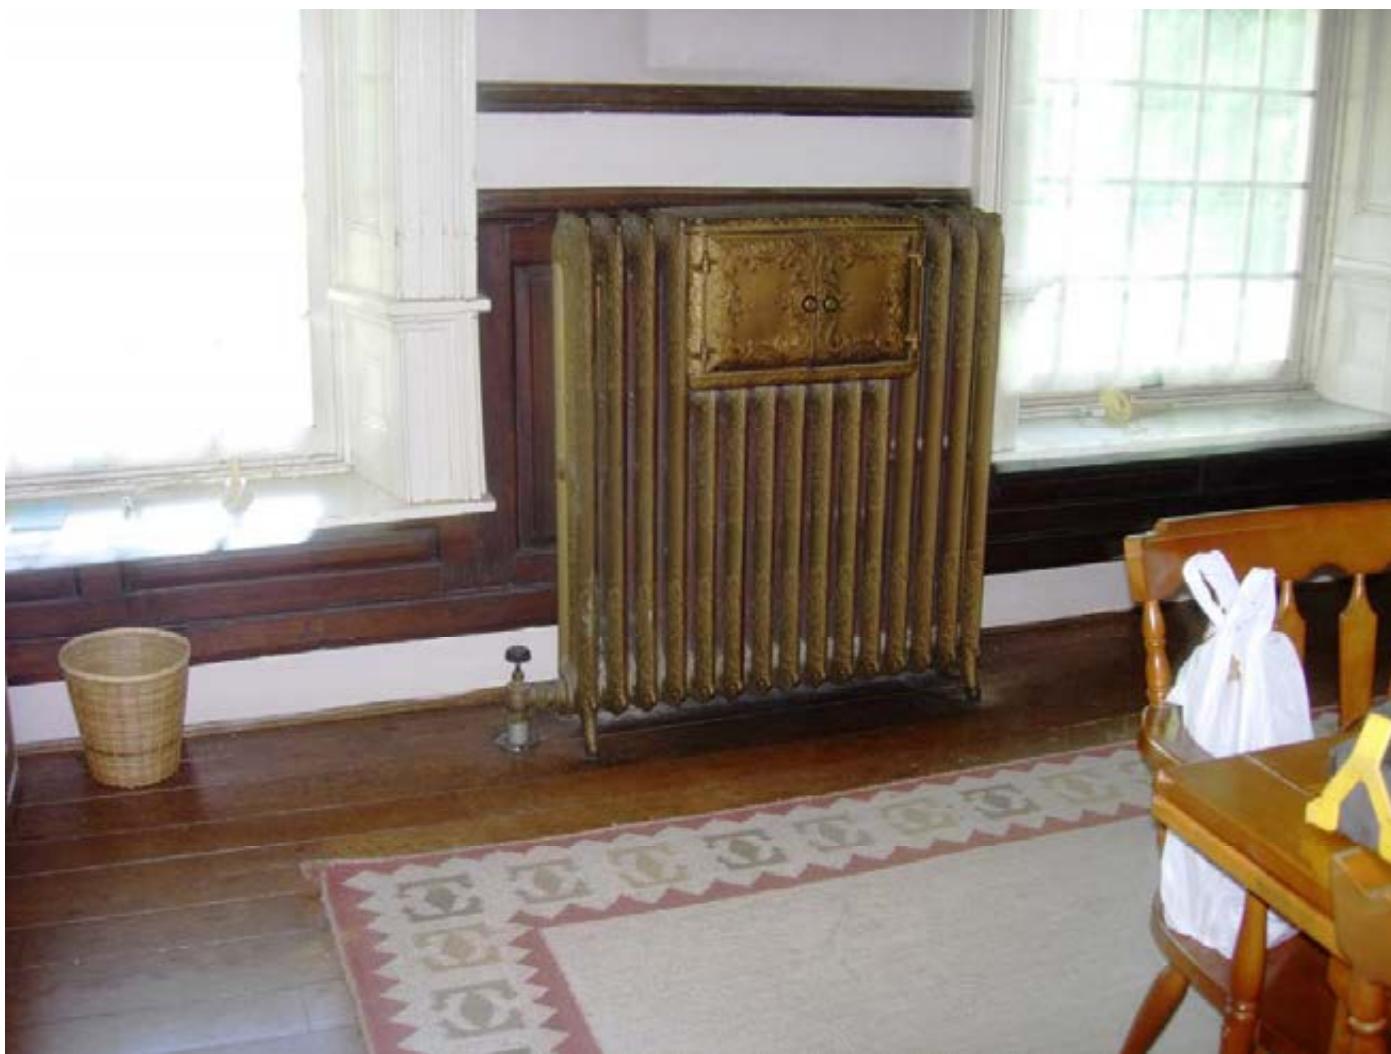
Radiator	Late 19th to early 20th century	36"W x 43"H	Ornate cast iron radiator with a 12" H by 16" W double-door, bun-warming chamber.	Excellent condition; brass/gold metallic painted finish.	5-35
Crown molding	19th century	17"	Laid up in place plaster colonial revival style plaster molding with a red-colored scratch coat over sawn wooden lath. Topcoat is white plaster.	Extremely poor; large hole over 18" in length at the southwest corner leads into a large crack that runs the rest of the length of this wall. The crack ranges from $\frac{1}{2}$ " to well over 1".	5-36 5-37
Flat Plaster Walls			Flat plaster with very light texturing applied over masonry wall.	Good condition with some minor repairs evident.

Figure 5-35. The dining room radiator. Photograph by Kathleen Manicke.

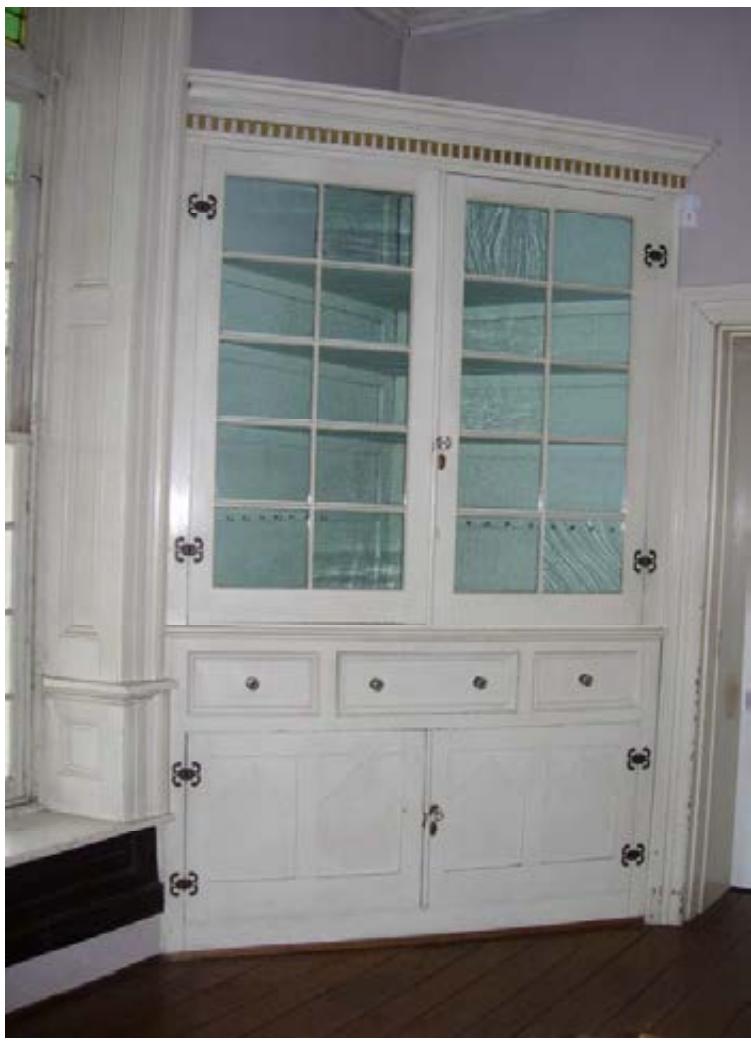
Figure 5-38. The corner cupboard in the dining room. Photograph by Kathleen Manicke.

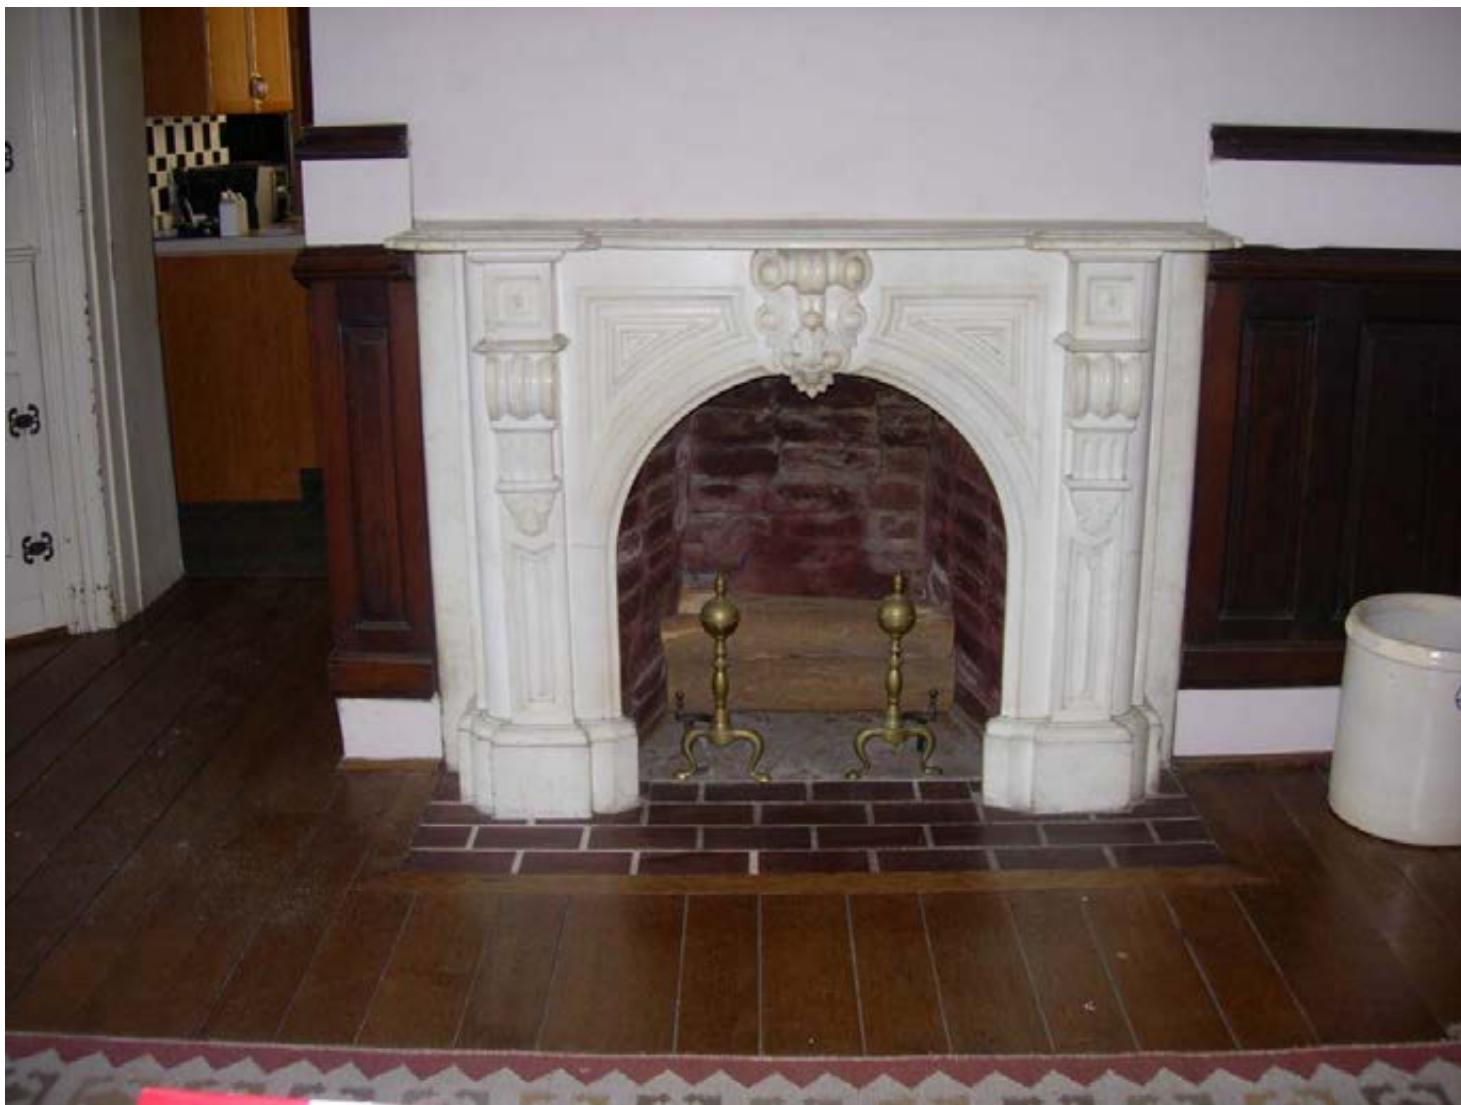
Door casing		5 1/4" W	Georgian style door casing with mitered corners	Good to excellent condition; painted finish	
Door framing	18th to 20th century	14" W	Wide door framing accommodates the masonry wall. This framing on the west side of the door is paneled; paneling on the east side of the door is different and flush with the plastered wall.	Good to excellent condition; painted finish	
Paneling	19th century	52"H	Black walnut; painted above the chair rail level and at the baseboard level; consists of raised black walnut panels with machine-milled molding; paneling largely hidden by radiator on this wall.	Good condition; some minor cracking along grain in panels.	5-40
Fireplace and mantel (1)	Mid to late 19th century	45"H x 60"W x 13"D	Protrudes 39" into the room. Mantel is rococo revival in white marble. It is obviously not original to this room since it sits almost 8" below the top of the paneling that abutted the original mantel. It was reportedly installed after the original caught fire. Firebox was restored in the 20th century using red brick.	Good condition with minor cracking and moderate staining of the marble.	5-40

Hearth tile	20th century	18" x 60"	Hearth is composed of 4" x 8" dark brown ceramic tile.	Excellent condition.	5-40
Flat plaster			Flat plaster with very light texturing applied over masonry wall.	Good condition with some small repairs evident.	5-39

Figure 5-40. The dining room fireplace. Photograph by Kathleen Manicke.

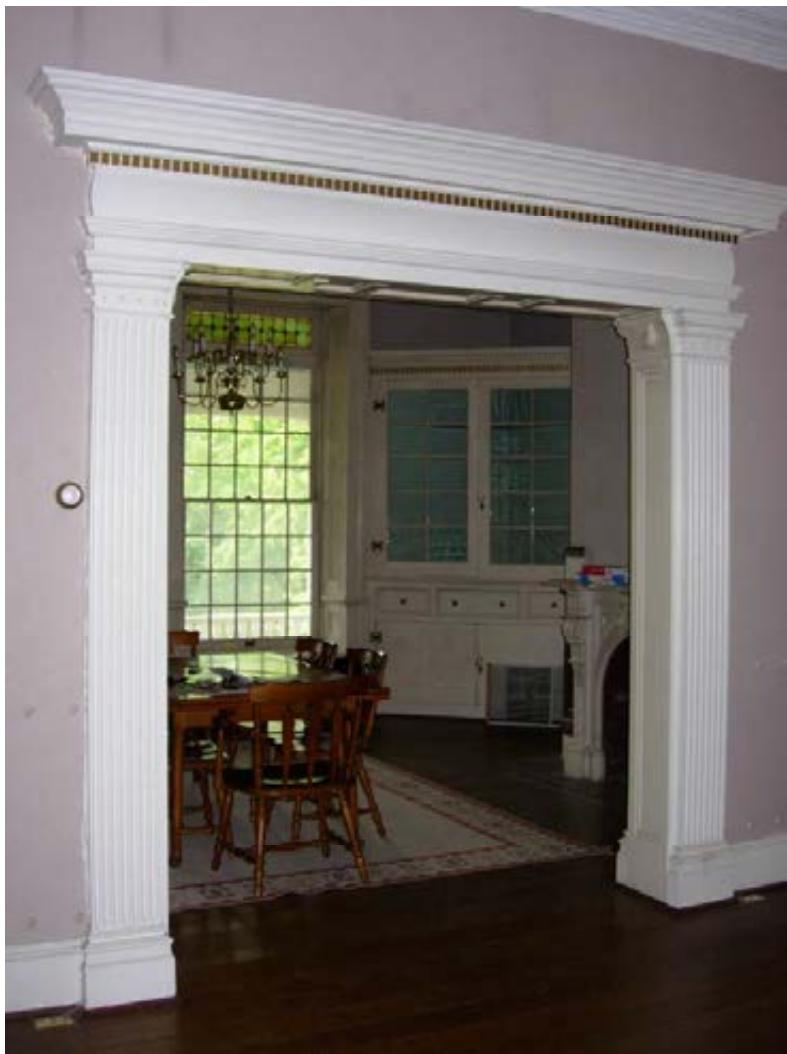
Figure 5-41. View through the west wall double door into the dining room. Both sides of the door are identical. Photograph by Kathleen Manicke.

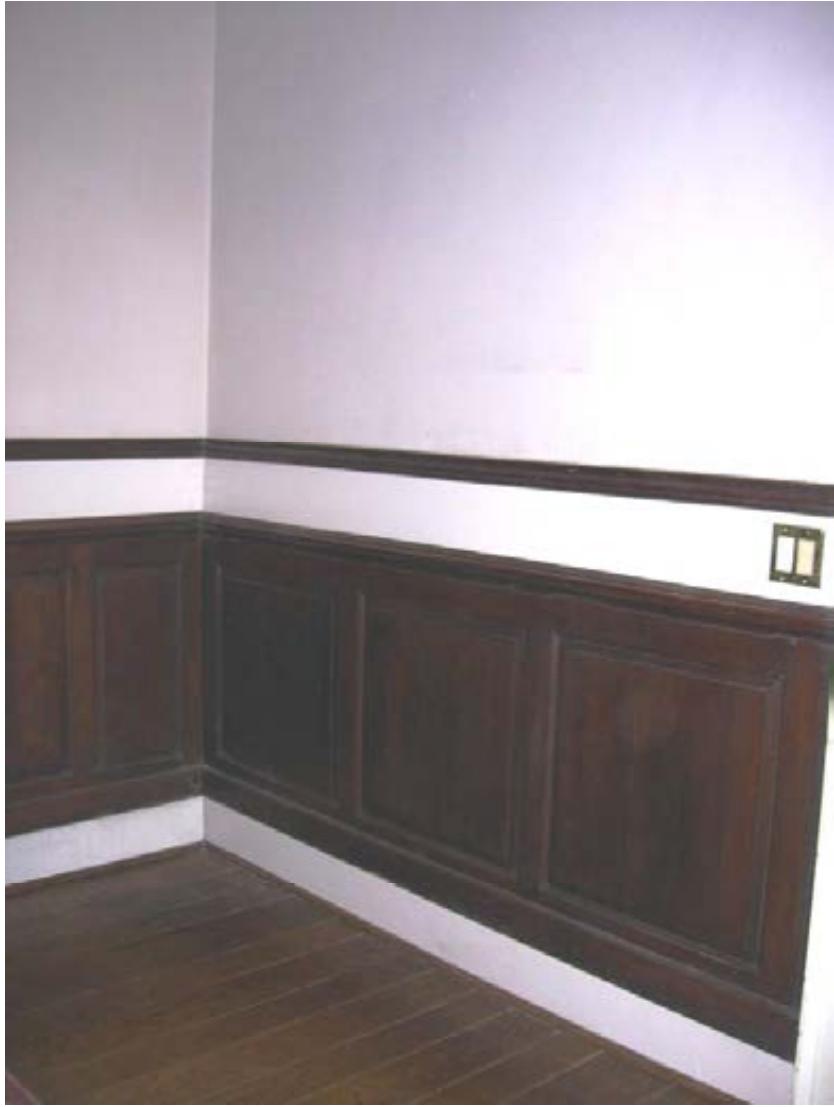
Figure 5-42. The paneling on the south wall of the dining room. Photograph by Kathleen Manicke.
