Building at Risk:

A Historic Structure Report for Bostwick in Bladensburg, MD

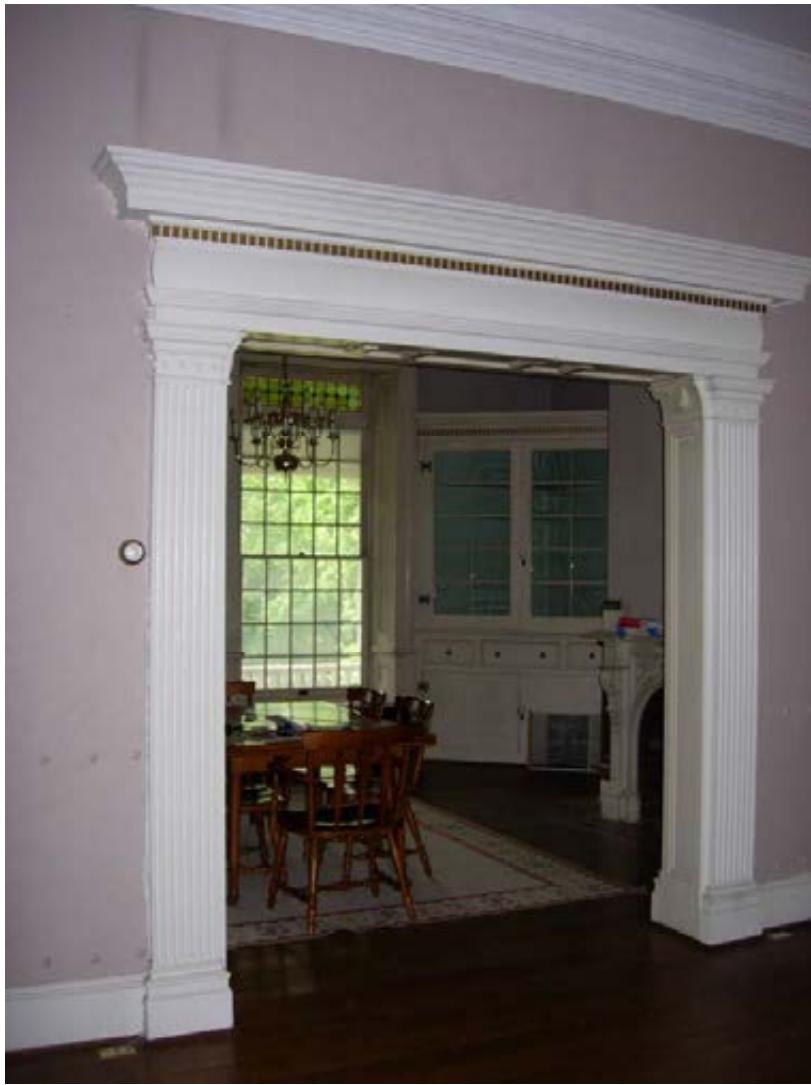
Location: Library~West Wall					
Item	Date	Size	Description	Condition	Figure #
Door to dining room (1)	Circa 1904 Kyner Restoration	75" W x 89" H	Colonial revival style double width passageway with elaborate detailing; cornice laid up from elaborate crown molding; immediately beneath the cornice is a piece of 1" reverse ogee molding with articulated 1" dentils below; plain architrave with sides that bow outward followed by another piece of crown molding 2" deep; this is followed by the remainder of the architrave, which also acts as the top of the paneled door frame; panels on this plane of the door frame alternate in size with three large panels separated by two smaller ones; the architrave and cornice are supported by a pair of matching fluted pilasters whose capitals are made of crown molding with an ornamented architrave; the top of the bases do not quite match the adjacent panel rail in height indicating two different periods of construction; the side door frames contain a single flat panel with a round, flat area above for holding portiere rods.	Excellent condition; painted finish.	5-44

Figure 5-44. The double door on the library's west wall. Photograph by Kathleen Manicke.

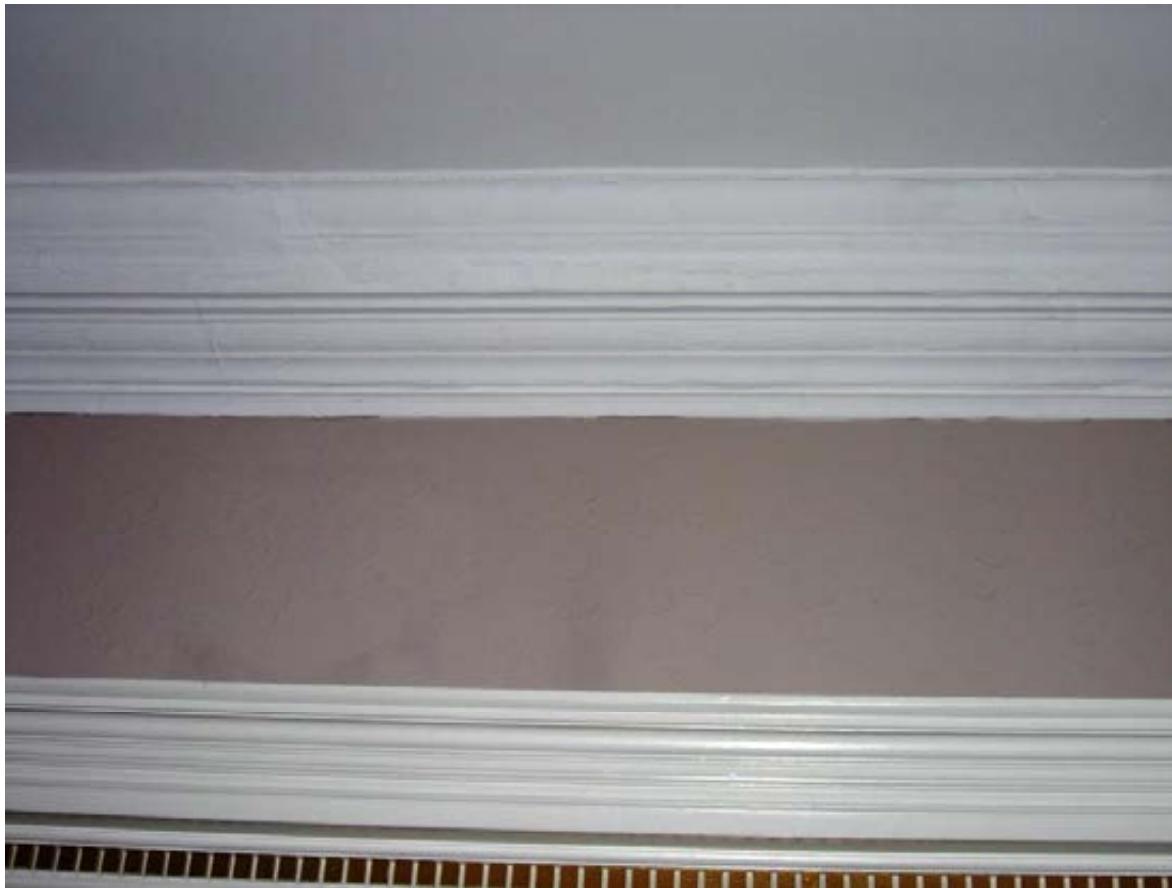
Figure 5-45. Crown molding above the double door on the west wall. Photograph by Kathleen Manicke.

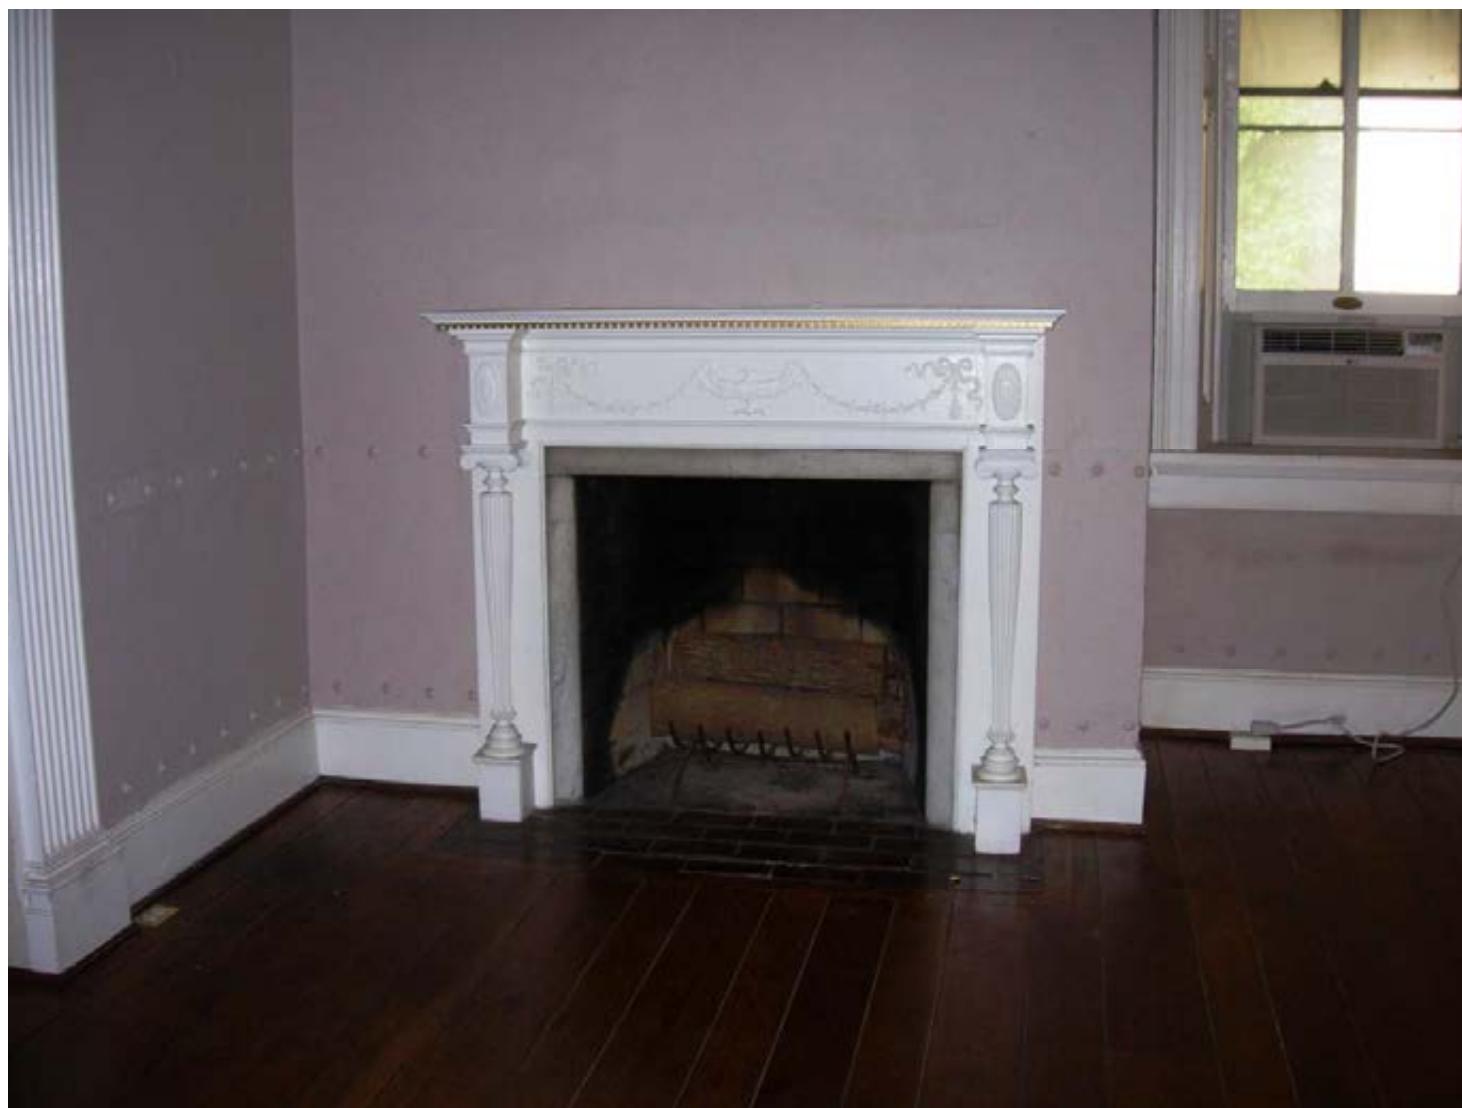
Window frame	19 th century	13" deep	Paneled window frame with two panels on each vertical surface and a single panel across the top	Good to excellent; painted finish	5-47
Window pull	Circa 1904 Kyner Restora-tion	3 1/2"W by 1 3/4"H	Oval with beaded edges; brass-colored metal	Good to excellent; painted finish	
Pin assembly			Used to hold window in 'up' position	Operable	
Latch			Painted metal	Operable	
Fireplace, mantel, and hearth	Circa 1904 Kyner Restora-tion	52" H x 60" W x 11" Deep	Fireplace protrudes 37" into the room and measures 87" W; firebox is lined with modern fire brick; early 20th century Adamsesque mantel with urn, ribbon/flower, and rosette motifs in the architrave; columns supporting the mantel shelf are urn-shaped with Ionic capitals; hearth is flush with the floor and paved with 4" x 8" dark brown ceramic tiles.	Excellent with a painted finish; non-operable due to condition of chimney.	5-46

Figure 5-46. The library's fireplace and mantel. Photograph by Kathleen Manicke.

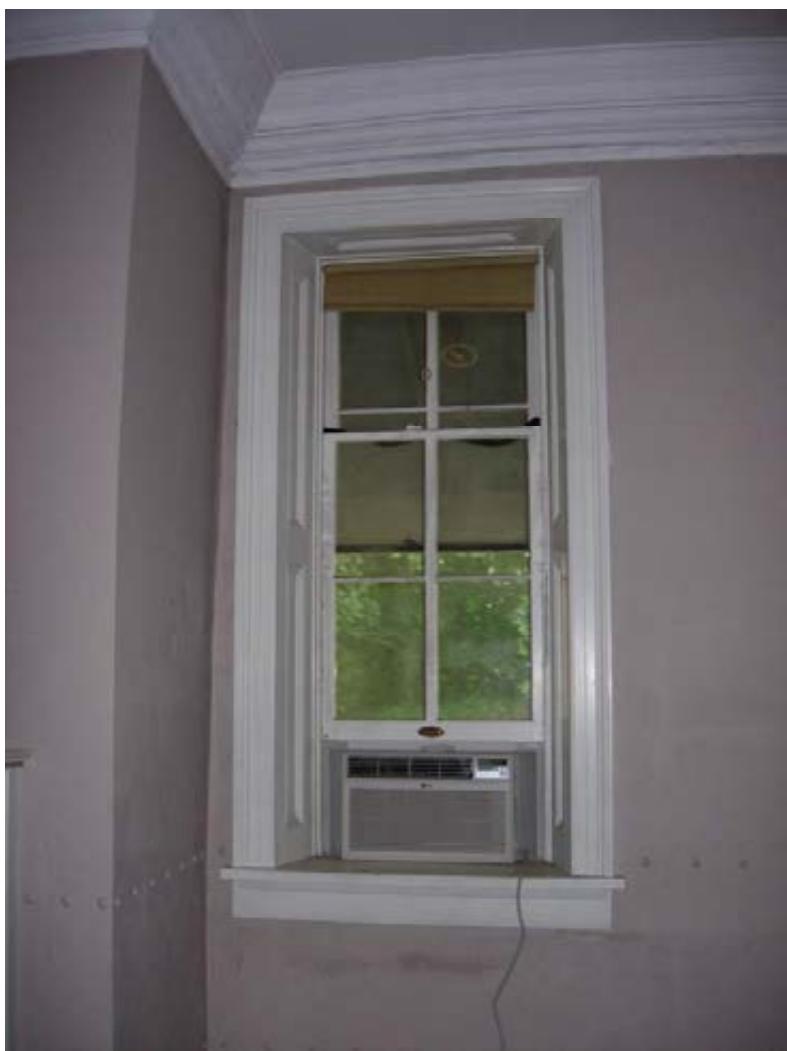
Figure 5-47. The window on the north wall of the library. Photograph by Kathleen Manicke.

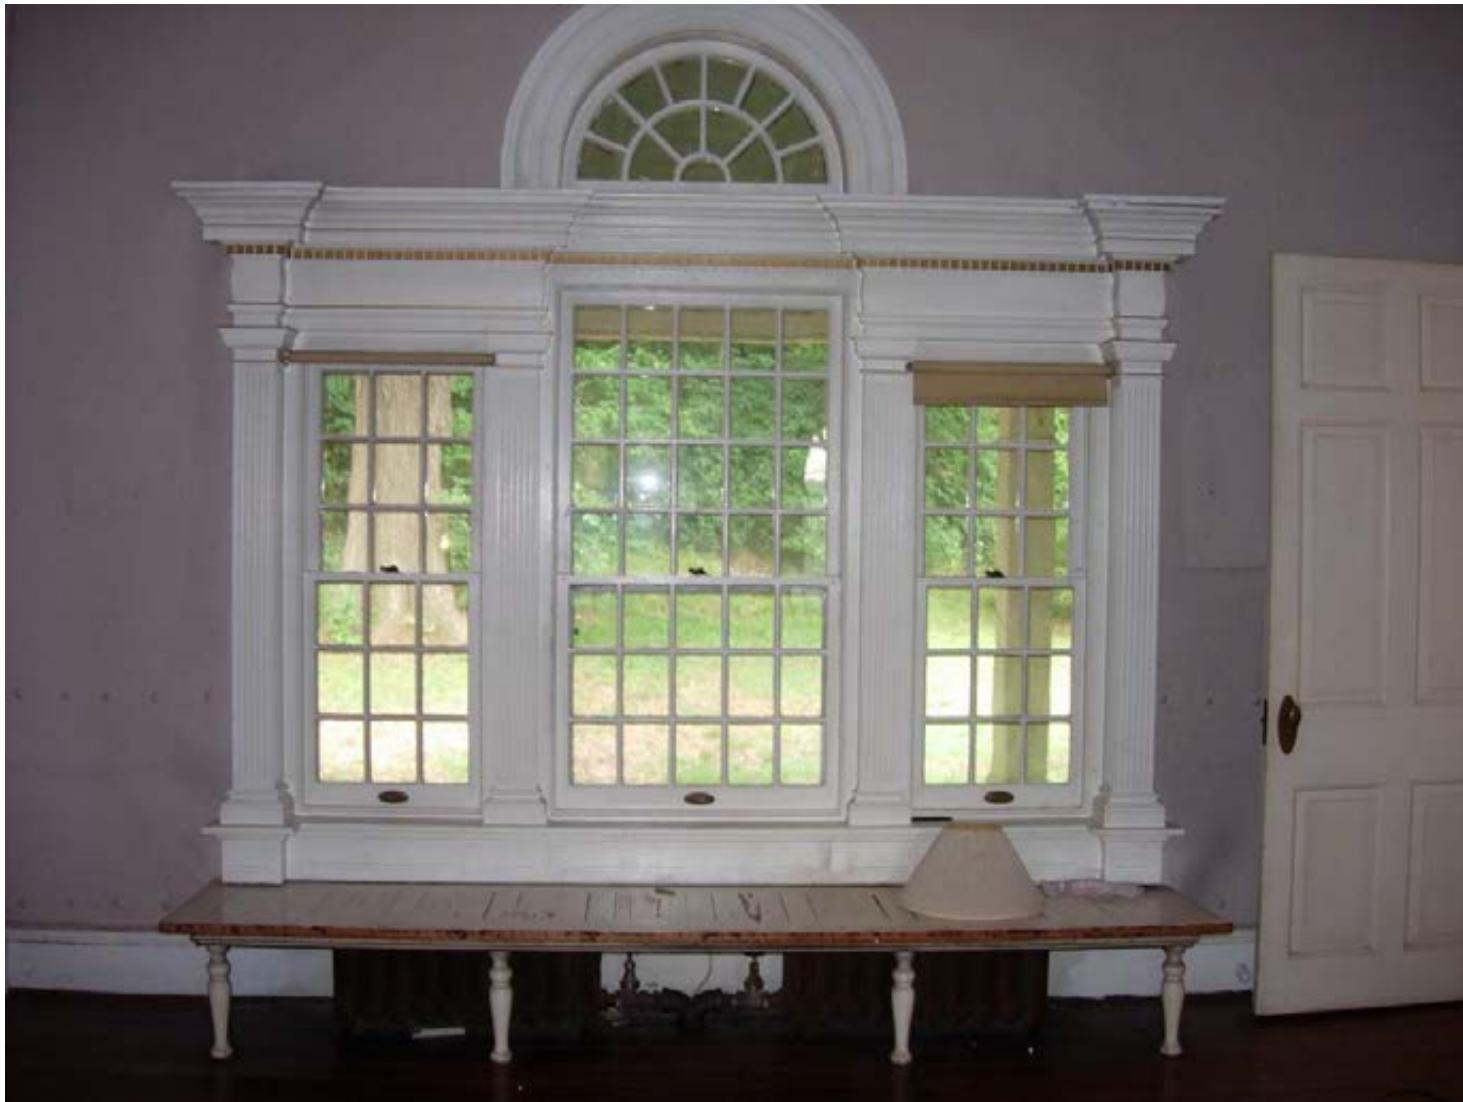
Crown Molding	19 th century	17"	Laid up in place, colonial revival style, plaster molding with a red-colored scratch coat over sawn wooden lath topcoat is white plaster.	Fair to poor condition with slight spalling of the top coat; moderate horizontal cracking; significant paint failure; inappropriate repairs (likely with drywall compound) have largely obscured its profile.	
Radiators (2)	20 th century	30" W x 14" H	Highly decorated cast iron radiators with a brass/gold metallic painted finish; obscured by a window seat.	Good condition; operable.	
Window seat/bench	20 th century	1'9" D x 9'8" L	Made of random width smooth boards; rear of the bench is attached to the wall under the Palladian window and over the radiators; 4 turned legs support the front.	Good condition; moderate paint failure; missing front edge.	
Palladian window	Circa 1904 Kyner Restora-tion		Palladian window replaced two earlier windows; Palladian window composed of a large twenty-over-fifteen light, double-hung window flanked by smaller nine-over-nine light, double-hung windows; 2 sets of pilasters—one set flanks the center window and the other flanks the entire grouping; large colonial revival cornice molding with dentils below separates the three windows from the single half-round fanlight above the center window.	Good condition with slight paint failure.	5-48

Figure 5-48. The Palladian window on the east wall of the library. Photograph by Kathleen Manicke.

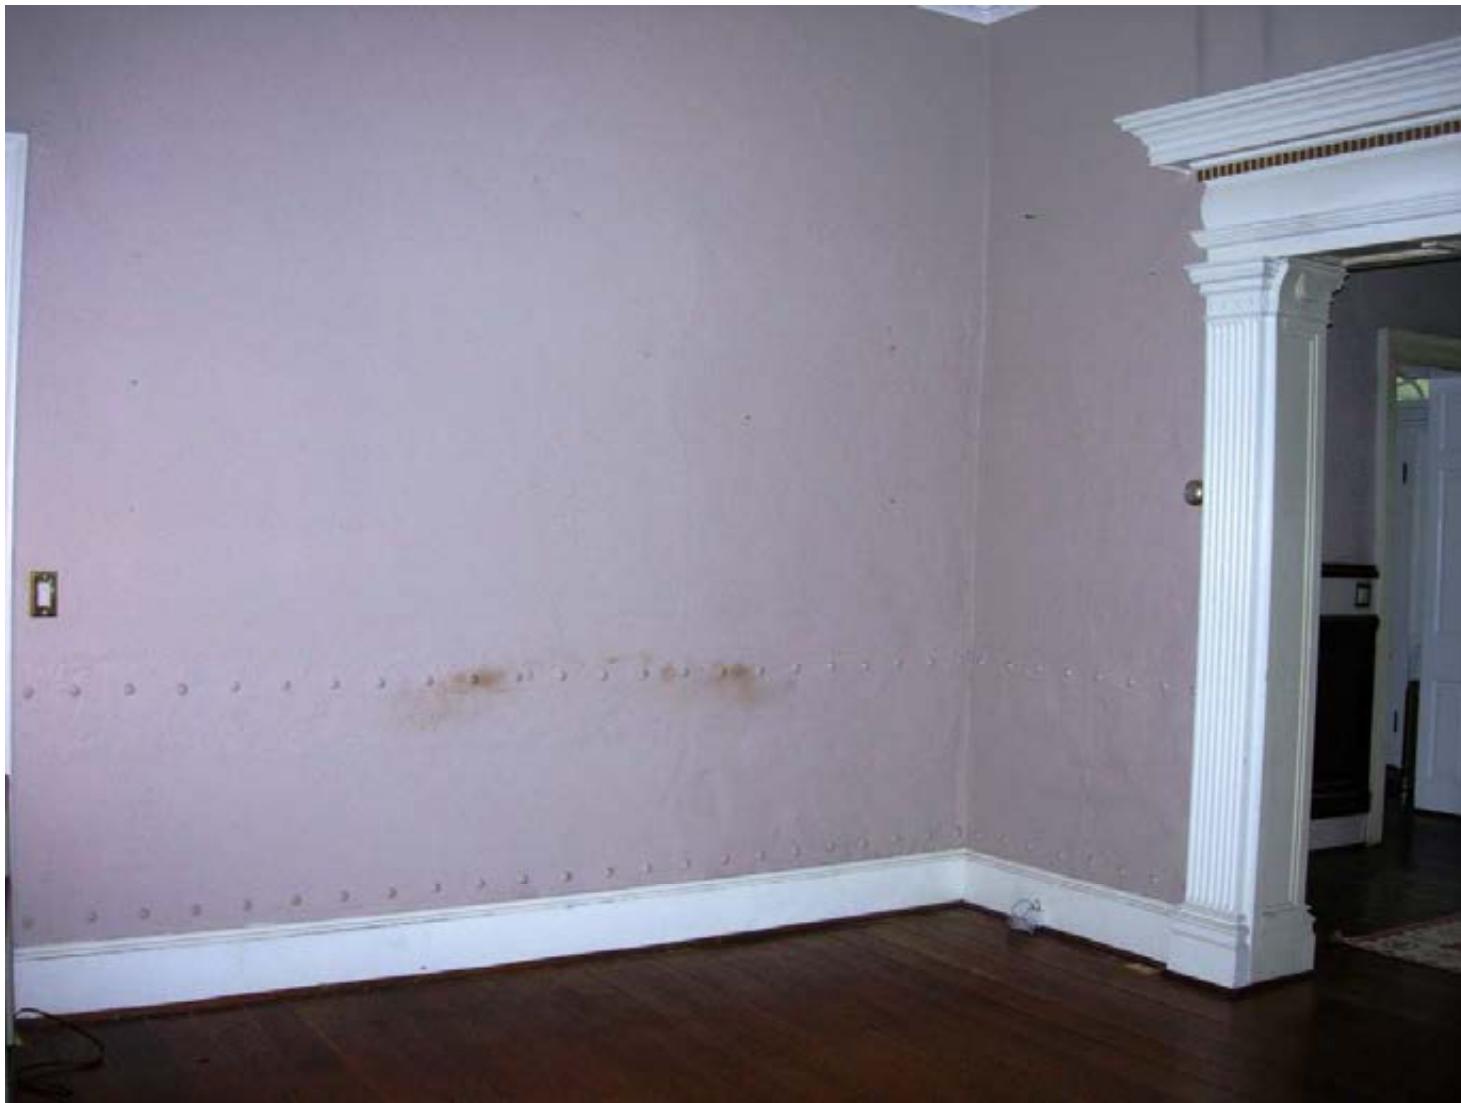
Location: Library~South Wall					
Item	Date	Size	Description	Condition	Figure #
Crown molding	19th century	17"	Laid up in place, colonial revival style, plaster molding with a red-colored scratch coat over sawn wooden lath; topcoat is white plaster.	Fair to poor condition with slight spalling of the top coat; moderate horizontal cracking; significant paint failure; inappropriate repairs (likely with drywall compound) have largely obscured its profile.	
Flat plaster above chair rail height	Circa 1904 Kyner Restoration		Above the chair rail, wall has a decorative plaster treatment drawn by hand into a wet, lightly textured plaster; decorative elements on this wall consist of the following: immediately beneath the crown molding there are branches of cherries/grapes running horizontally; height of this element varies from 12" to 18"; centered on the wall in the mid-section is a single large (4½' by 7½') plant-form design consisting of cattails, palm leaves, cherries, and elephant ears; this is the largest design found in the two rooms at Bostwick that have this type of decorative plaster treatment.	Excellent condition.	5-49

Door Frame	18 th -19 th century	14" W	Wide door framing accommodates the masonry wall. This framing is paneled, and the panel sizes reflect those in the door. There are three panels of unequal sizes on both sides and two panels of equal size across the top.	Excellent condition; painted finish.	
Baseboard		9½" H	Composed of two pieces: flat lumber 8" high topped with a 1½" piece of ogee molding.	Good to excellent condition; painted finish.	5-49

Figure 5-49. The south wall in Bostwick's library. Photograph by Kathleen Manicke.

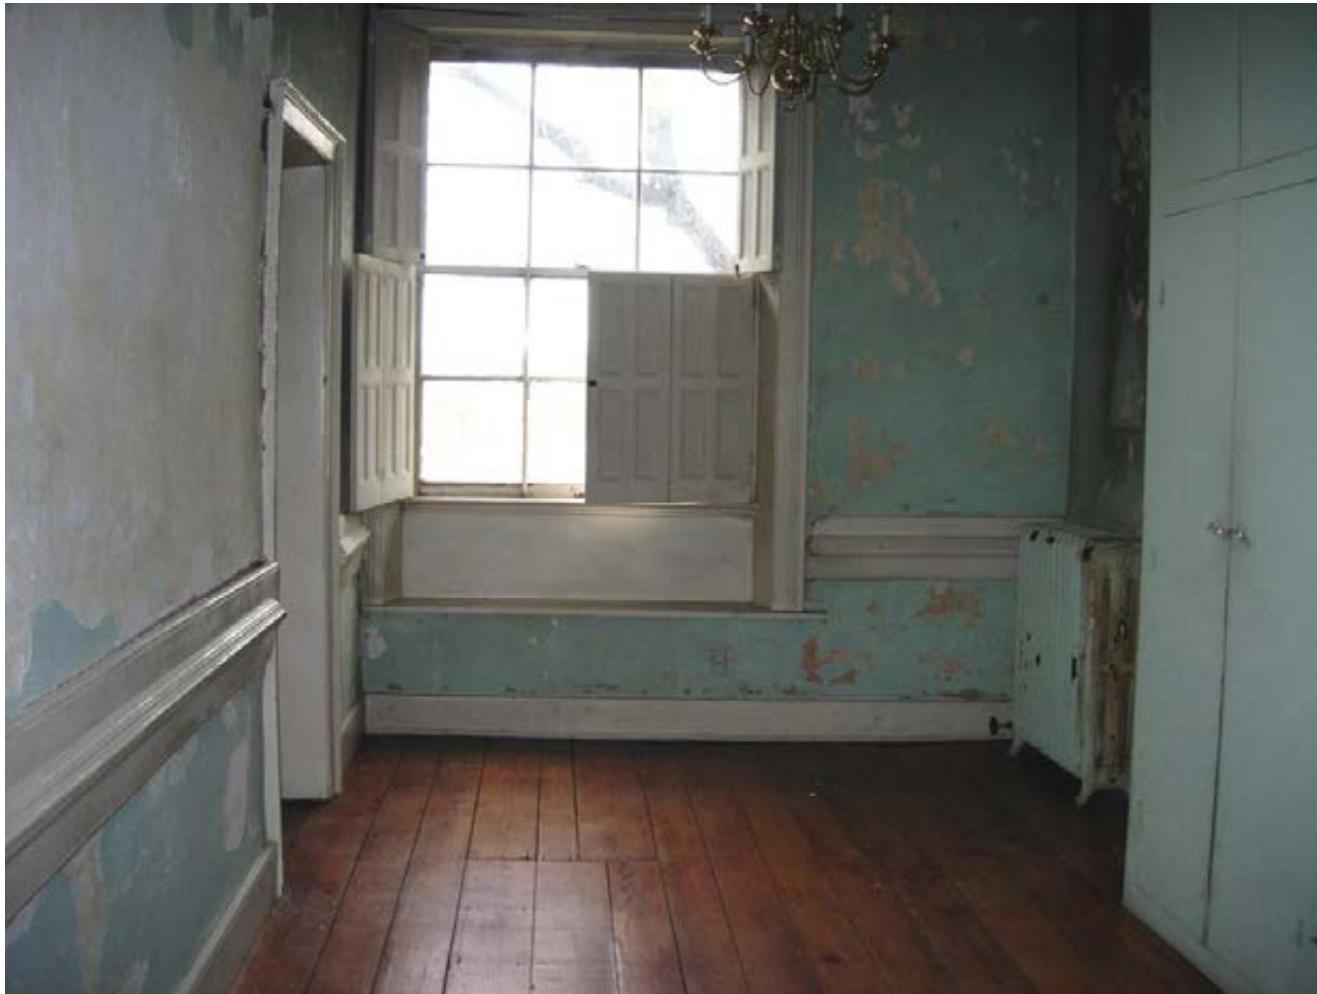
Figure 6-2. The second floor center hall. Photograph by Kathleen Manicke.

Location: Center Hall~West Wall					
Item	Date	Size	Description	Condition	Figure #
Window	19th century		Large six-over-six, wooden, double-sash window; narrow muntins; lights are 17" by 17"; some older glass containing waves and flaws.	Fair condition; muntins were repaired by sistering a piece of molding over the muntins; 2 broken lights; moderate paint failure; some rot on the rails and horizontal muntin surfaces; neither sash can be raised/lowered at this time.	6-2 6-3
Window hardware			Painted metal thumb lift, catch, and pin assembly for raising window.	Fair condition.	
Window casing		5½" W	Early style casing with a beaded inner edge followed by a flat plane, an ogee, then a narrow flat plane; ogee and narrow plane is the same along the south corner of the hall, other plane is narrower; corners are mitered.	Fair to good condition; mild paint failure.	6-2 6-3
Window frame	19th century	7" W	Flat lumber used for this frame indicates that the rooms on this level were lower in the decorative hierarchy than rooms on the first floor where there is paneled framing.	Good condition; painted finish; no rot or paint failure visible.	6-2 6-3

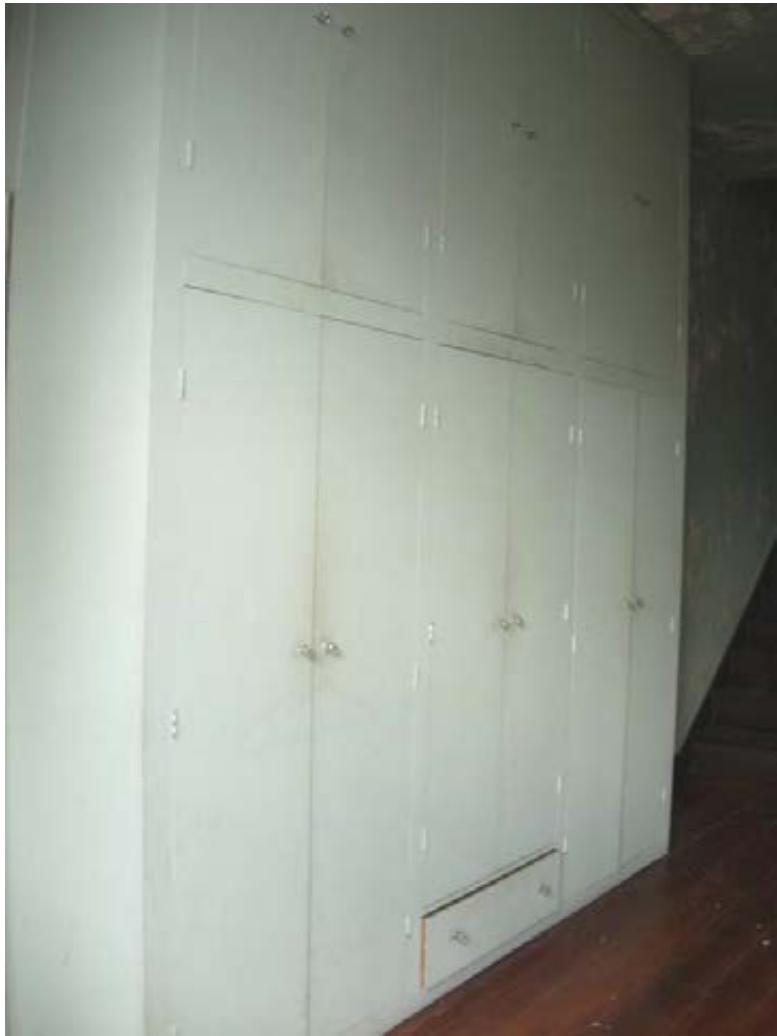
Figure 6-4. The built-in cabinets on the north wall of the upstairs center hall. Photograph by Kathleen Manicke.

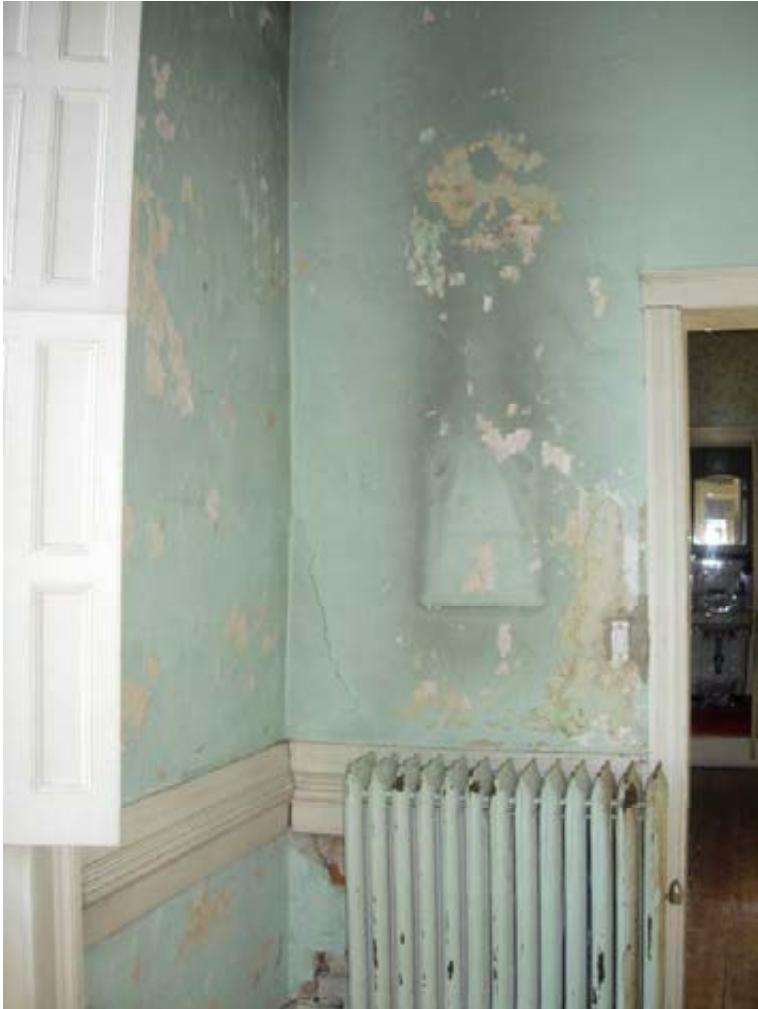
Figure 6-5. The north wall of the upstairs center hall showing smoke damage above the radiator. Photograph by Kathleen Manicke.

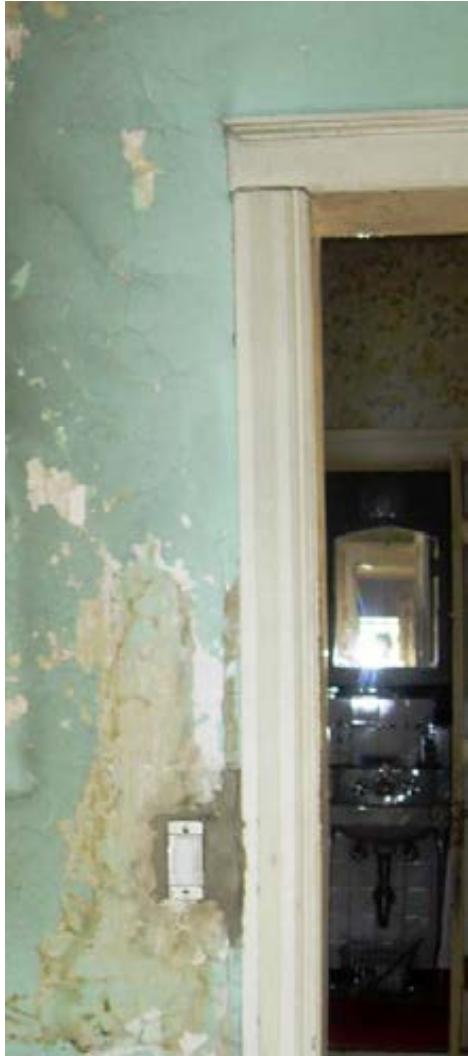
Figure 6-6. Inappropriate repairs on the casing of the door to the northwest bedroom. The upright portion has been replaced with a later material. Photograph by Kathleen Manicke.

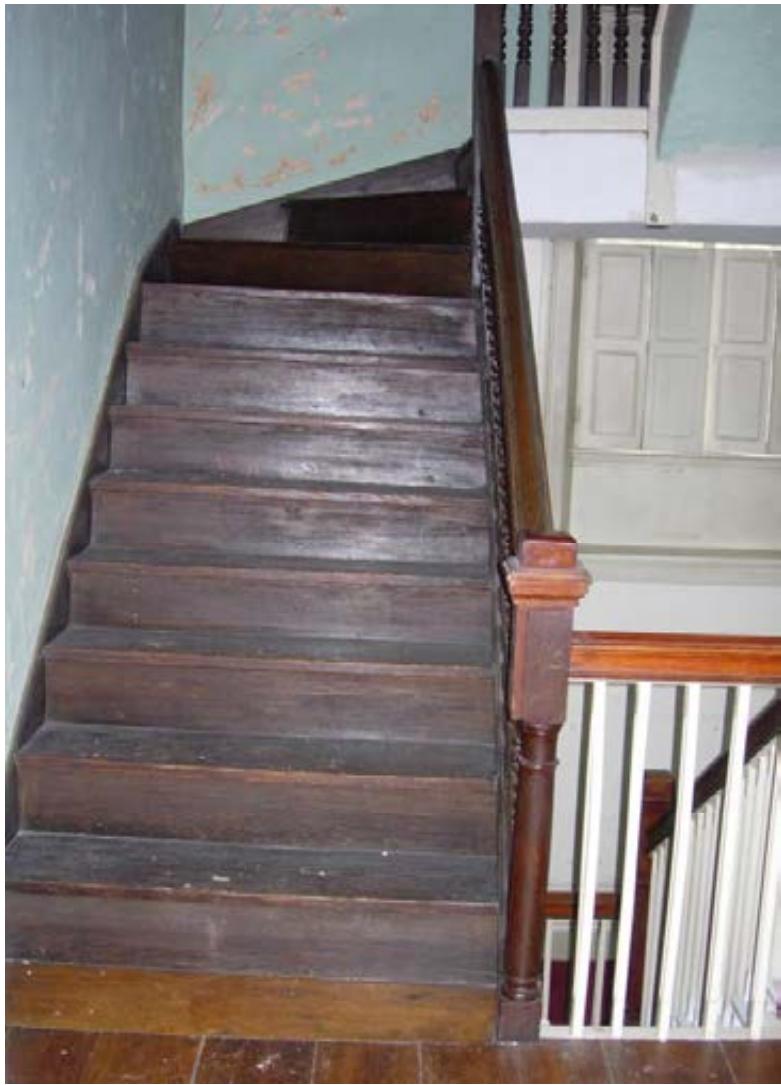
Figure 6-7. The stairs leading to the attic on the east wall of the second floor center hall. Photograph by Kathleen Manicke.

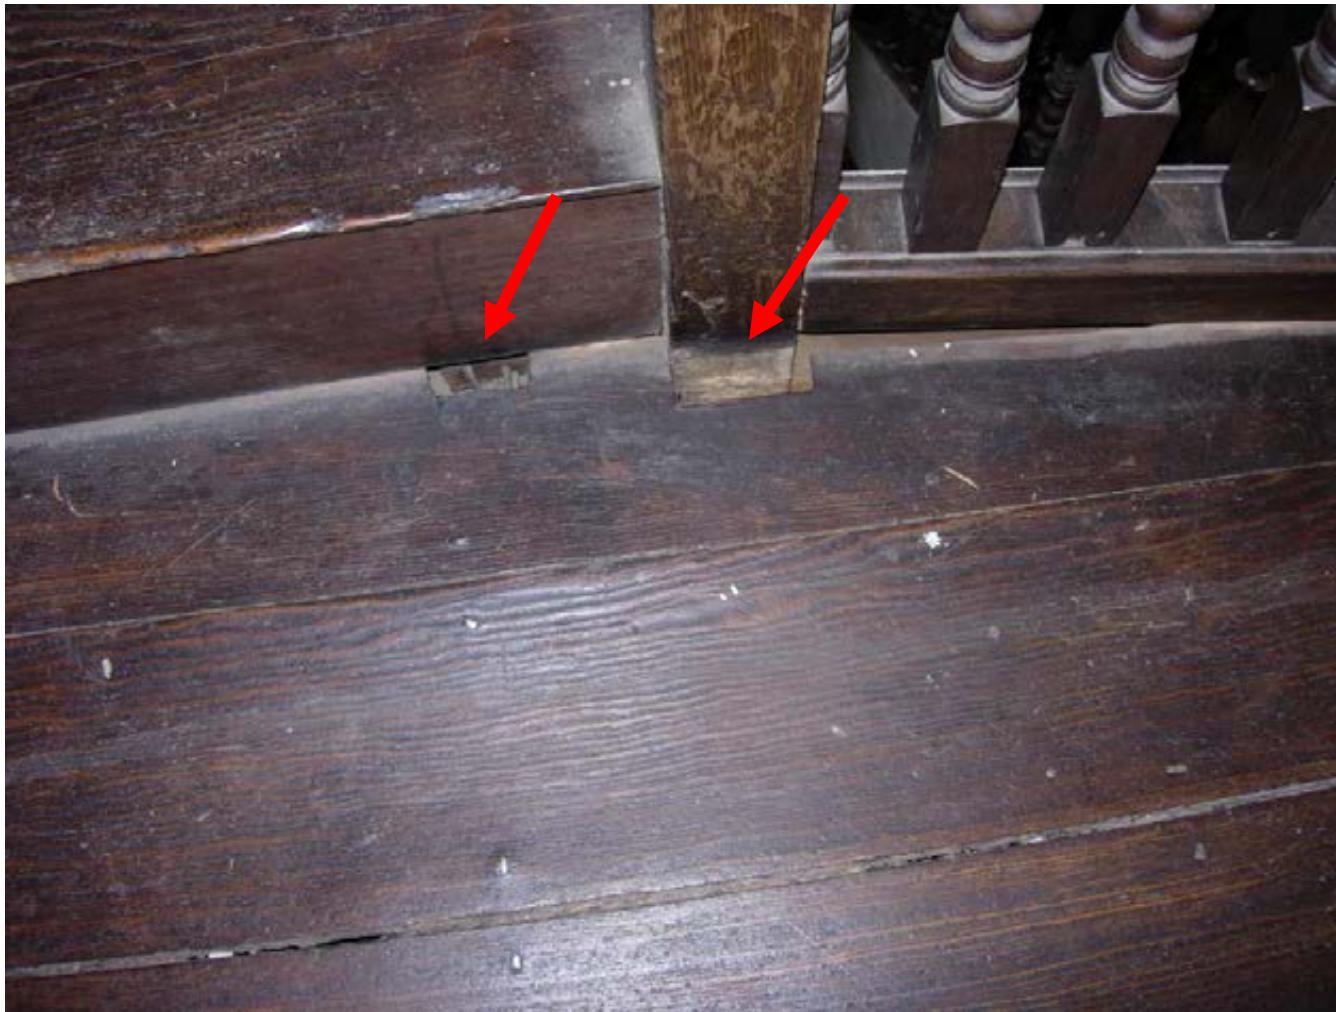
Figure 6-8. Red arrows point to the places where the stairs have pulled away from the structure, indicating movement and settling of the house. Photograph by Kathleen Manicke.

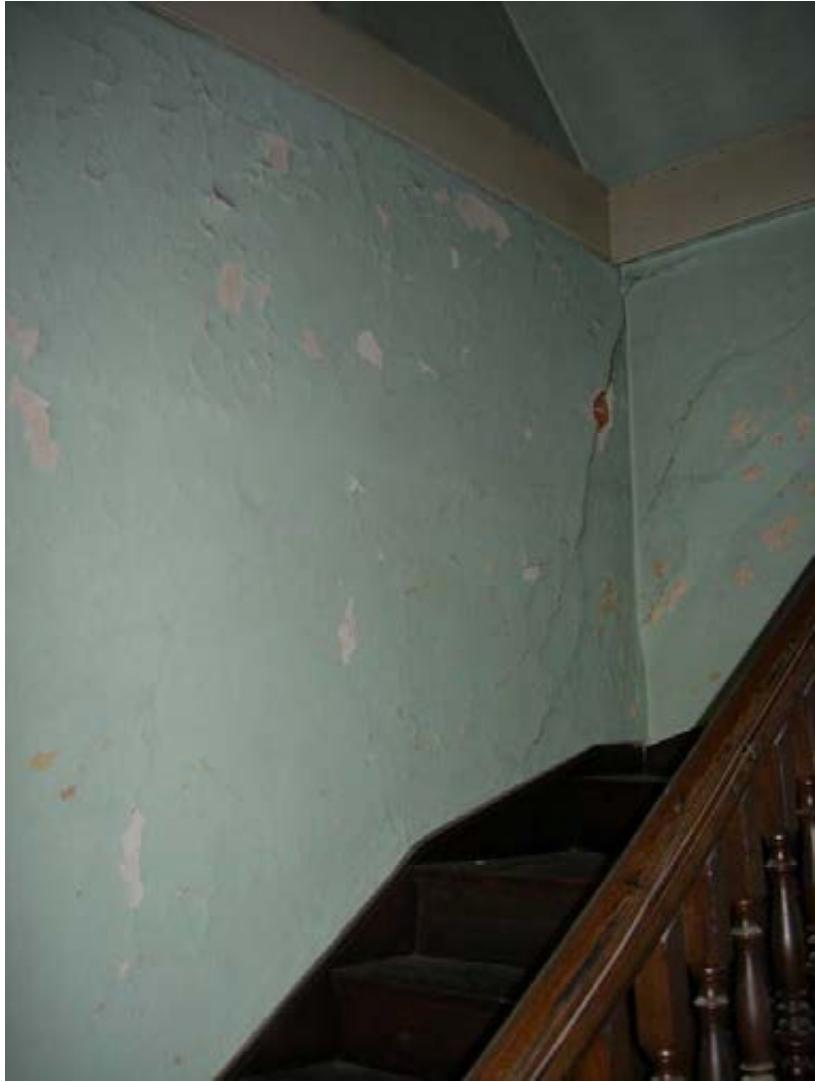
Location: Center Hall-East Wall					
Item	Date	Size	Description	Condition	Figure #
Stairs	18th-19th century		Early stairway with turned balusters in a dark stained wood; shape of handrail and knife marks on balusters indicate high level of hand work and thus an earlier date; some treads may have been replaced.	Good condition; stairs have pulled away from the walls due to the settling and movement of the house.	6-7 6-8
Flat plaster			Plaster over masonry wall with a smooth finish coat.	Excessive damage to plaster; severe cracking in area around stairs due to the movement and settling of the house; extreme paint failure.	6-9

Figure 6-9. Cracking and damage to the flat plaster walls around the stairs to the attic. Photograph by Kathleen Manicke.

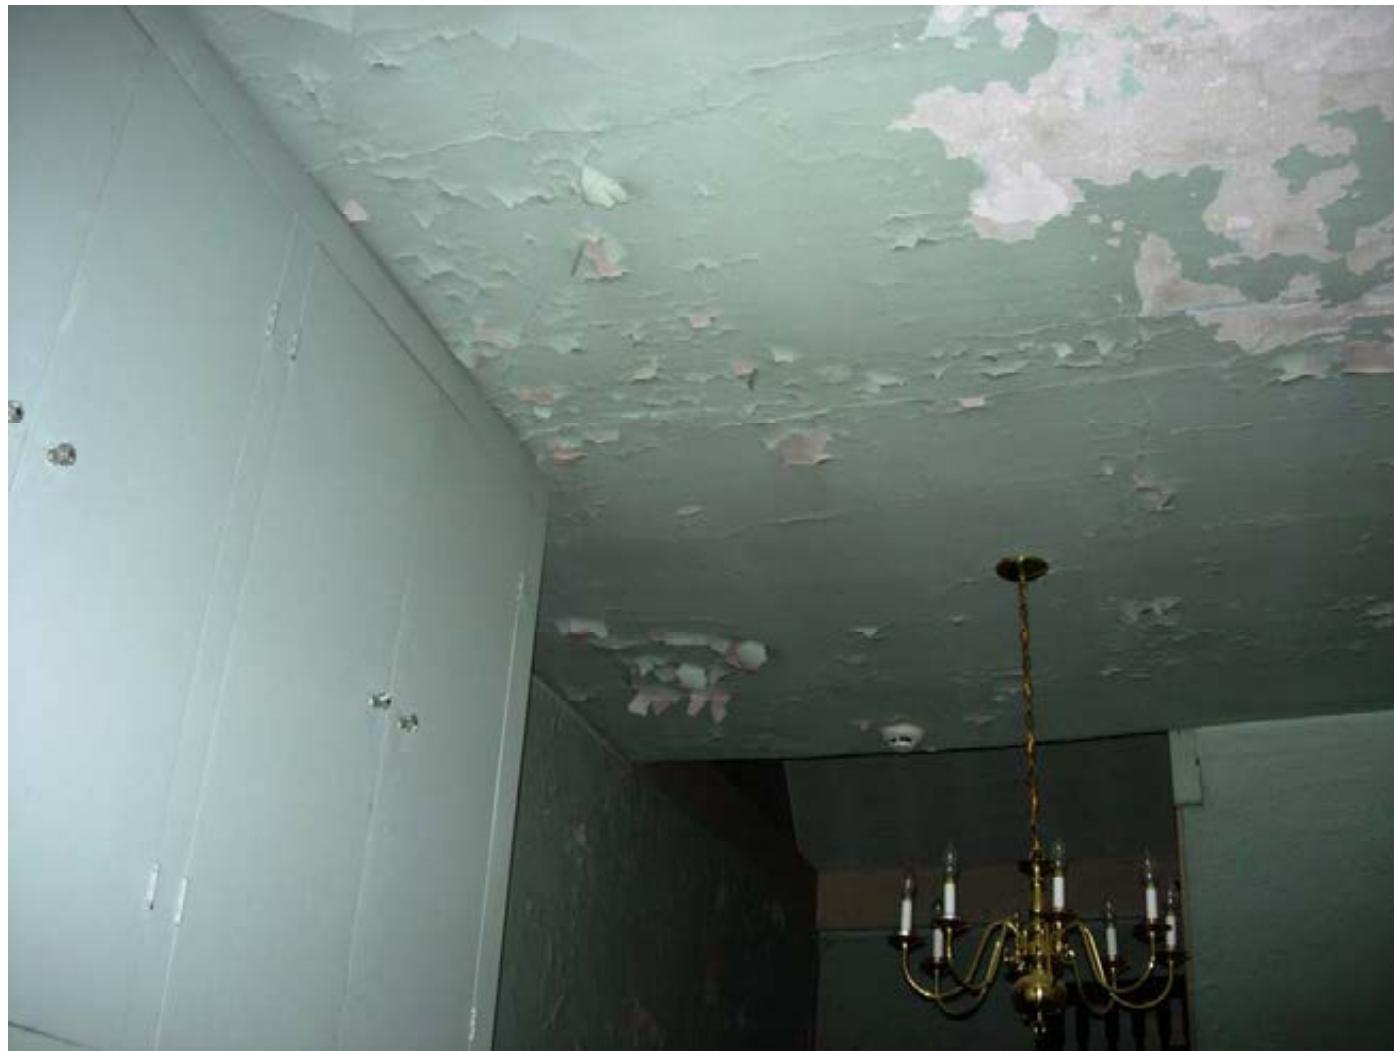
Figure 6-13. The eastern end of the ceiling. Photograph by Kathleen Manicke.

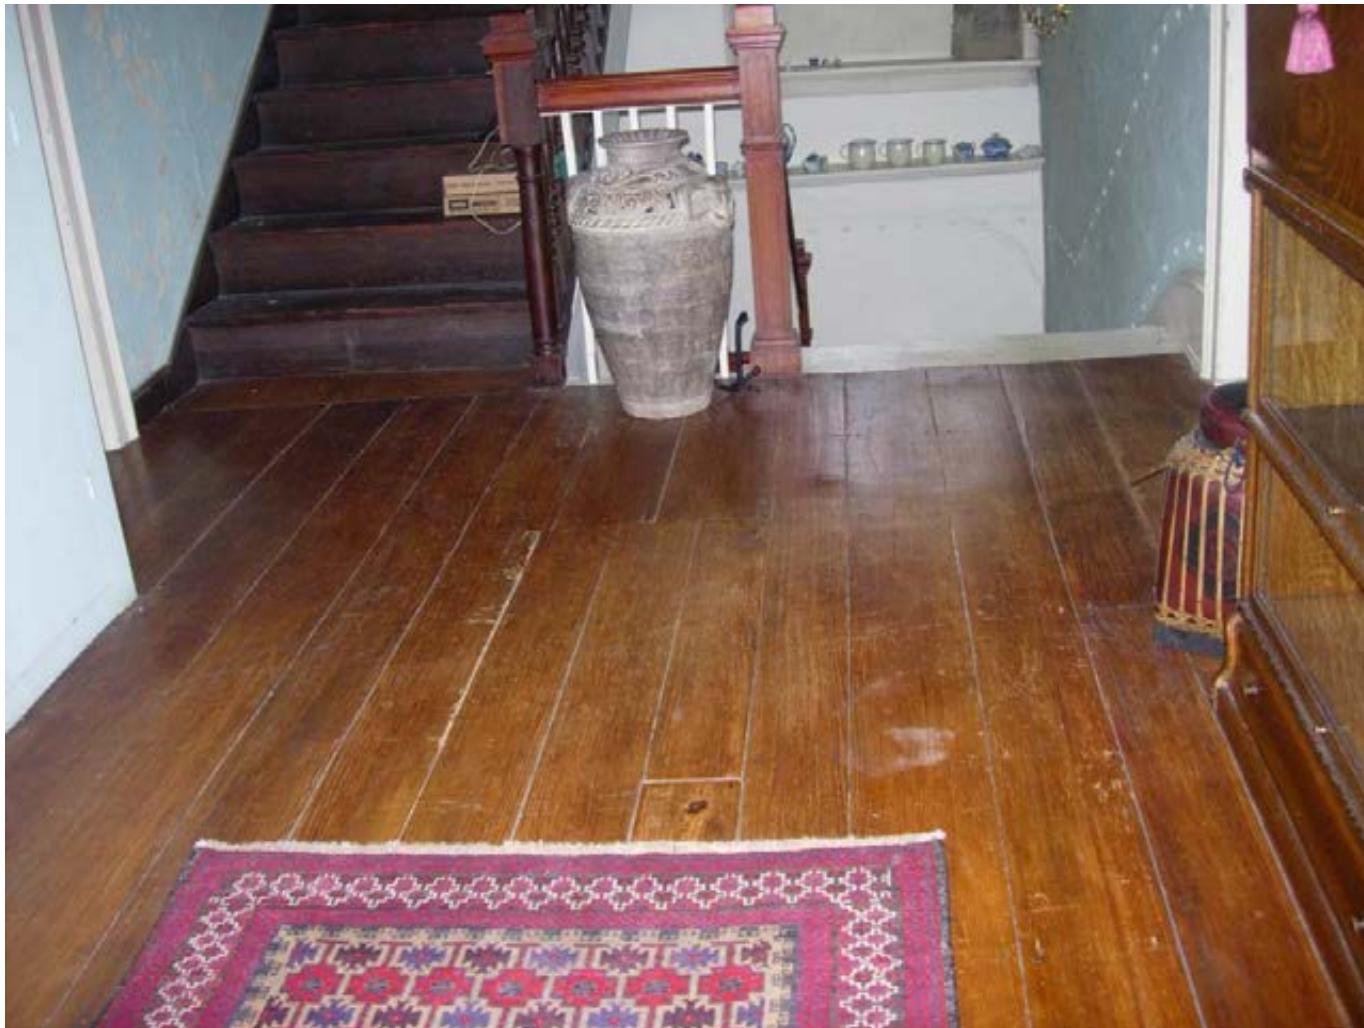
Figure 6-14. The floor in the upstairs center hall. Photograph by Kathleen Manicke.

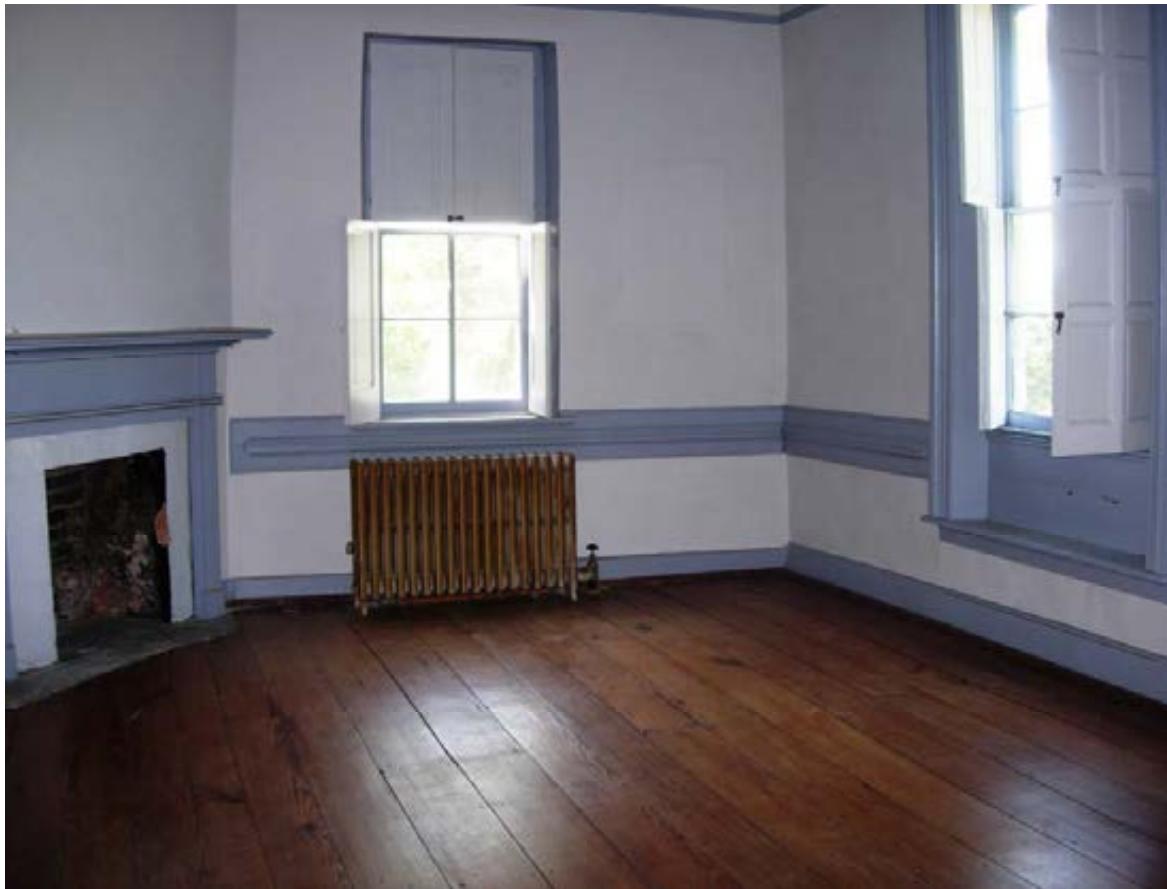
Figure 6-16. Bostwick's southwest bedroom. Photograph by Kathleen Manicke.

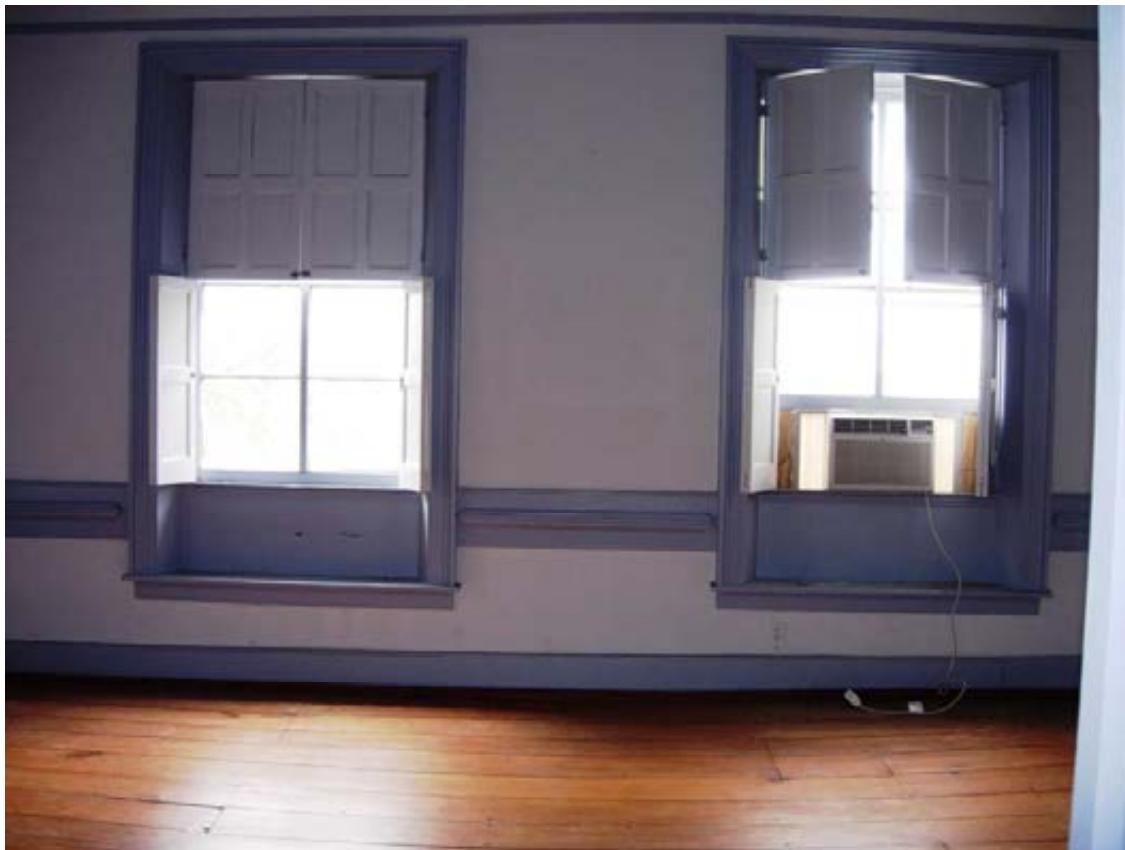
Baseboard	18th century	6" H	Minimum 1" deep flat lumber with beaded top edge.	Good condition; painted finish.	6-17

Picture rail	19th-20th century	2" W	Runs even with the top of the windows approximately 12" below the ceiling; wooden, ogee-shaped molding used for holding metal picture-hanging clips.	Good condition; painted finish.	6-17
Flat Plaster			Flat plaster over masonry with smooth finish; room replastered since the town's purchase in 1997.	Excellent condition.	6-17

Figure 6-17. The west wall of the southwest bedroom on Bostwick's second floor. Photograph by Kathleen Manicke.

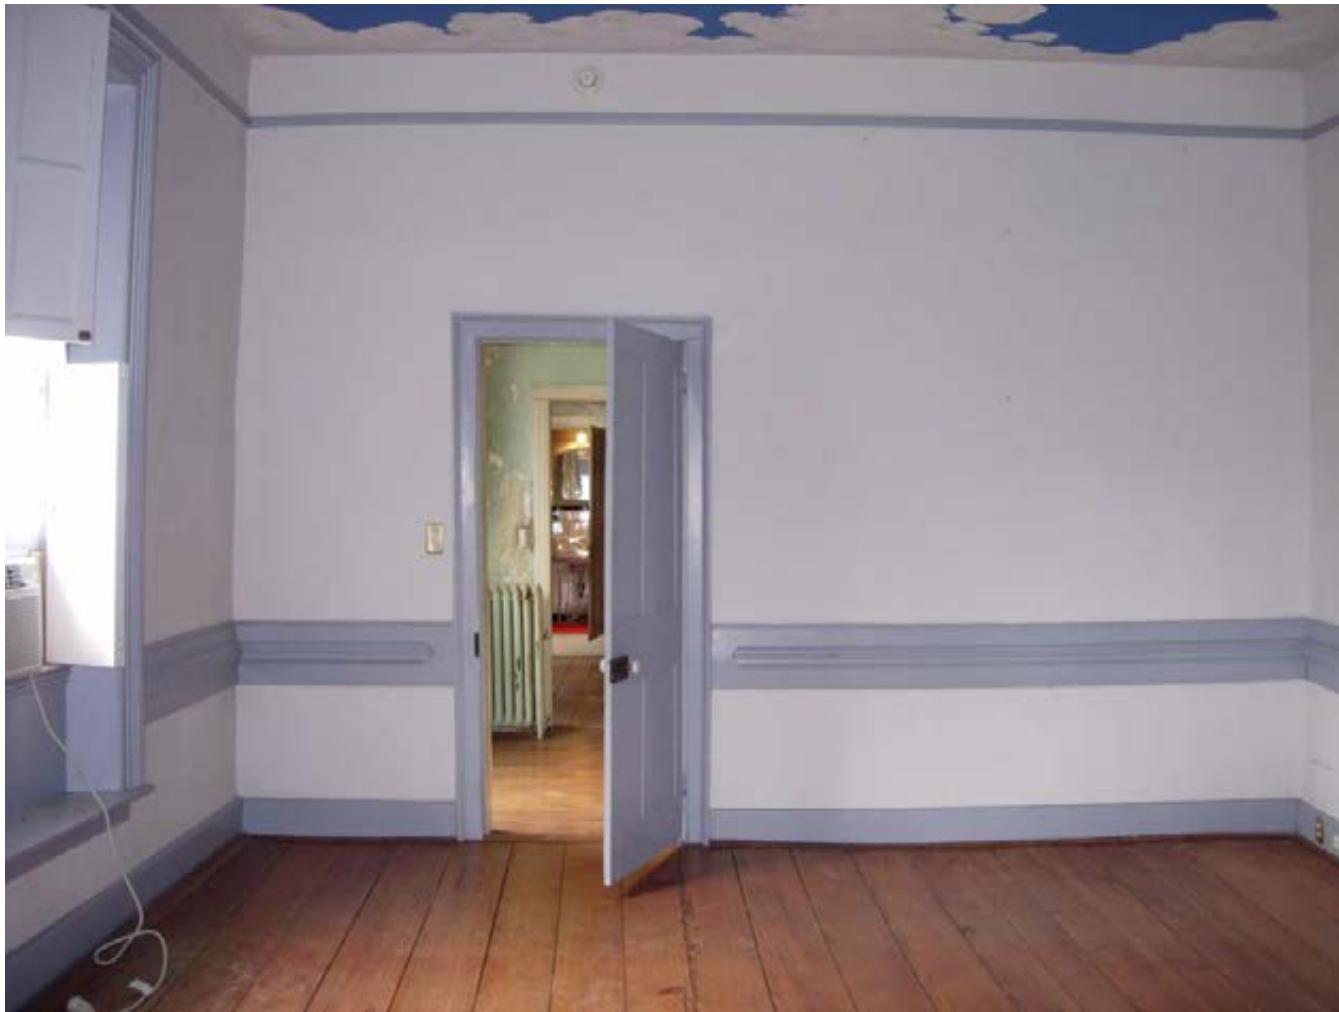
Lockset	19th-20th century		Rectangular, surface mount lockset.	Good condition; operable.	
Door casing	19th-20th century	1" x 4½"	Flat lumber with a 2½" backboard molding that sits above the plane of the adjacent flat plaster wall.	Good condition; painted finish.	
Door frame	19th century	10"	Flat lumber.	Good condition; painted finish.	
Flat plaster			Flat plaster over masonry with smooth finish; room replastered since the town's purchase in 1997.	Good condition.	6-18

Figure 6-18. The north wall of the southwest bedroom. Photograph by Kathleen Manicke.
