Building at Risk:

A Historic Structure Report for Bostwick in Bladensburg, MD

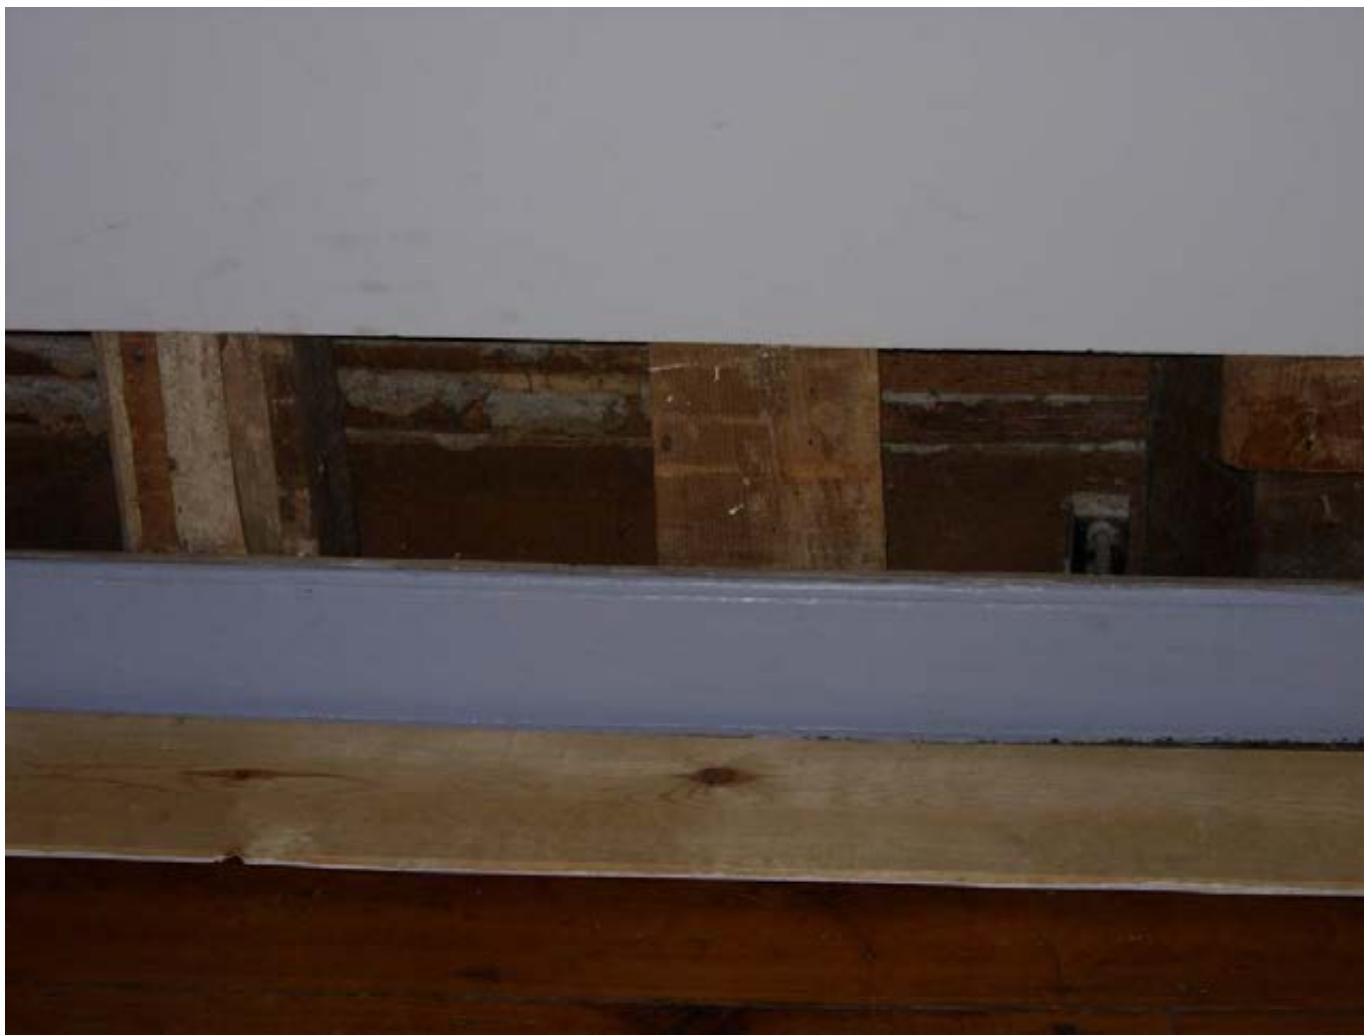
Figure 6-20. Inside the east wall of the southwest bedroom. Photograph by Kathleen Manicke.

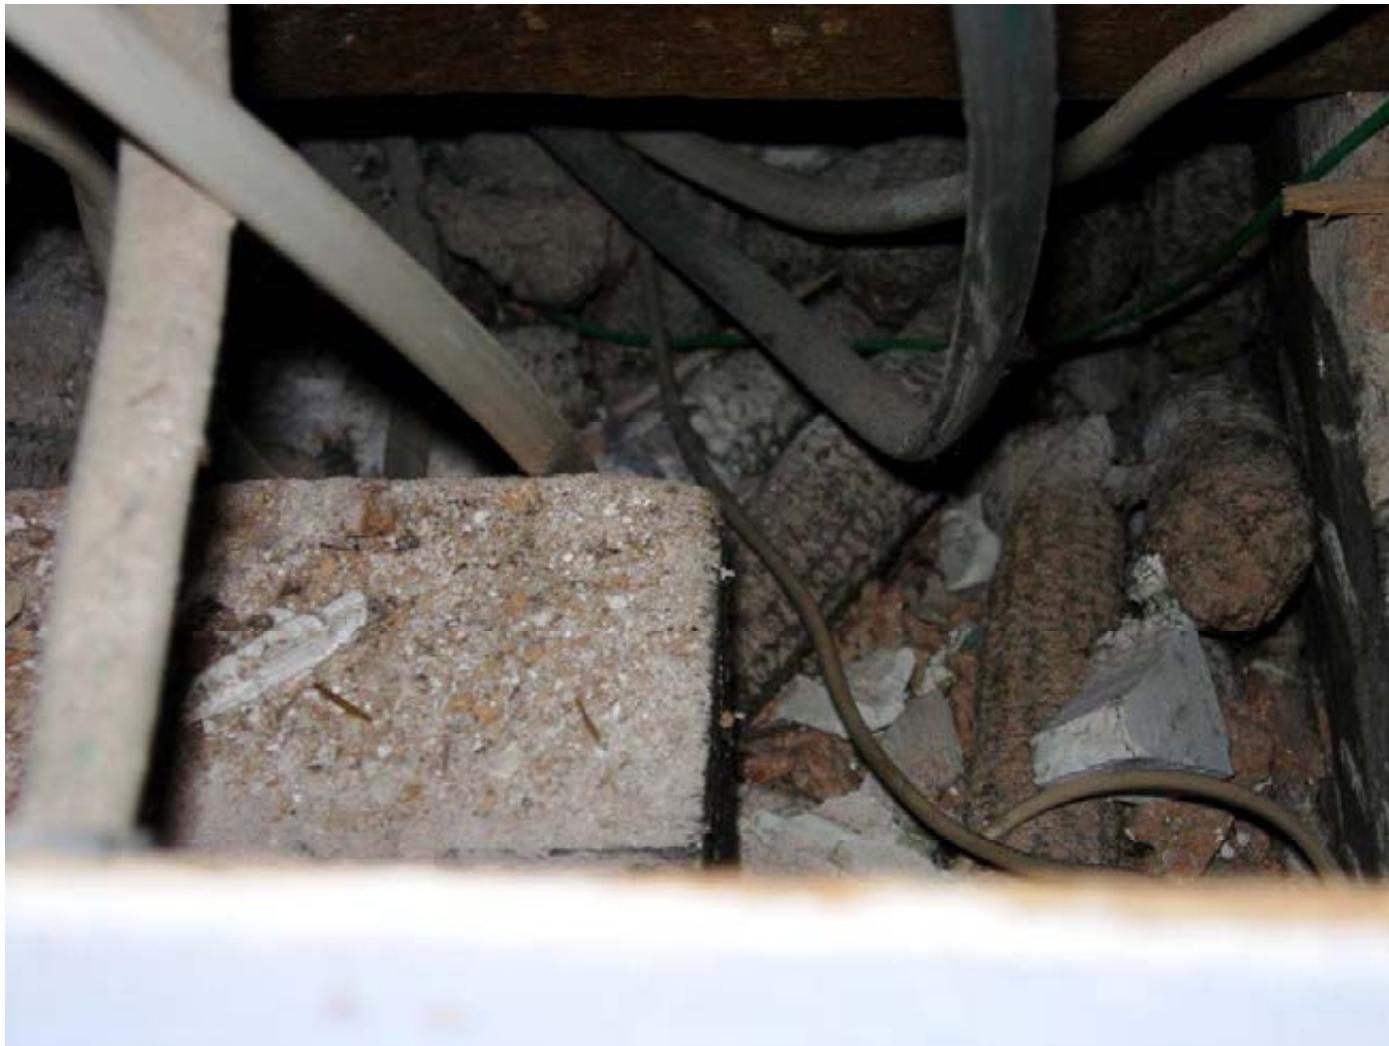
Figure 6-21. The space between the floor joists was filled with corncobs for insulation. Photograph by Kathleen Manicke.

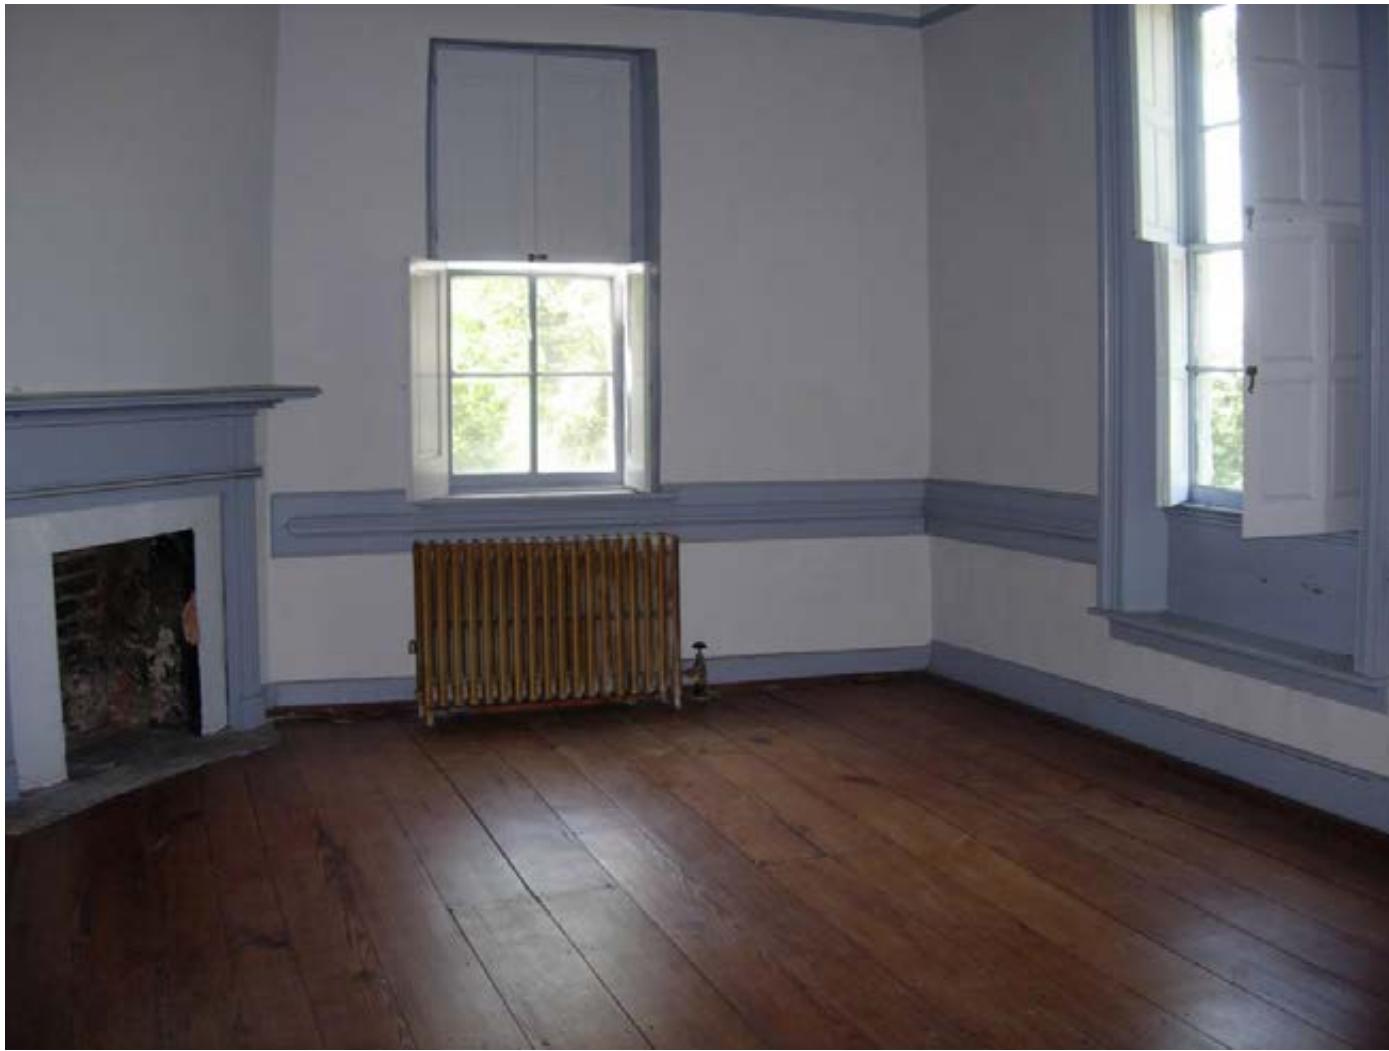
Radiator	19th-20th century	45" W x 30" H	Cast iron radiator with logo "McKeesport" at top.	Good condition; operable; gold(brass metallic paint finish.	6-22

Figure 6-22. The south wall in the southwest bedroom. Photograph by Kathleen Manicke.

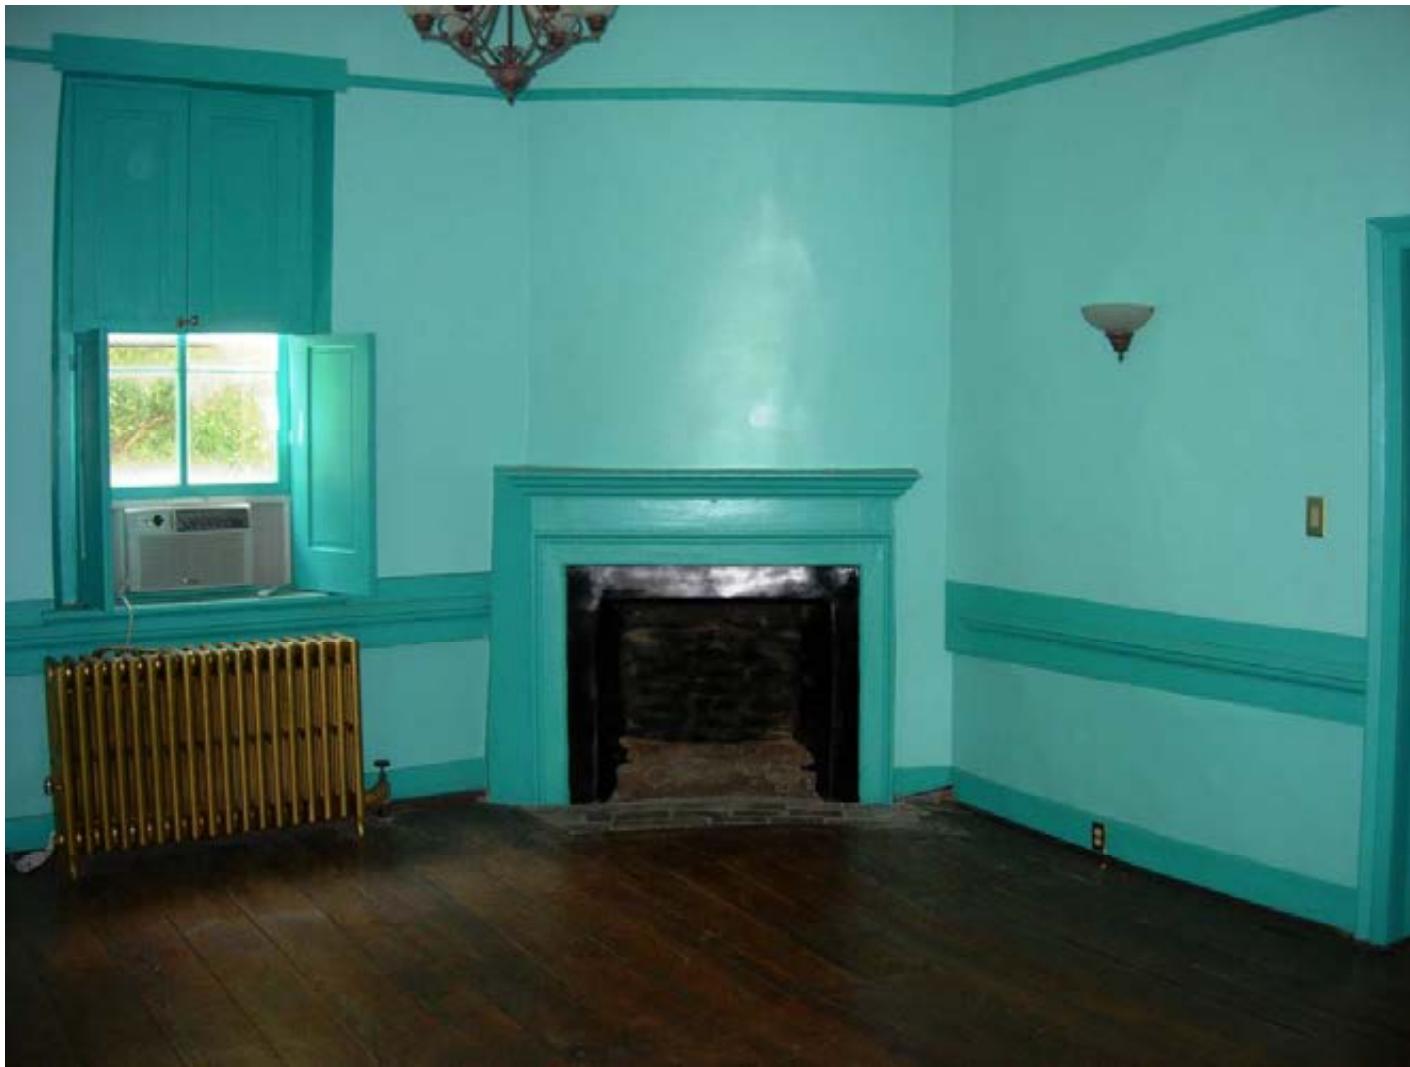
Figure 6-25. The southeast bedroom on the second floor. Photograph by Kathleen Manicke.

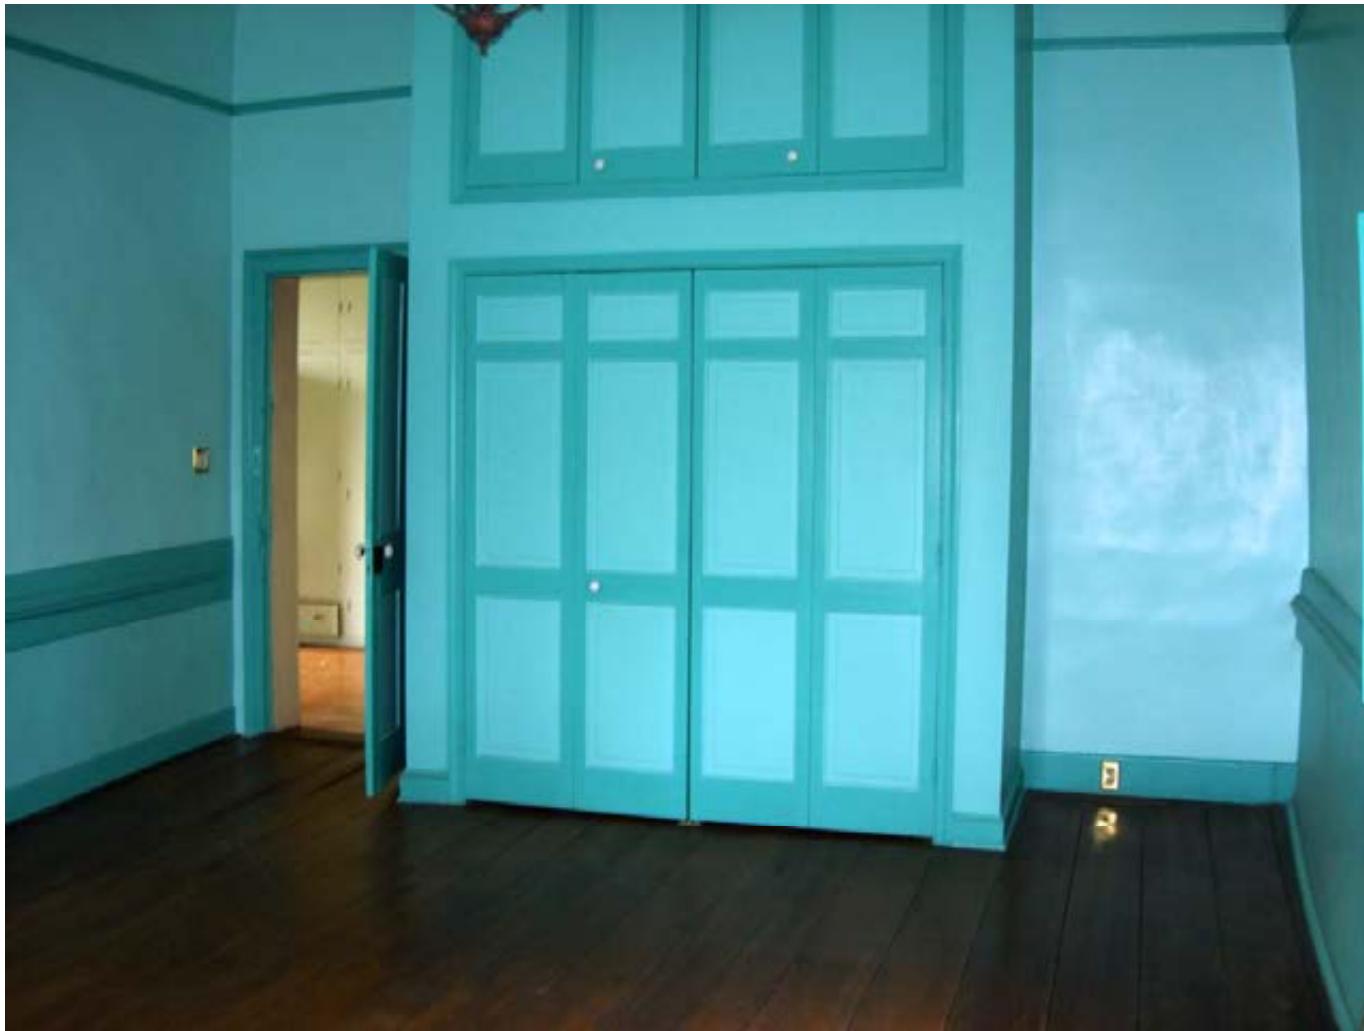
Hinges (2)	18th-19th century		Early hand-wrought "L"-shaped strap hinges; mortised into the flat panel side of the door; wall side of hinge enclosed within casing; top hinge has 2 large wrought nails on the horizontal strap and 5 smaller nails on the vertical strap; lower hinge is similar.	Fair condition; operable; painted.	
Lockset	19th-20th century		Rectangular, surface mount lockset.	Good condition; operable.	
Door casing	19th-20th century	1" x 4½"	Flat lumber with a 2½" backboard molding that sits above the plane of the adjacent flat plaster wall.	Good condition; painted finish.	6-26
Door frame	19th-20th century	10" W	Flat lumber.	Good condition; painted finish.	
Flat Plaster			Flat plaster over masonry with smooth finish; room replastered since the town's purchase in 1997.	Excellent condition.	6-26
Built-in closet	2000	7'7½" W x 27"deep	Built-in closet with cupboard above; bi-fold doors are panels with modern hinges and gold/white ceramic knobs; side walls are drywall; elevated floor is plywood.	Excellent condition.	6-26

Figure 6-26. The closet on the north wall of the southeast bedroom. Photograph by Kathleen Manicke.

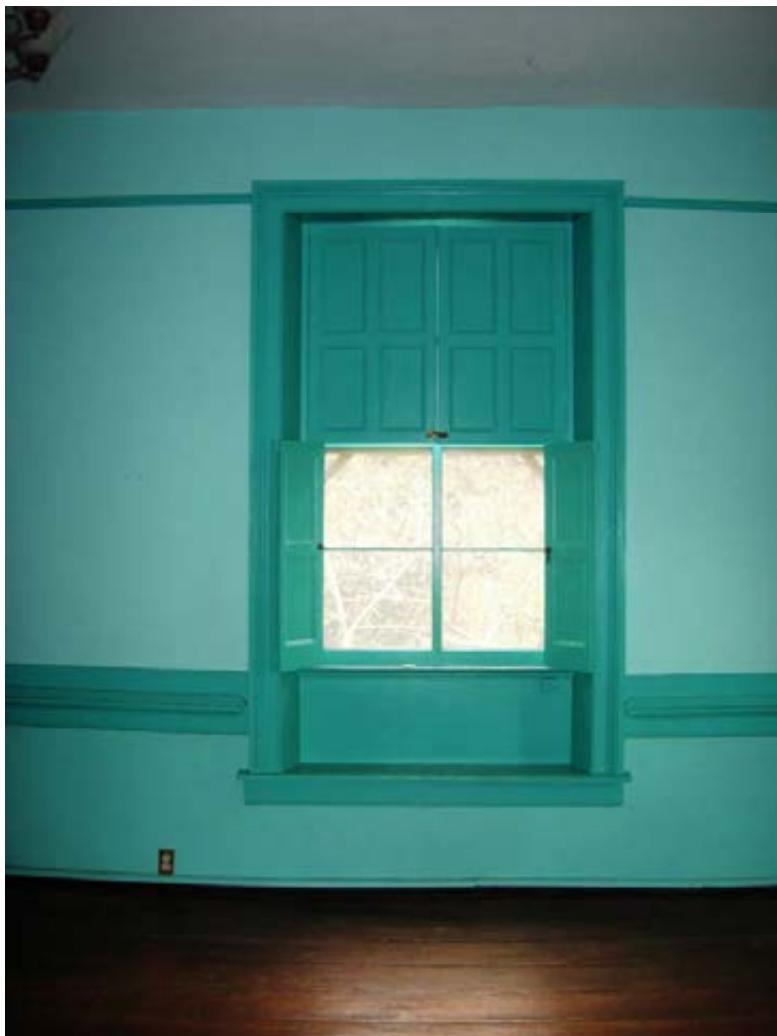
Flat plaster			Flat plaster over masonry with smooth finish; room replastered since the town's purchase in 1997.	Excellent condition.	6-27

Figure 6-27. Window on the east wall of the southeast bedroom. Photograph by Kathleen Manicke.

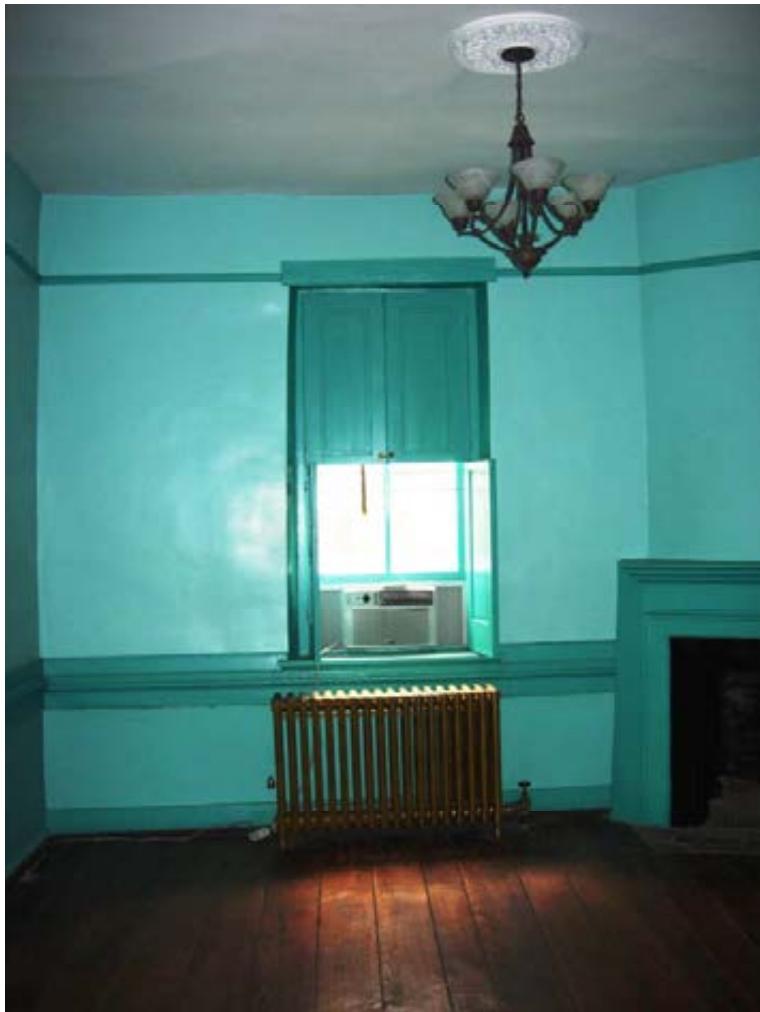
Radiator	20th century	45"W x 30"H	Cast iron radiator with logo "McKeesport" at the top.	Good condition; operable; gold-brass metallic painted finish.	6-28

Figure 6-28. Window on the south wall of the southeast bedroom. Photograph by Kathleen Manicke.

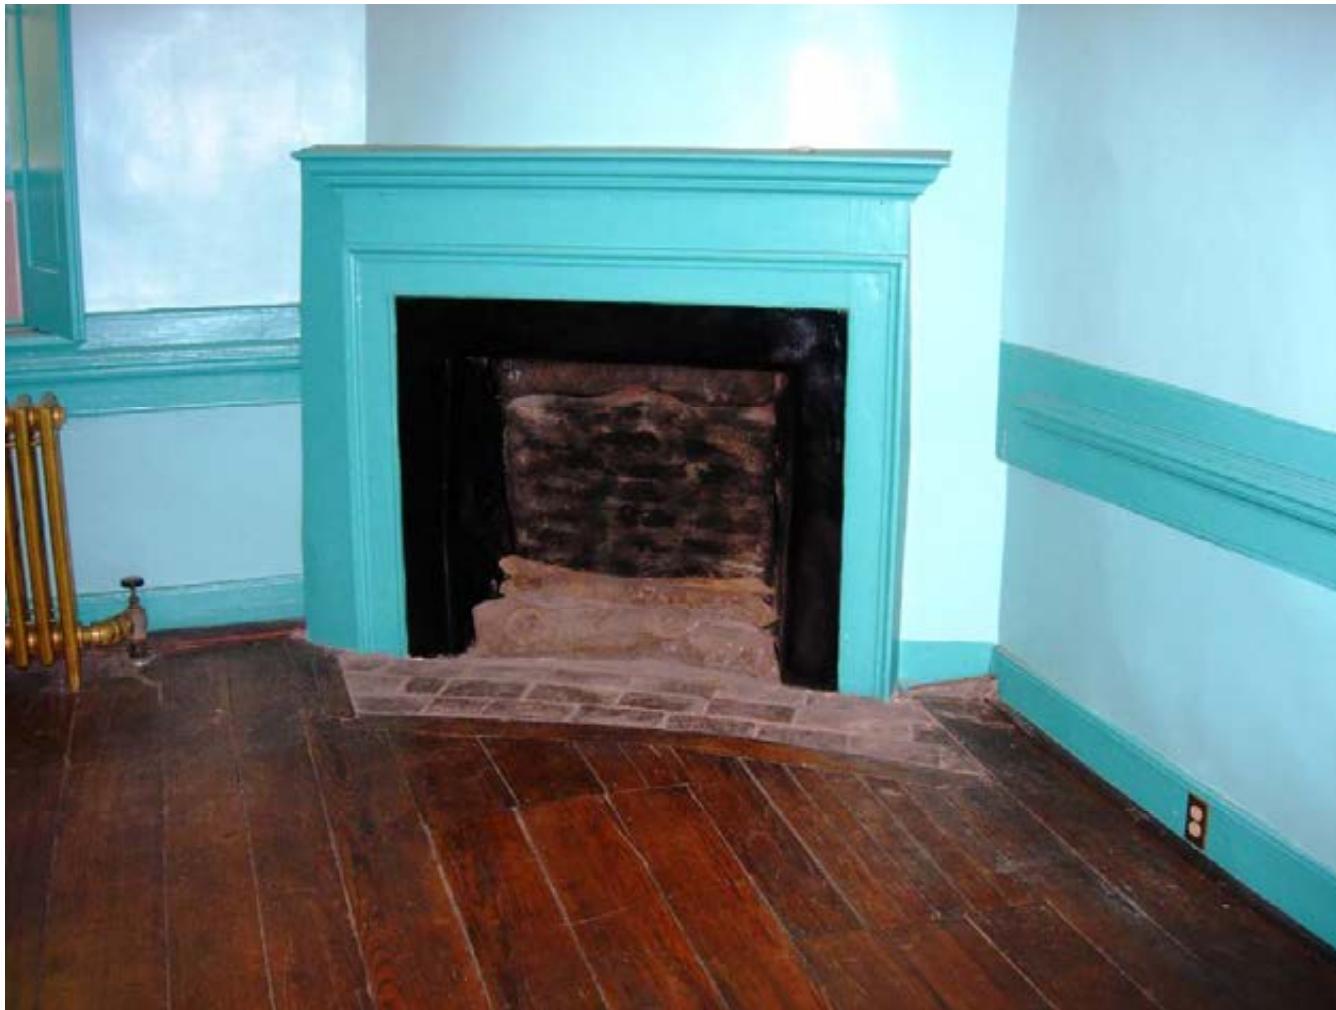
Figure 6-29. Fireplace on the south wall of the southeast bedroom. Notice the curved wall behind the mantel. Photograph by Kathleen Manicke.

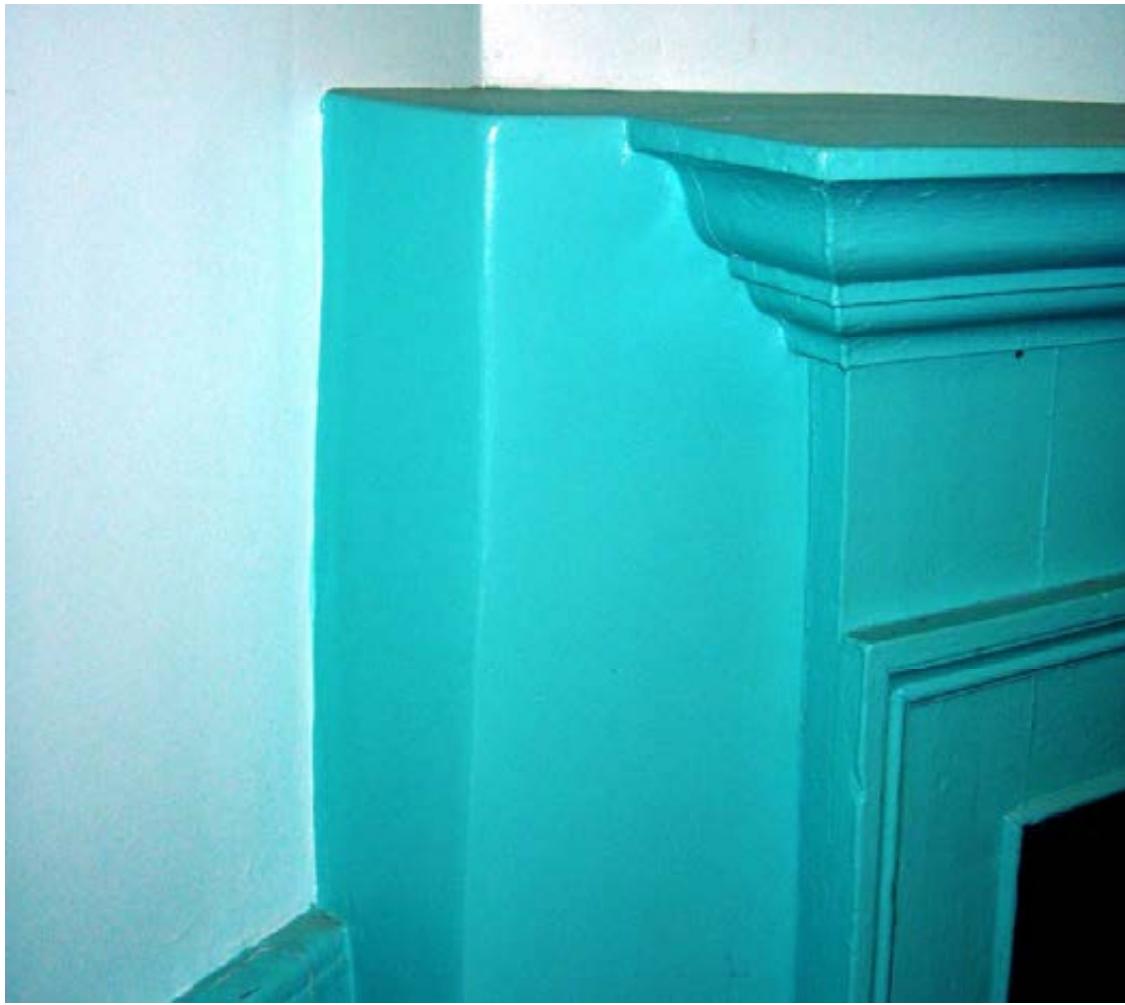
Figure 6-30. Joining the straight mantel to the curved fireplace wall at the corner of the south wall. Photograph by Kathleen Manicke.

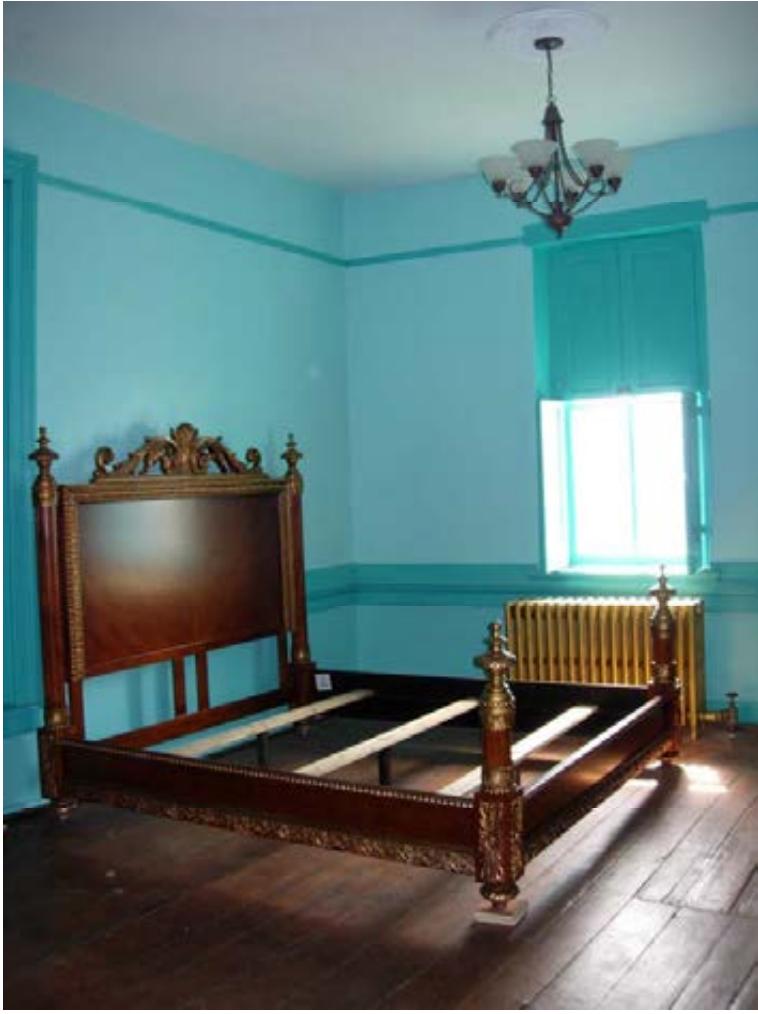
Figure 6-32. The floor in the southeast bedroom. Notice the blocking required to level the bed. Photograph by Kathleen Manicke.

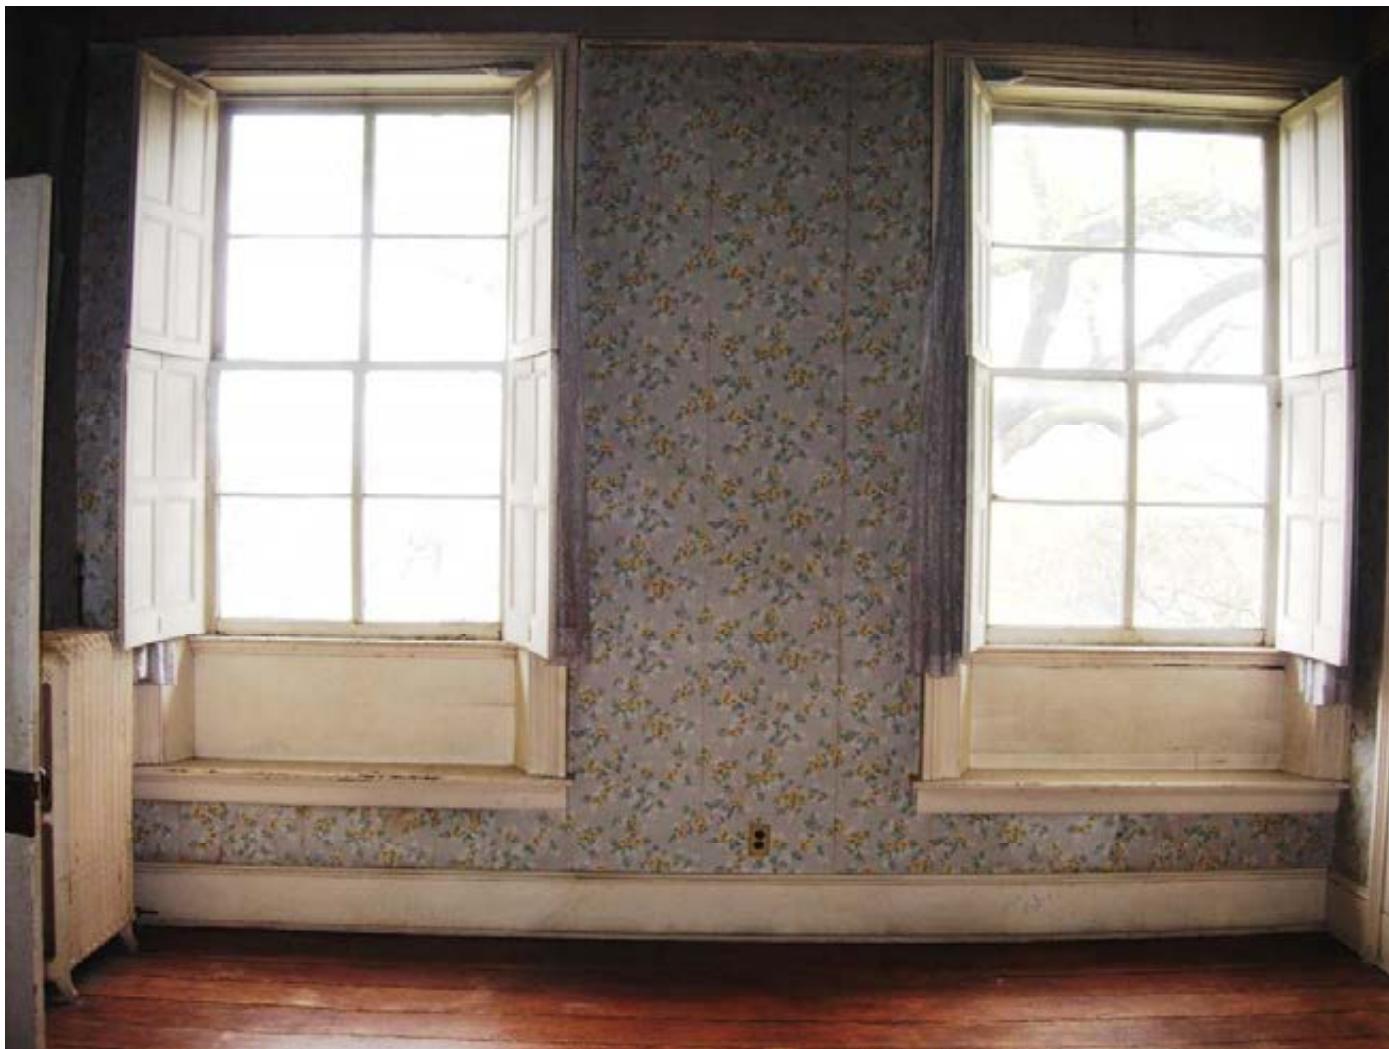
Window frame	19th century	7"	Composed of flat lumber.	Good to fair condition with a painted finish exhibiting some paint failure.	6-34
Picture rail molding			Wooden, ogee-shaped molding for holding metal picture-hanging clips; runs even with the top of the windows approximately 12" below the ceiling level.	Fair to good; significant chipping and peeling of the painted finish.	
Baseboard	20th century	9½" H	8" flat lumber topped by 1½" ogee milled cap molding.	Good to fair with a painted finish.	6-34
Flat plaster			Flat plaster is covered with at least two layers of wallpaper over a green painted finish; paper above the picture rail is neutral color, random feather pattern; paper below rail is wild yellow roses on a gray background.	Poor condition; mild to moderate cracking of plaster; wallpaper peeling due to moisture infiltration and glue failure; water staining under south window; loose and torn wallpaper; grimy wallpaper.	6-34

Figure 6-34. The west wall of the northwest bedroom. Photograph by Kathleen Manicke.

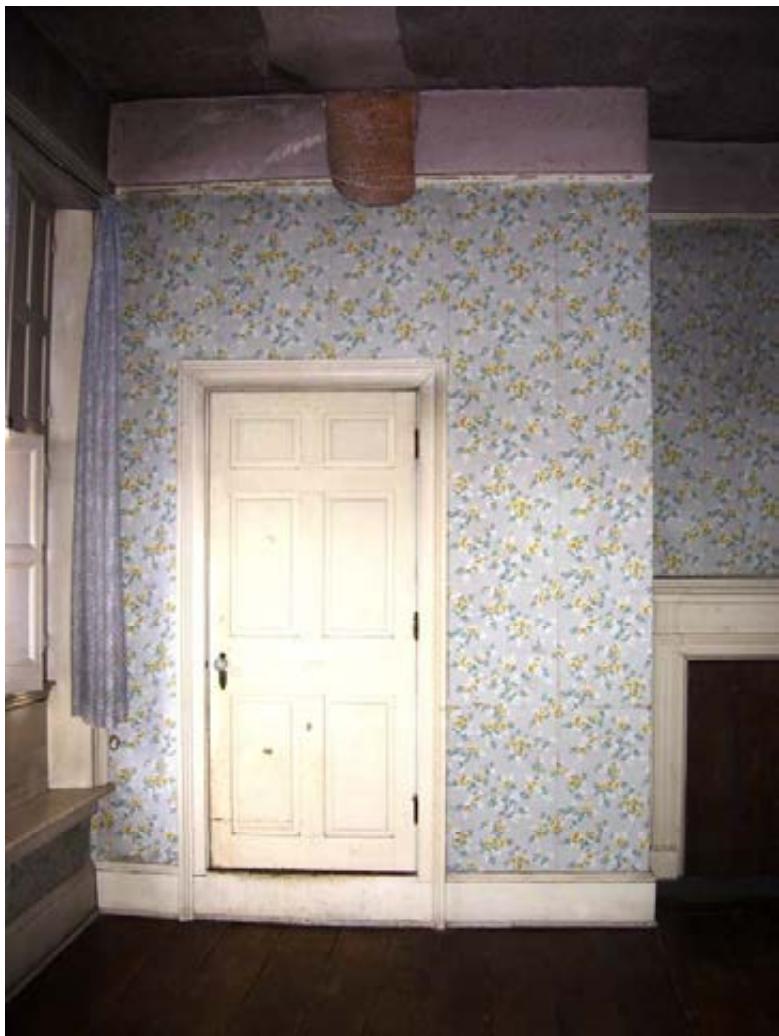
Figure 6-35. The door to the bathroom in the northwest bedroom. Photograph by Kathleen Manicke.

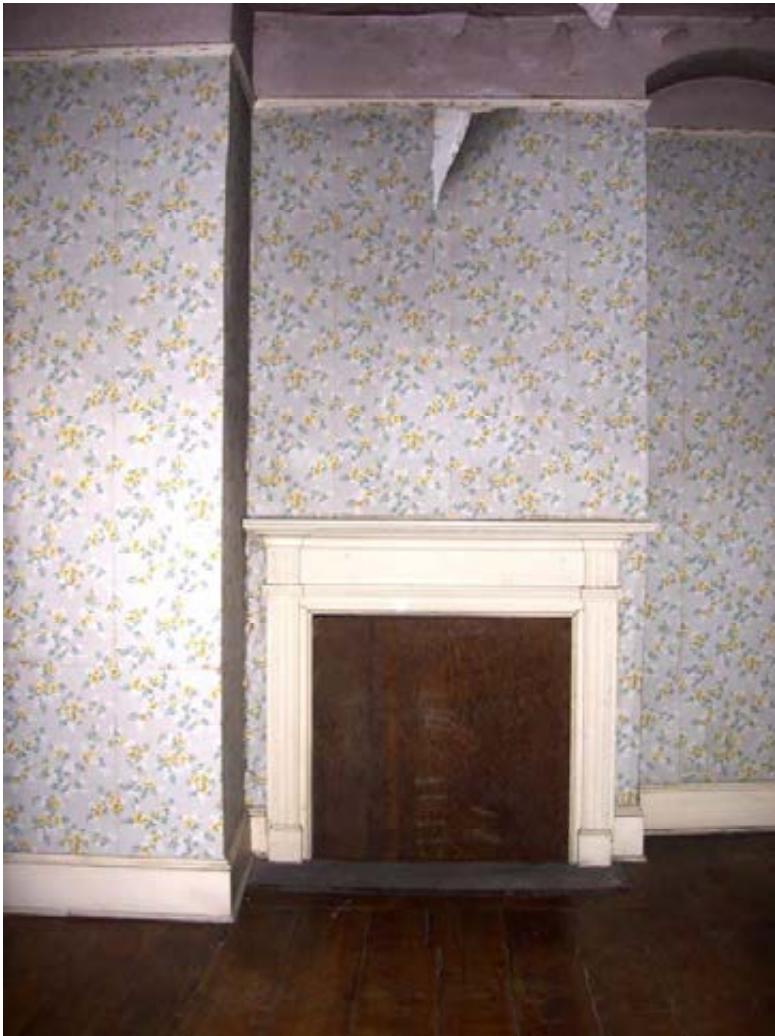
Figure 6-36. The fireplace on the north wall of the northwest bedroom. Photograph by Kathleen Manicke.

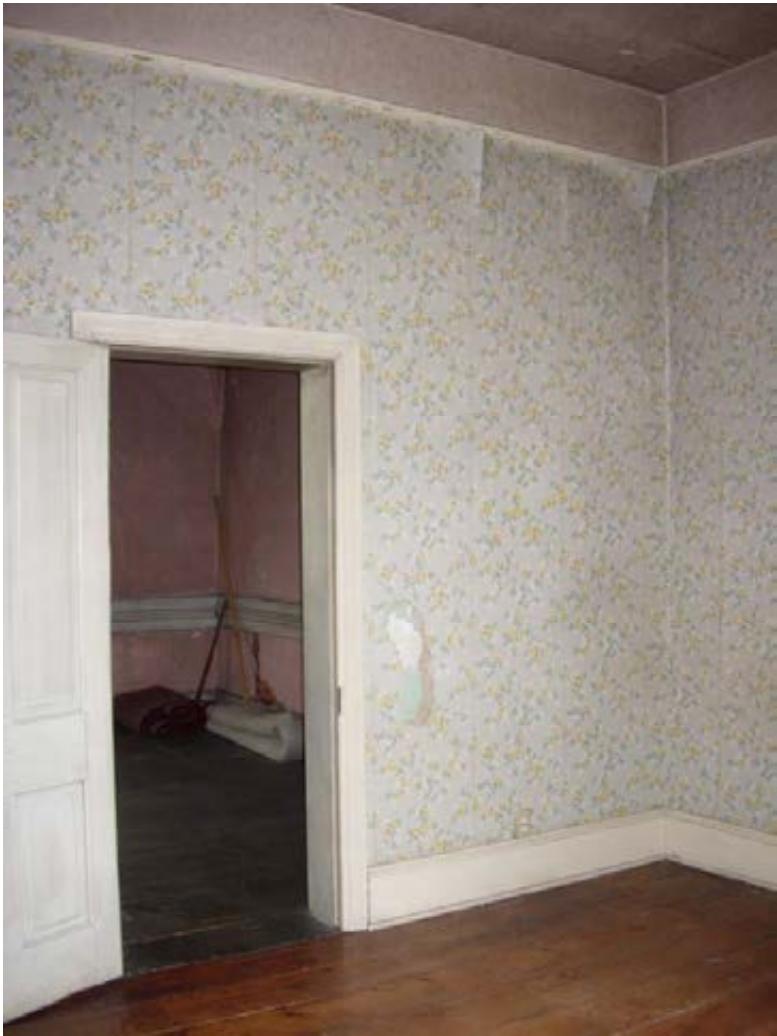
Location: Second Floor Northwest Bedroom~East Wall					
Item	Date	Size	Description	Condition	Figure #
Door (1)	20th century	34" W x 81½" H x 1½" T	4-panel, cross style door featuring feathered panel edges on both sides of the door; pin style hinges, painted steel surface-mounted lockset with white ceramic doorknobs.	Good condition.	6-37
Casing	20th century	1" x 4"	Differs from that on other doors in the room; consists of flat lumber with fluting in the center area; mitered corners.	Good; painted finish.	6-37
Door frame	20th century	10" W	Flat lumber with ¼" door stop.		6-37
Picture rail molding		2" W	Wooden, ogee-shaped molding for holding metal picture-hanging clips; runs even with the top of the windows approximately 12" below the ceiling level.	Fair to good; significant chipping and peeling of the painted finish.	6-37

Baseboard	20th century	9 ½" H	8" flat lumber topped by 1½" ogee milled cap molding.	Good to fair with a painted finish.	6-37
Flat Plaster			Flat plaster is covered with at least two layers of wallpaper over a green painted finish; paper above the picture rail is a neutral color, random feather pattern; paper below rail is wild yellow roses on a gray background.	Poor condition; severe cracking within the niche area near the northeast corner; wallpaper is stained and torn.	6-37 6-38

Figure 6-37. The east wall of the northwest bedroom. Photograph by Kathleen Manicke.

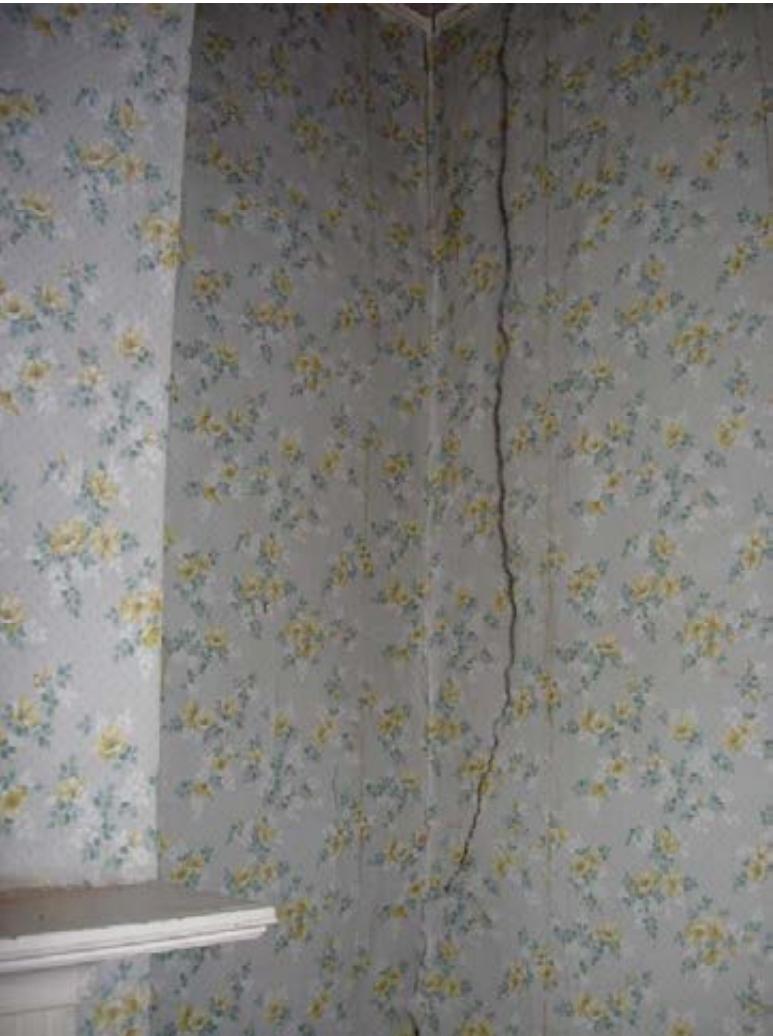
Figure 6-38. Large crack in the east wall at the northeast corner. Photograph by Kathleen Manicke.

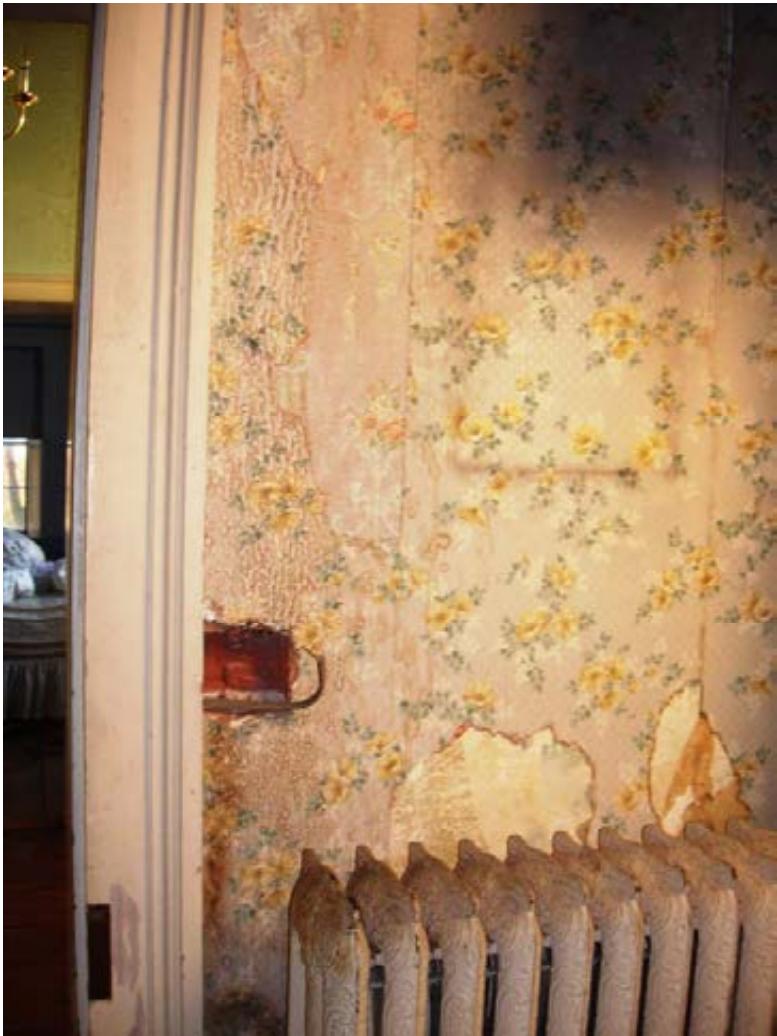
Picture rail molding		2" W	Wooden, ogee-shaped molding for holding metal picture-hanging clips; runs even with the top of the windows approximately 12" below the ceiling level.	Fair to good; significant chipping and peeling of the painted finish.	
Baseboard	20th century	9 ½" H	8" flat lumber topped by 1½" ogee milled cap molding.	Good to fair with a painted finish.	
Flat Plaster			Flat plaster is covered with at least two layers of wallpaper over a green painted finish; paper above the picture rail is a neutral color, random feather pattern; paper below rail is wild yellow roses on a gray background.	Poor to fair condition; large crack from corner of door to ceiling; smaller cracks over entire wall surface.	
Radiator	19th-20th century	24" W x 42" H	Highly ornamented cast iron radiator.	Fair to good; failure of painted finish; rust and rust stains are also evident; operable.	6-39

Figure 6-39. The door casing and wallpaper on the south wall in the northwest bedroom. Photograph by Kathleen Manicke.

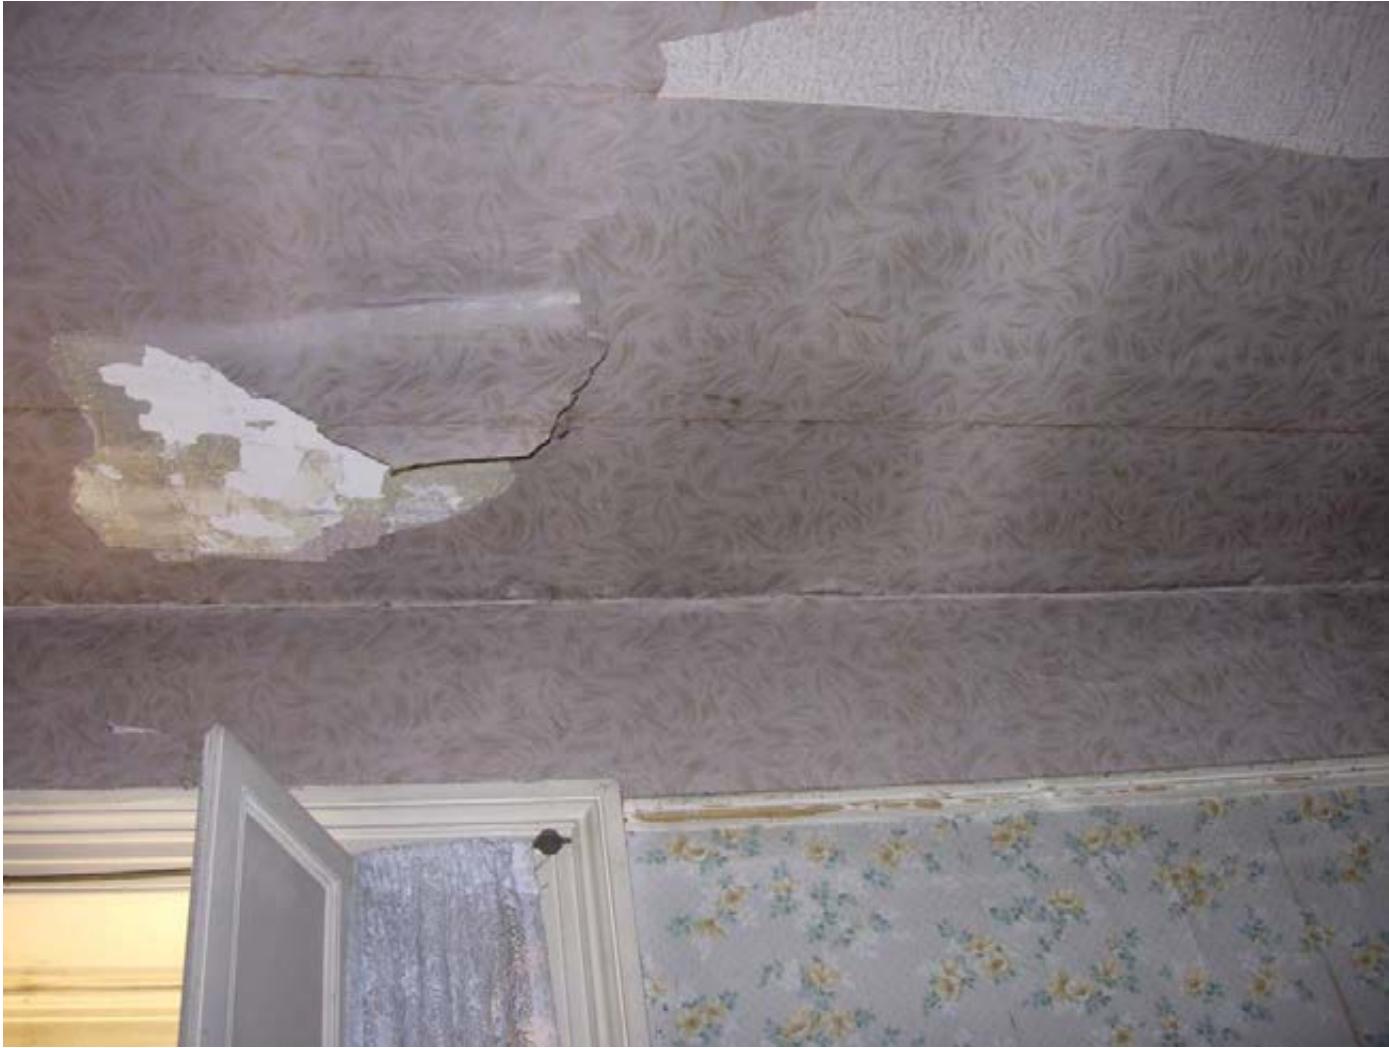
Location: Second Floor Southwest Bedroom~Ceiling, Floor, and Bathroom					
Item	Date	Size	Description	Condition	Figure #
Ceiling			Flat plaster with at least two layers of wall paper.	Undetermined condition; some cracking of the ceiling evident through the wall paper; loose and hanging wall paper.	6-40
Floor	18th-19th century		Random-width, wide board flooring of an undetermined type of wood; top nailed; nails have square or oblong heads.	Good condition; slight wearing of the finish; slightly uneven in places	
Bathroom (1)	20th century	6'5" x 4'10"	Located in the corner of the west and north walls; contains toilet, wall sink, and bathtub; sink is dated 1932; black and white ceramic tile floor; walls are covered with white 4" ceramic tiles with a black border; large plywood cupboard over the bathtub contains a galvanized steel mailbox mortared into the chimney wall.	Generally good condition with some cracked and broken tiles.

Figure 6-40. The ceiling of the northwest bedroom. Notice the two different types of wallpaper. Photograph by Kathleen Manicke.

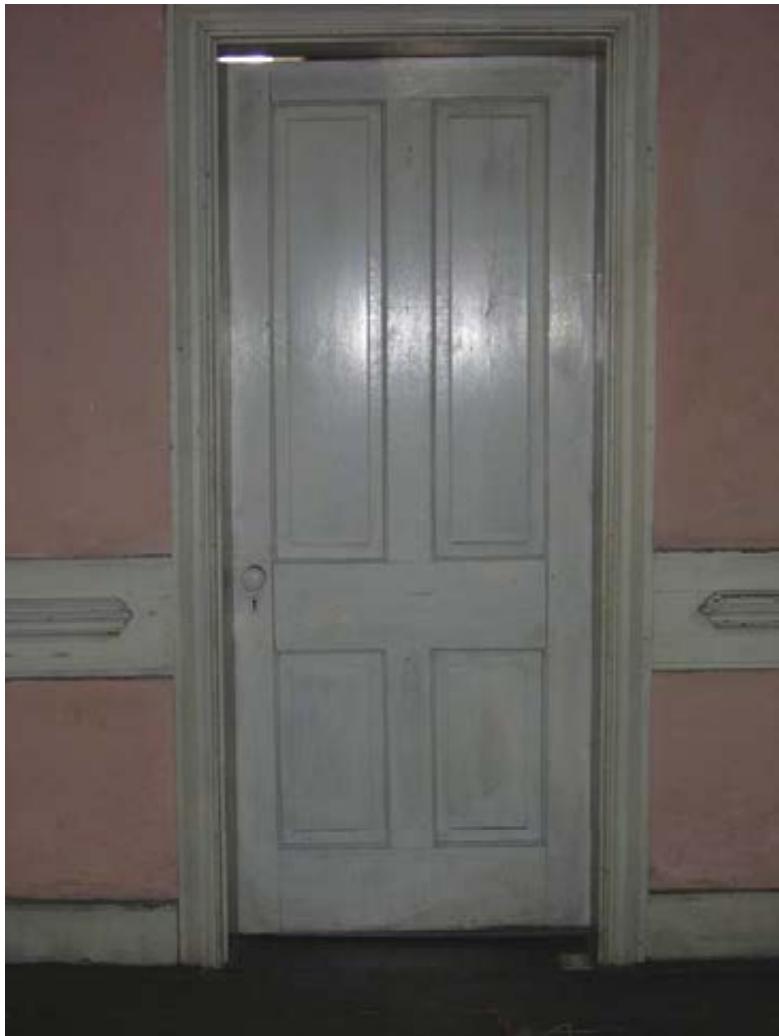
Door (1)	20th century	34" W x 81½" H by 1½" T	4 panel, cross style door featuring feathered panel edges on both sides of the door; pin style hinges, painted steel surface-mounted lockset with white ceramic doorknobs.	Good condition.	6-42
Door Casing	19th-20th century	6" W	Colonial revival style; composed of machine made moldings; mitered corners.	Good condition; painted finish exhibits mild to moderate alligatoring and chipping.	6-42
Door frame	20th century	10" W	Flat lumber with integral ¼" door stop.	Good condition; painted finish.

Figure 6-42. The door on the west wall in the northeast chamber. Photograph by Kathleen Manicke.
