Building at Risk:

A Historic Structure Report for Bostwick in Bladensburg, MD

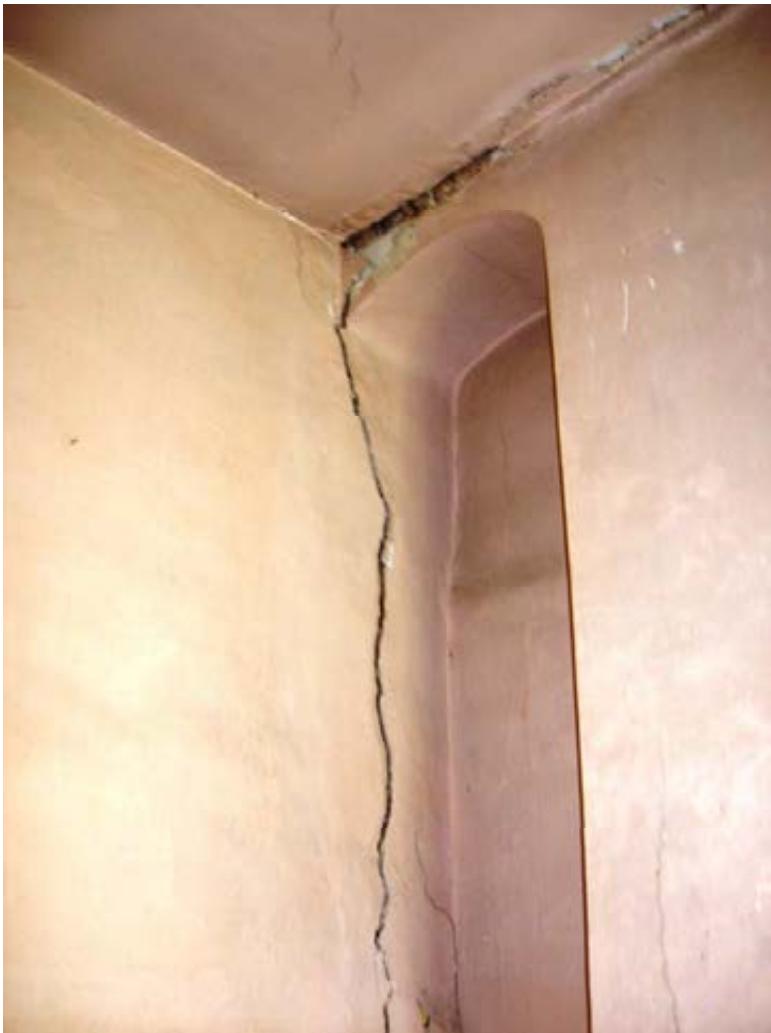
Location: Second Floor Northeast Chamber~West Wall					
Item	Date	Size	Description	Condition	Figure #
Chair rail molding	18th century	12" H	12" wide and 1" thick; single bead along both top and bottom edges; wide bolection mold in center; similar piece found in attic shows pit-saw marks and wrought, spade-tipped nails indicating 18th-century date.	Excellent condition; painted finish exhibits significant alligatoring and chipping; no apparent sign of rot or insect damage.	6-42
Baseboard	18th century	6" W	Minimum 1" deep flat lumber with beaded top edge.	Good condition; painted finish exhibits significant alligatoring and chipping; no apparent sign of rot or insect damage.	6-42
Flat plaster			Flat plaster with smooth finish over masonry wall.	Generally good but poor in the area of the niche at the northwest corner that has a very large structural crack up to 1" through both the plaster and the brick wall behind it; crack runs from the ceiling to the floor; this severe cracking indicates that the north wall of the main block is settling at a different rate and/or direction than the rest of the main block; this is likely due to the addition of the Stoddert era kitchen wing.	6-43 6-44

Figure 6-44. Large crack on the west wall of the northeast chamber near the southwest corner. Photograph by Kathleen Manicke.

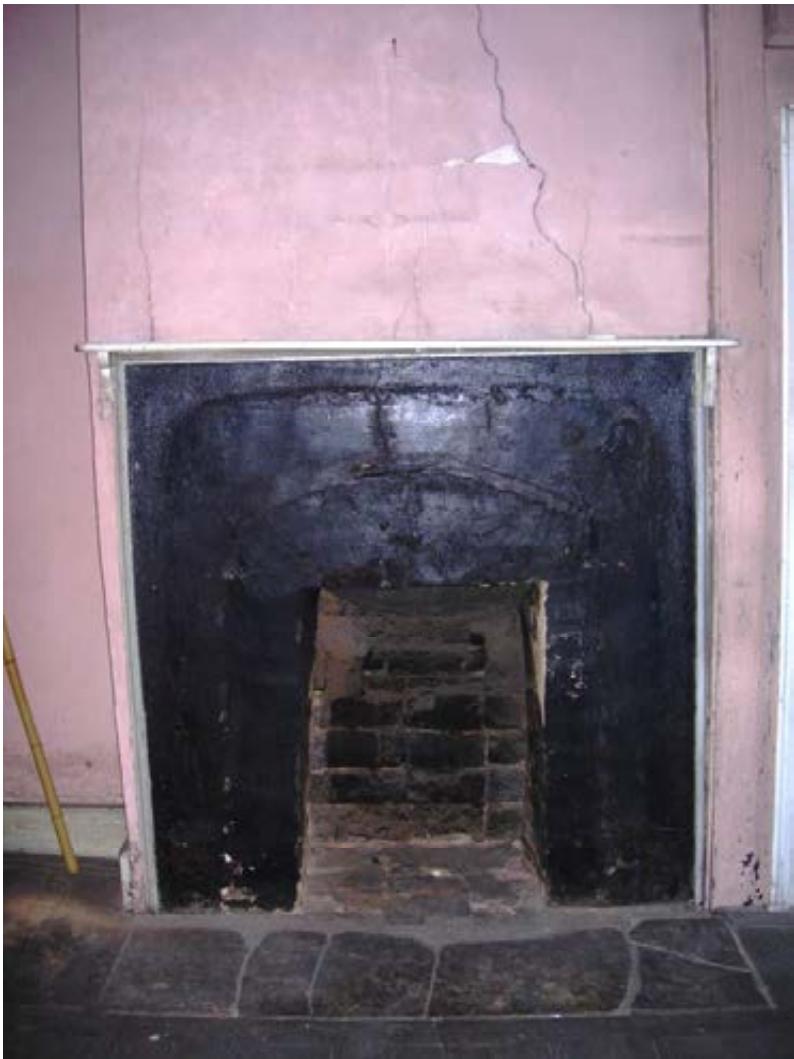
Figure 6-45. The fireplace on the north wall of the northeast chamber. Photograph by Kathleen Manicke.

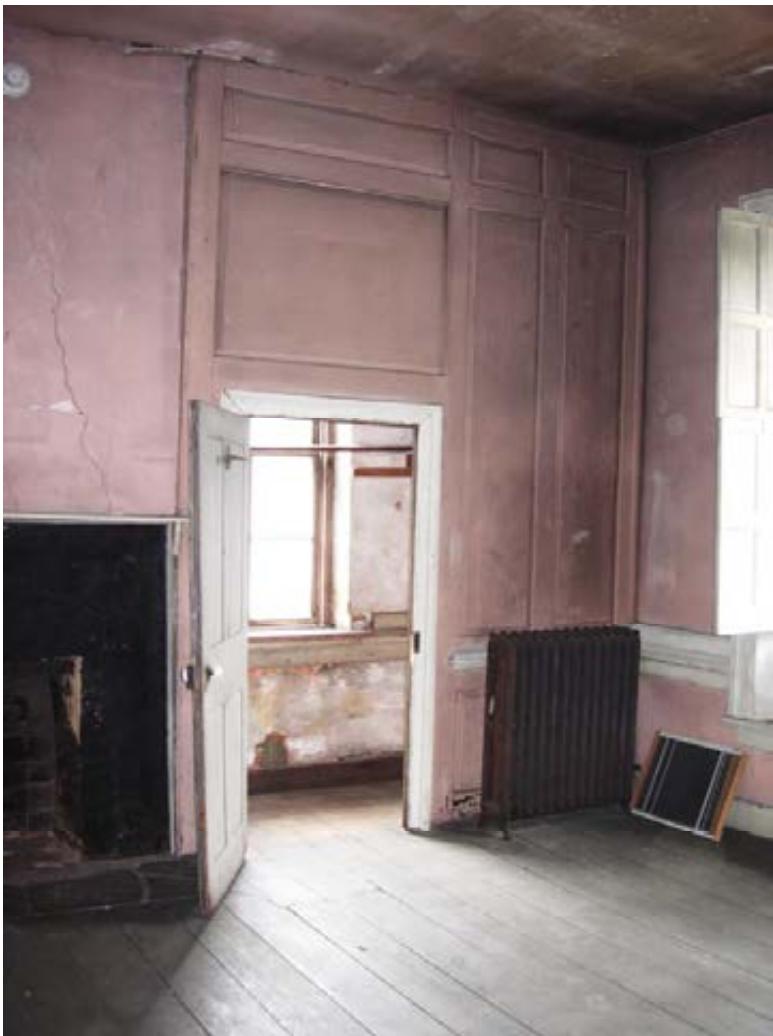
Location: Second Floor Northeast Chamber-North Wall					
Item	Date	Size	Description	Condition	Figure #
Fireplace	18th-19th century	61" W	Fireplace protrudes 15" into the room and reaches from floor to ceiling; firebox measures 17" D x 25" W by 35" H and is lined with older type brick; there is the shadow of an earlier arched opening; at present, there is no mantel on this fireplace; a shelf, measuring 6" by 61", has been installed over the fireplace; stone hearth.	Poor condition; lacks mantel; changes in shape and size of the firebox opening; missing and damaged bricks in the firebox lining.	6-45
Baseboard	18th century	1" x 6"	Flat lumber with beaded top edge.	Good condition; painted finish exhibits significant alligatoring and chipping; no apparent sign of rot or insect damage.	
Paneling	19th-20th century	8'4" W x 11'6" H	Wood paneling with mortise and tenon joinery; one large horizontal panel and four smaller ones combined with two tall vertical panels above chair rail level; bolection molding at chair rail height is similar to that found on the chair rail throughout the house; room side of paneling has raised panels with feathered edges while the closet side has flat panels; no hand planing marks are evident so the paneling was probably machine planed.	Good condition; side facing room has painted finish with significant alligatoring of the paint; side facing closet remains unpainted; some loose panels; no apparent evidence of rot or insect damage.	6-46

Flat plaster			Smooth finish over masonry walls.	Poor condition; structural cracks over $\frac{1}{4}$ " wide in the area of the niche and fireplace including one crack that is over 1" wide; some spalling of plaster where the wall meets the ceiling in the niche area; cracks may be because the north wall of the main block could be moving/settling at a different rate/direction than the remainder of the main block due to the addition of the Stoddert era kitchen.	6-44 6-46
Radiator	19th- 20th century	30" W x 38" H	Ornate, cast-iron radiator that has not been painted; marked "Rococo;" chrome vent.	Excellent; operable.	6-46

Figure 6-46. The paneling, door, and radiator on the north wall of the northeast chamber. Photograph by Kathleen Manicke.

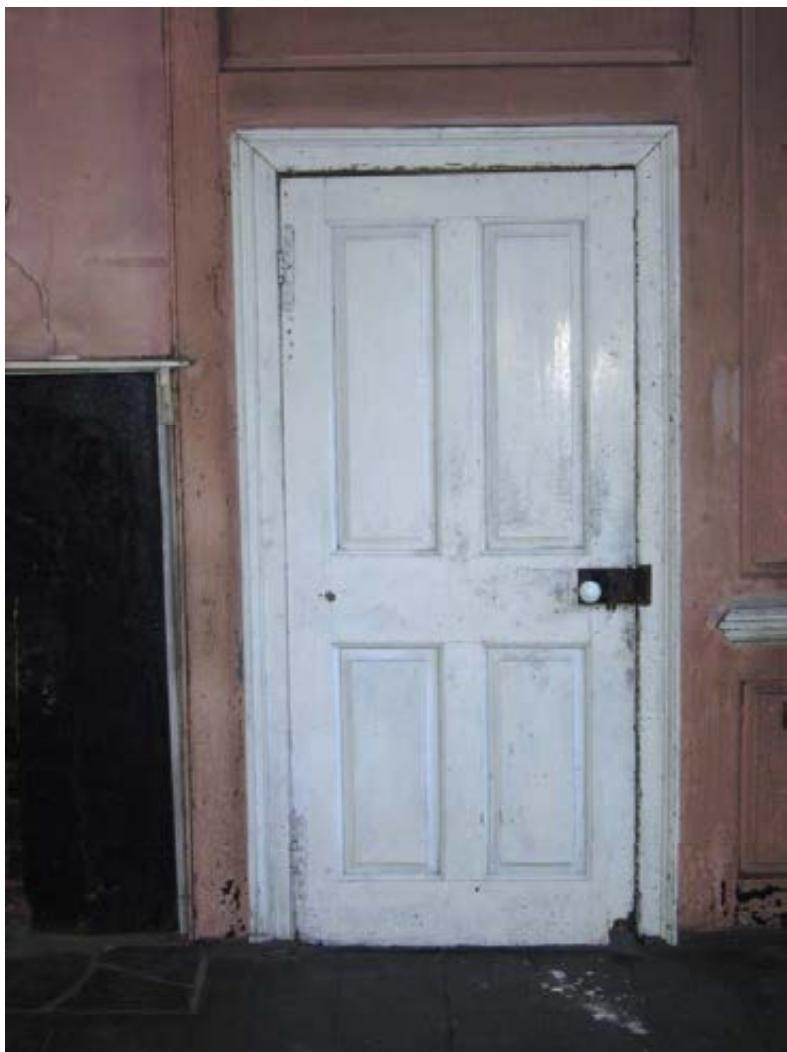
Closet door (1)	19th century	34" W x 76" H	Early cross-style, four panel wooden door; raised panels with feathered edges on the side facing the room; flat panels on the side facing the closet; 2" x 3" section has been cut from the bottom of the latch side of the door; mortise and tenon joinery visible on both stiles; joints held together with wooden pins; nail holes from earlier hinges evident as well as additional holes near the lockset.	Poor condition; failing painted finish; areas of rot along the lower edge; some insect damage; inappropriate top nailing where all three rails meet the stiles.	6-47
Door hardware	19th-20th century		Rectangular surfaced mounted lockset and latch; H-type strap hinges with six large nails; each strap is 1" x 8"; casing portion of hinge has been covered with the casing.	Good condition; operable; painted with what appears to be the same paint as the door; additional holes through the door near the lockset and the poorly filled cut around the latch indicate that the lockset and latch may not be original.	6-47 6-48

Door casing		1" x 4"	Flat lumber with applied molding on the outside edge; mitered corners.	Fair condition; large cut around the latch indicates that the existing latch is probably not original to the door.	6-47
Door frame		1" x 4"	Flat lumber with applied molding on the outside edge; mitered corners.	Good to fair condition; some areas of rot.

Figure 6-47. The door on the north wall of the northeast chamber. Drawing by Kathleen Manicke.

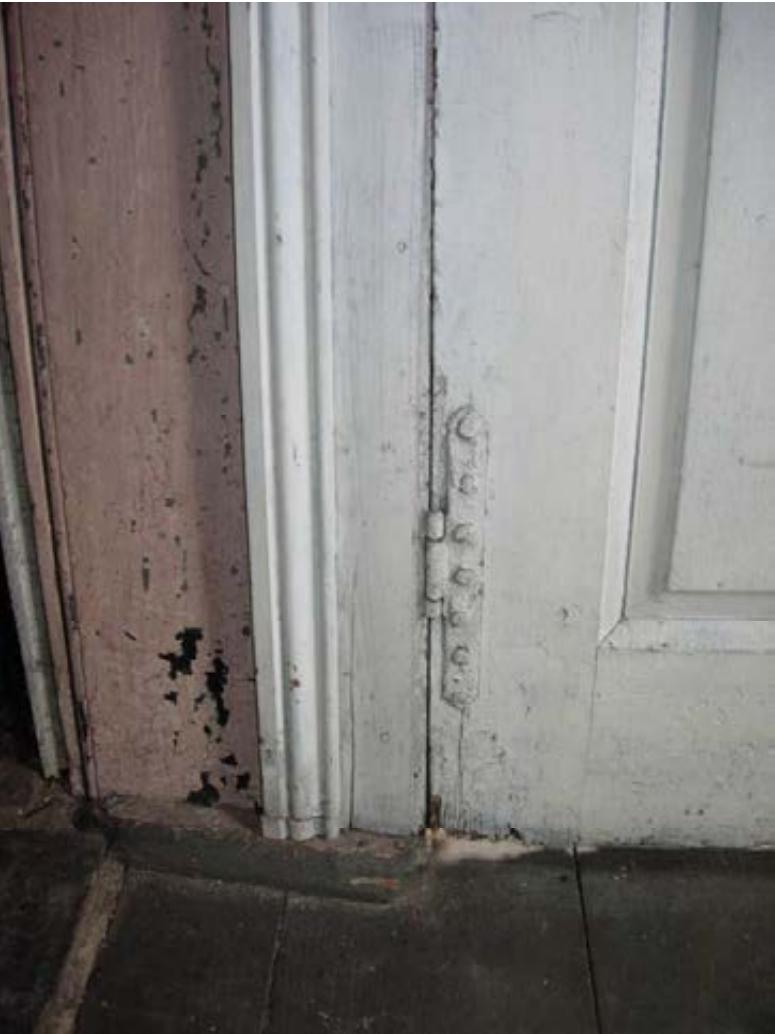
Figure 6-48. Hinge detail from the door on the north wall of the northeast chamber. Notice the rot at the bottom of the stile.
Photograph by Kathleen Manicke.

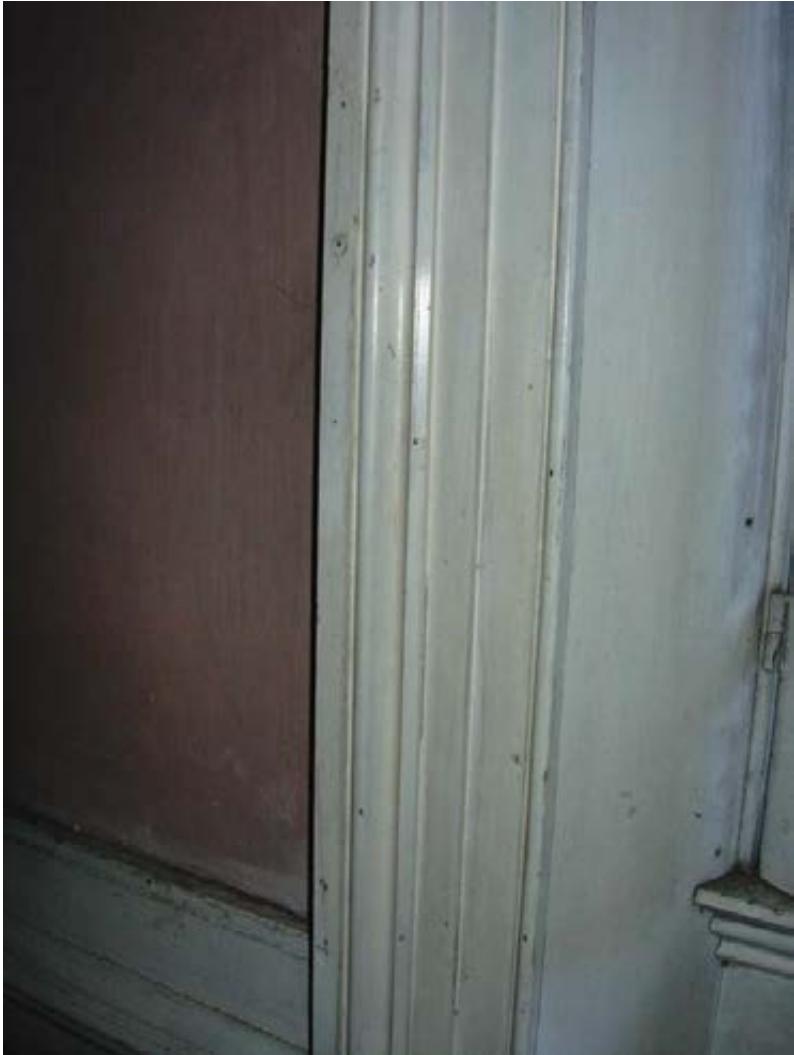
Figure 6-49. Casing and frame on the window in the east wall of the northeast chamber. Photograph by Kathleen Manicke.

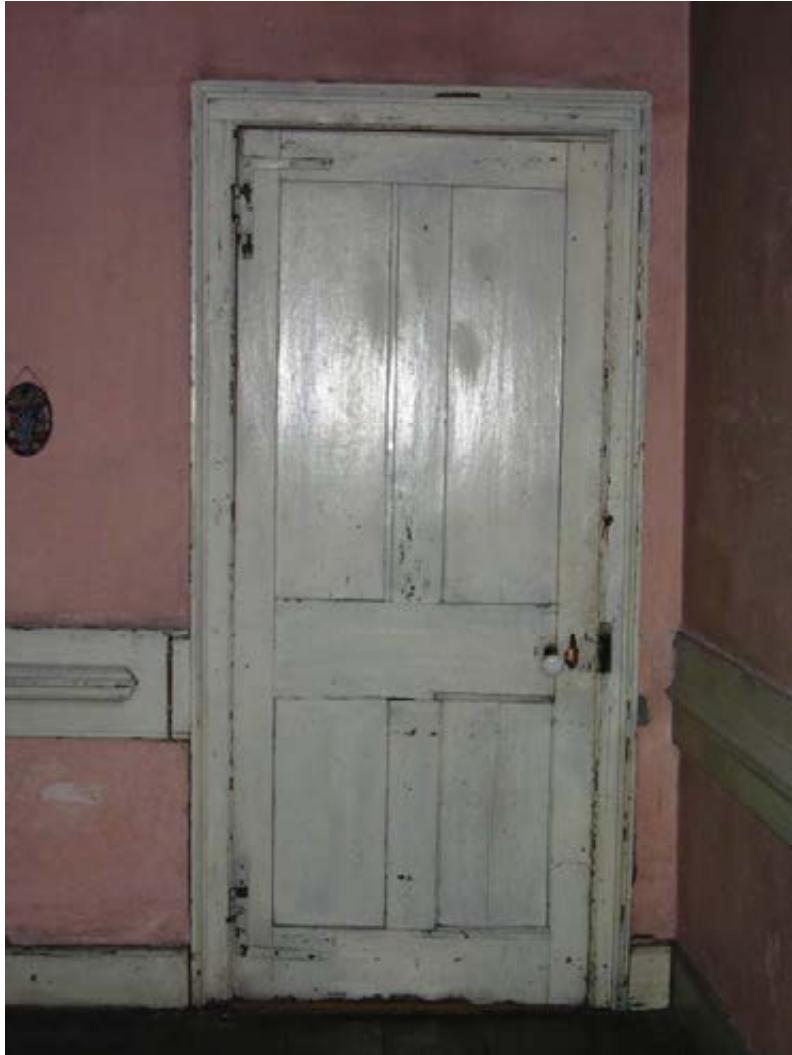
Chair rail molding	18th century	12" H	12" wide and 1" thick; single bead long both top and bottom edges; wide bolection mold in center; similar piece found in attic shows pit-saw marks and wrought, spade-tipped nails indicating 18th-century century.	Fair condition; largely hidden by radiator.	6-51 6-52
Baseboard	18th century	1" x 6"	Minimum 1" deep flat lumber with beaded top edge; does not meet that on the east wall at the corner; 2" piece of wood bridges the gap.	Good condition; painted finish exhibits significant alligatoring and chipping; no apparent sign of rot or insect damage.	6-51
Flat plaster			Flat plaster with smooth finish over masonry wall.	Poor condition; several large cracks running diagonally from the top of the wall at the east corner to below the chair rail; large section of plaster has been knocked out to install an electrical outlet and wiring.	6-51 6-52

Figure 6-51. The door on the south wall of the northeast chamber. Note the flat panels and old style hinges. Photograph by Kathleen Manicke.

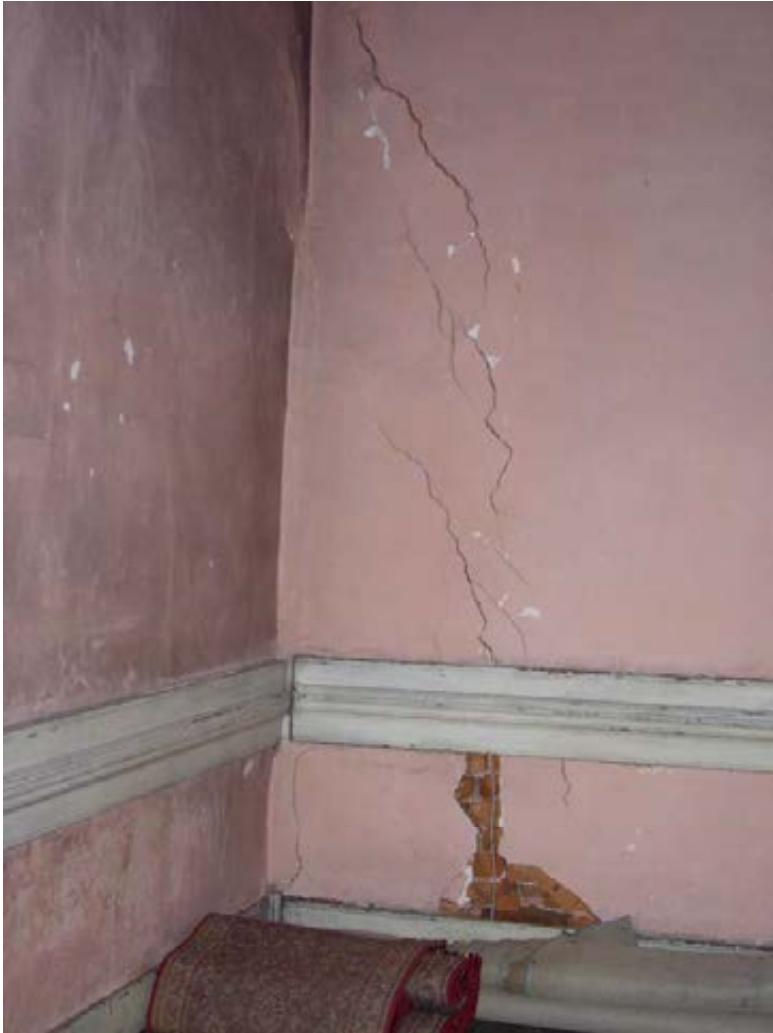
Figure 6-52. Damage to the flat plaster at the east end of the south wall in the northeast chamber. Photograph by Kathleen Manicke.

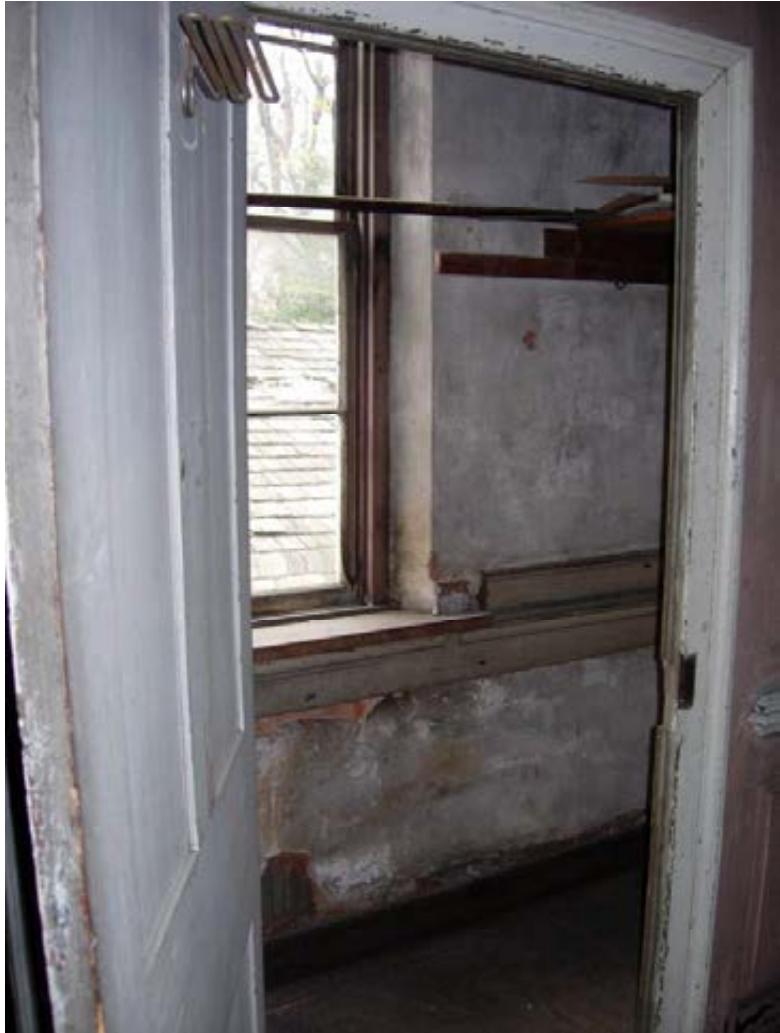
Location: Second Floor Northeast Chamber~ Ceiling, Floor, and Closet					
Item	Date	Size	Description	Condition	Figure #
Ceiling			Flat plaster over lath.	Fair to poor condition; mild to moderate cracking of the plaster surface.	
Floor			Wide, random-width plank floors; top nailed; nails have square or oblong heads.	Good condition; painted finish; some loose boards; unmatched trim pieces around the floor's perimeter; large gap between the floor and the wall varies from $\frac{1}{2}$ " to 2".	
Closet		2'9" x 8'2"	Northeast corner of room enclosed with paneling to make closet area; plaster walls; four-over-four, wooden, double-sash window; chair rail, flat plaster walls and ceiling; ceiling has 1" x 4" with beveled edges approximately 16" on center to support the plaster of the ceiling; various hooks at a convenient height for hanging clothes.	Generally poor condition; inappropriate repairs to the window stool cut into the chair rail; moderate to severe cracking of plaster; spalling plaster; missing plaster; "lick and stick" pictures adhered to flat paneled wall.	6-53

Figure 6-53. The closet in the northeast chamber. Photograph by Kathleen Manicke.

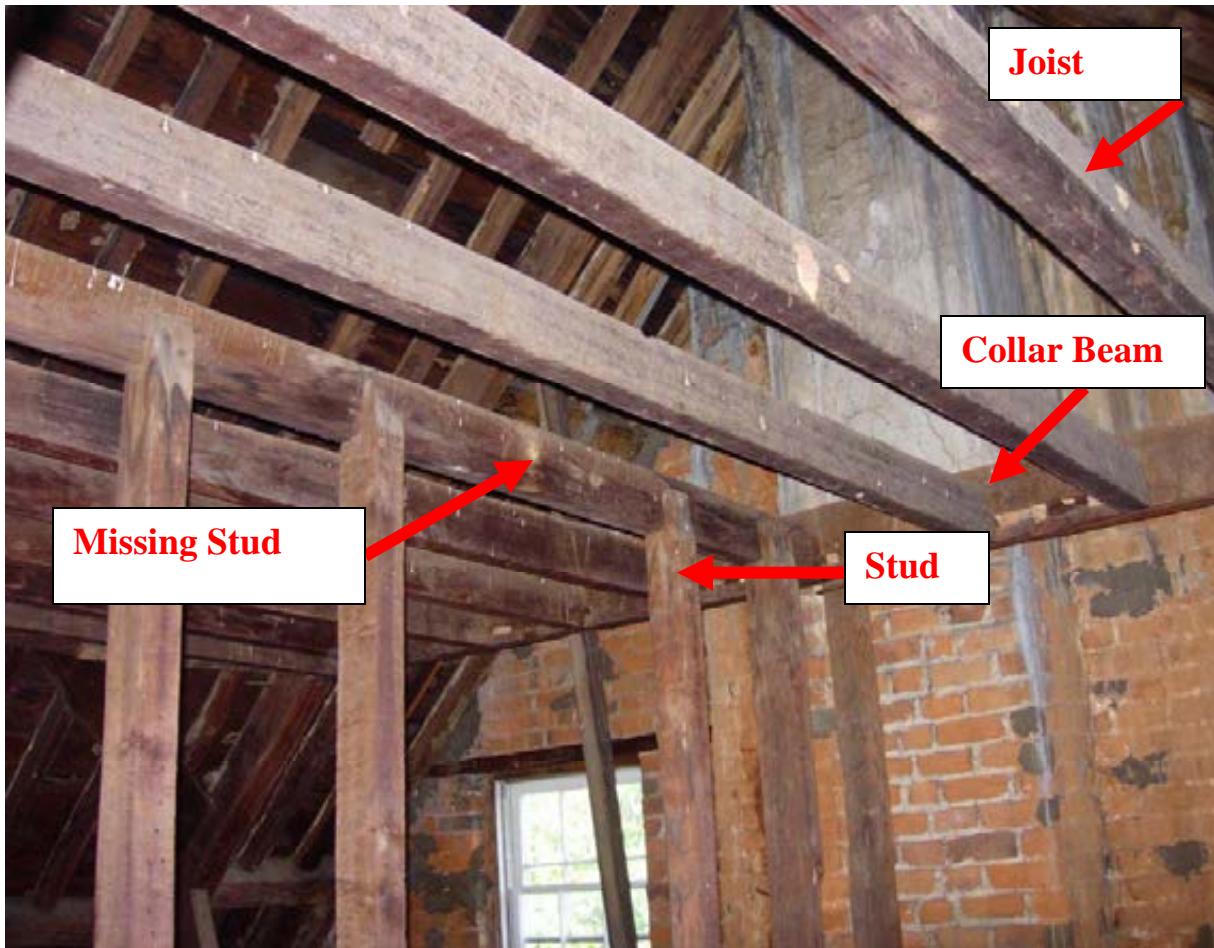
Location: Attic South Bay					
Item	Date	Size	Description	Condition	Figure #
King post	1746	Upright 9" x 9" side braces 4½" x 6"	King post of undetermined variety of wood; located at the mid-point of the center wall in this bay; post and braces are hewn lumber with mortise and tenon joinery held together with wood pins; center beam and braces contain scribe mark <u>V</u> .	King post generally in excellent to good condition; lumber is sound with no evidence of rot or insect damage; signs of moisture infiltration; marks of mud wasp nests.	7-3
Center stud wall	1746	3" x 4" x 108" H	Runs along the center of the south bay from north to south; lap joints at the top join these studs to the joist above; lap joint is nailed with wrought nails, two per stud; these studs rest on the beam below; all but one have pulled away from the beam due to the settling of the house; one has fallen away completely.	Fair condition due to the sagging of the beam that holds this wall; studs are sound with no evidence of rot or insect damage.	7-2

Figure 7-2. Joists, collar beams, and studs in the area of the center wall in the south bay. Photograph by Kathleen Manicke.

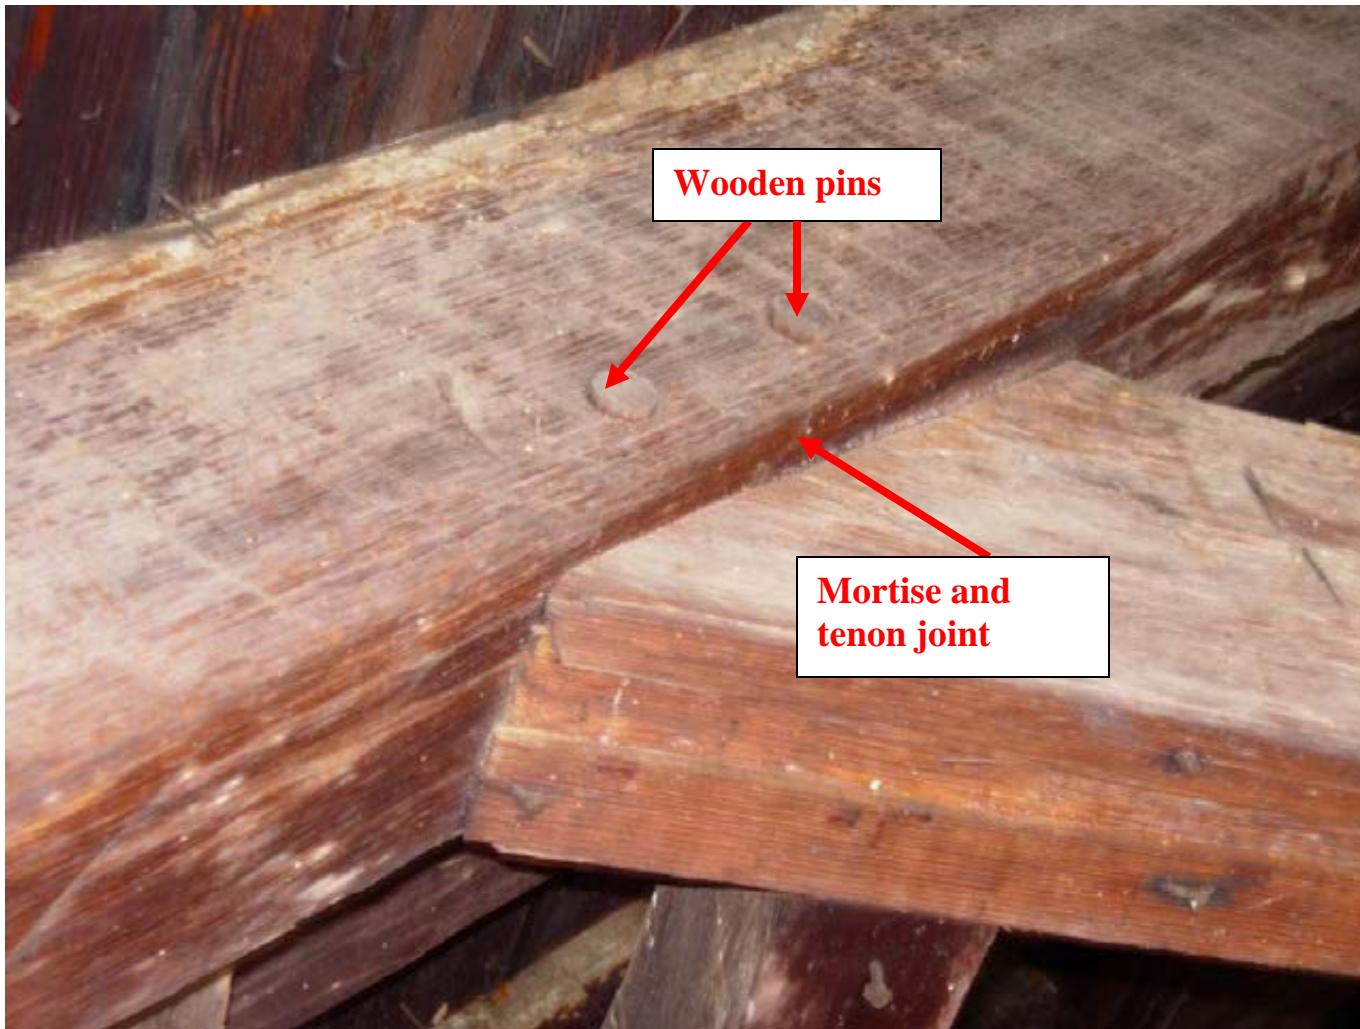
Figure 7-3. Mortise and tenon joinery on the king post. Notice the wooden pins. Photograph by Kathleen Manicke.

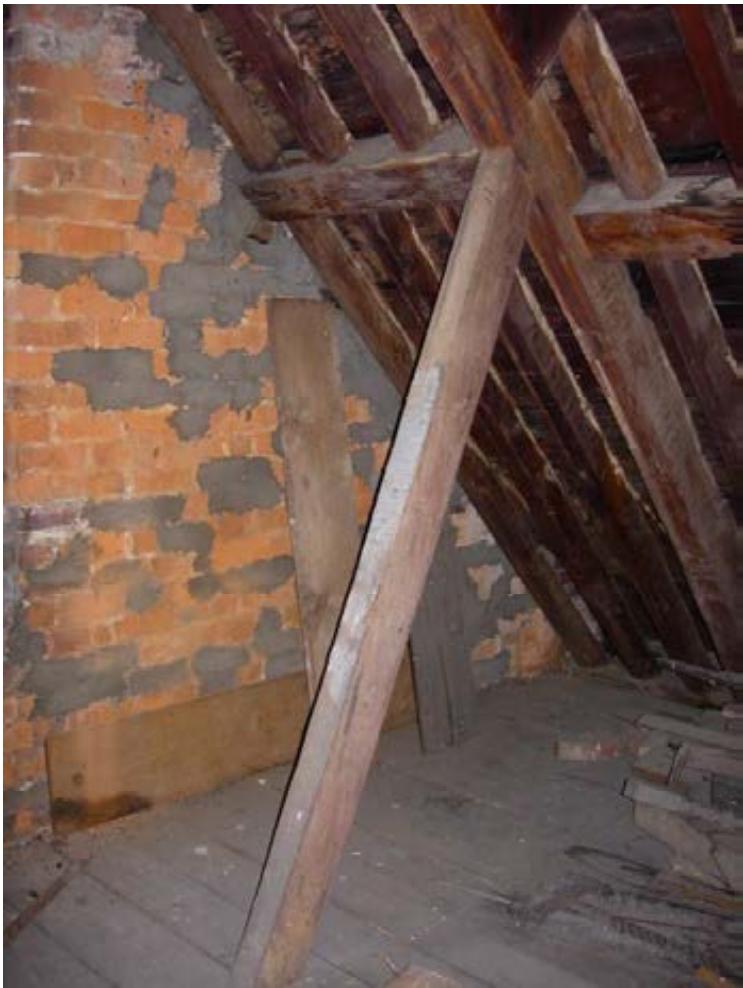
Principal rafters	1746	4½" x 7½"	Principle rafters are pit-sawn and of an undetermined variety of wood; the west wall of the south bay contains four principal rafters as does the east wall: one at each end of the bay and one on either side of the dormer; mortise and tenon joints are held together with wooded pins; principal rafters and bracing contain scribe marks.	Principal rafters are generally sound; water-marked areas are somewhat soft upon probing; no evidence of insect damage; some white mold bloom.	7-4
Common rafters	1746	2 ½" x 3 ½"	Common rafters are 12-13" on center; undetermined variety of wood; common rafters have pit-saw marks; sections of the common rafters in the dormer area were removed to accommodate the dormer.	Common rafters are generally sound; water-marked areas are somewhat soft upon probing; no evidence of insect damage; some white mold bloom.	7-4 7-9
Purlins	1746	5" x 6"	Purlins made of pit-awn lumber of an undetermined variety.	Purlins are generally sound; water-marked areas are somewhat soft upon probing; no evidence of insect damage; some white mold bloom.	7-4 7-9

Roof deck	18th- 19th century		Random width; rough sawn lumber of undetermined variety; some appear to be pit sawn; black roofing felt is visible at seams and where knots have fallen away; some spade-tipped nails come through the deck; other nails are modern wire nails.	Evidence of roof leaks along the ridge; some white mold bloom.	7-4 7-9

Figure 7-4. Principle rafter with brace in the south bay of the attic. Notice the inappropriate parging and mortar repair on the brick wall. Photograph by Kathleen Manicke.

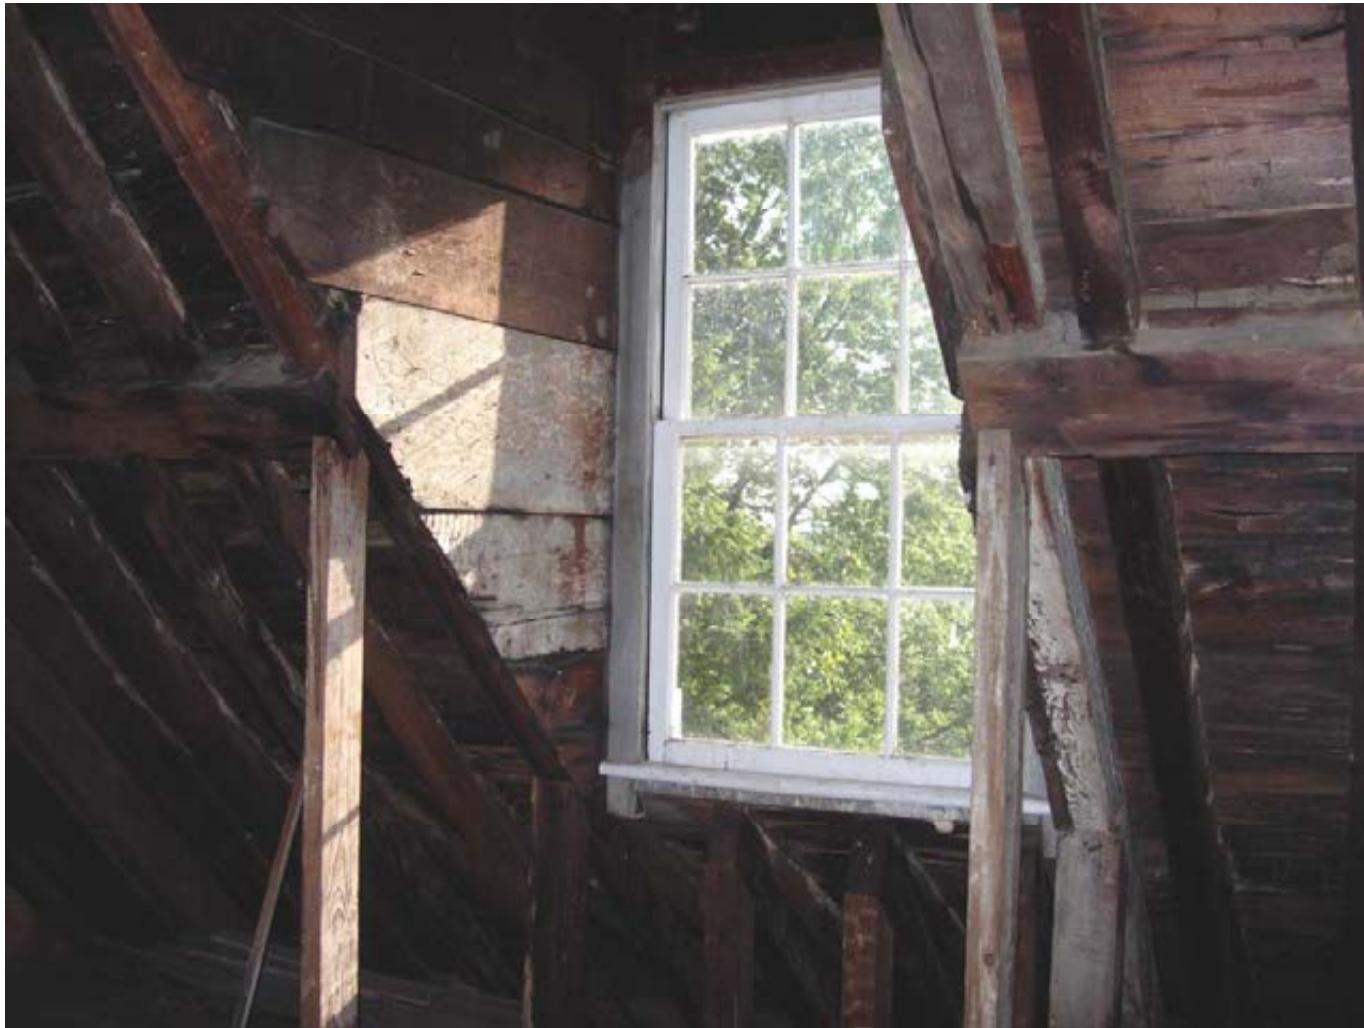
Collar beams	1746		Collar beams tie into principal rafters with mortise and tenon joints; collar beams also have mortises for joists; beams appear to be pit-sawn with the edges trued up with an axe.	Generally good condition.	
Roof joists	1746		Run at right angles to the collar beams; joined to the collar beams with mortise and tenon joints with wood pins; two joints have apparently been removed--perhaps to allow access to the area above.	Generally good condition	7-2 7-11
Ridge line	1746	1" x 4"	Light weight ridgeline approximately 1' x 4".	Ridge line generally sound; water-marked areas are somewhat soft upon probing; no evidence of insect damage; some white mold bloom.	7-7
Dormer (2)	19th century	37" W x 103" H	Dormers were added after house was built since lumber and construction techniques differ; sides of dormers are 1" thick lumber of varying widths; lengths of this lumber are not sawn to size; some have evidence of old paint/whitewash; some of this lumber was sawn using a reciprocal saw; sill areas are supported by three uprights each with plaster marks indicating that they were brought in from elsewhere; lumber was nailed in place using square-headed nails.	Generally good to fair condition; cutting of common rafters has caused some sagging of the roof in the area of the dormer.	7-5 7-6

Dormer windows (2)	20th century	30" W x 52" H	Six-over-six, wooden, double sash windows; no waves and flaws in the glass.	Good condition; painted finish.	7-5
South wall windows (2)	20th century	32" W x 52" H	Six-over-six, wooden, double sash window with rough lumber frame; wire nails.	Good condition; painted finish; painted shut.	7-11
Chimney	1746		Massive, T-shaped brick chimney centered on the south wall; protrudes 4' into the attic; this chimney has no firebox openings indicating that the south bay may have been used primarily as a storage area.	Fair to poor condition due to spalling of the brick; mortar has significantly washed away; some inappropriate parging with cement-based mortar; large structural cracks; portion of chimney above the collar beams and joists have plaster coating.	7-11
Brick wall	1746		South wall of attic area is structural masonry.	Fair to poor condition due to spalling of the brick; mortar has significantly washed away; some inappropriate parging with cement-based mortar; some structural cracking.	7-11

Figure 7-5. The dormer in the west wall of the south bay of the attic. Photograph by Kathleen Manicke.

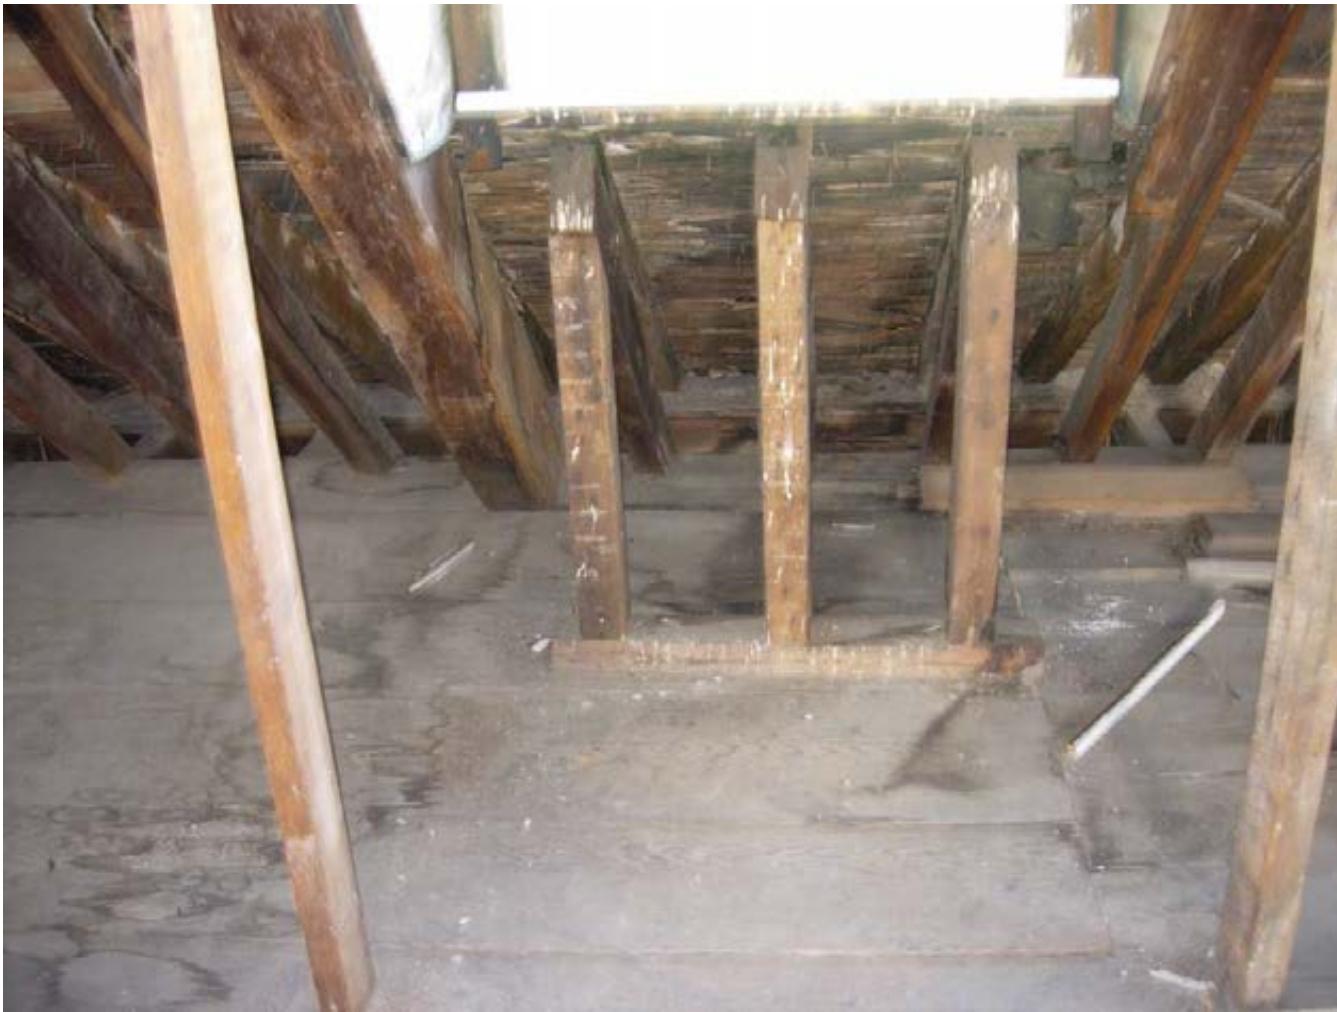
Floor	18th - 19th century		Random width boards of an undetermined variety; top nailed with square-headed nails.	Generally good to fair condition; some insect damage at the south end.	7-6

Figure 7-6. Uprights added to support the window in the west dormer. Photograph by Kathleen Manicke.

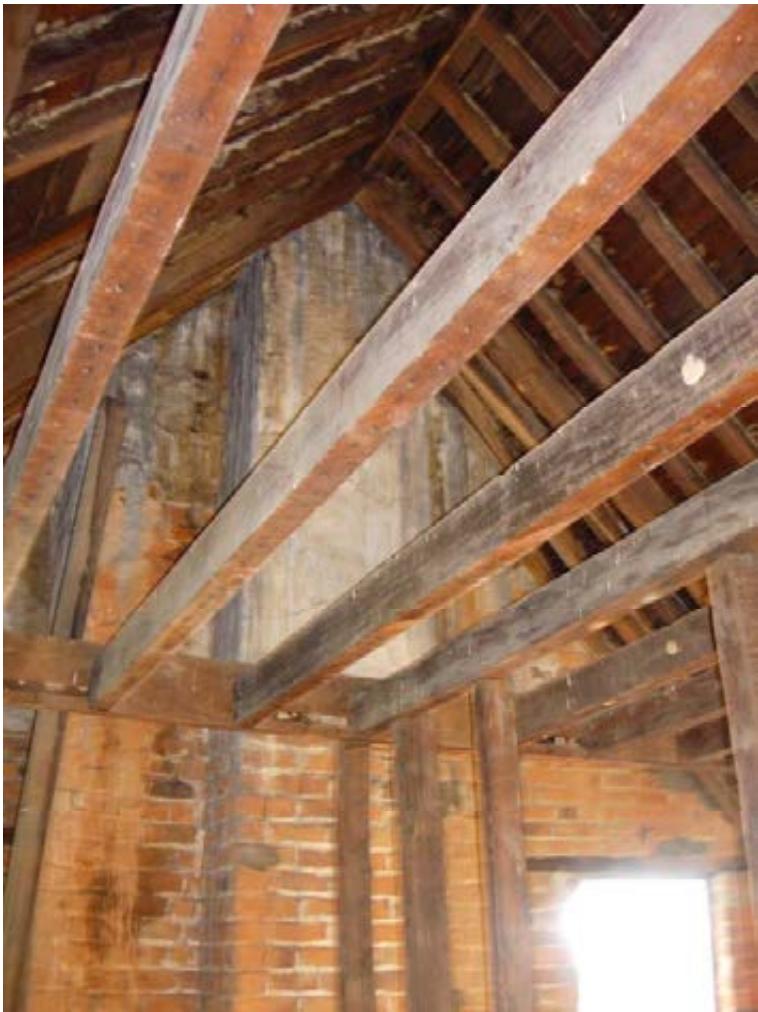
Figure 7-7. Plastered chimney in the south bay. Note the mold bloom on the rafters. Photograph by Kathleen Manicke.

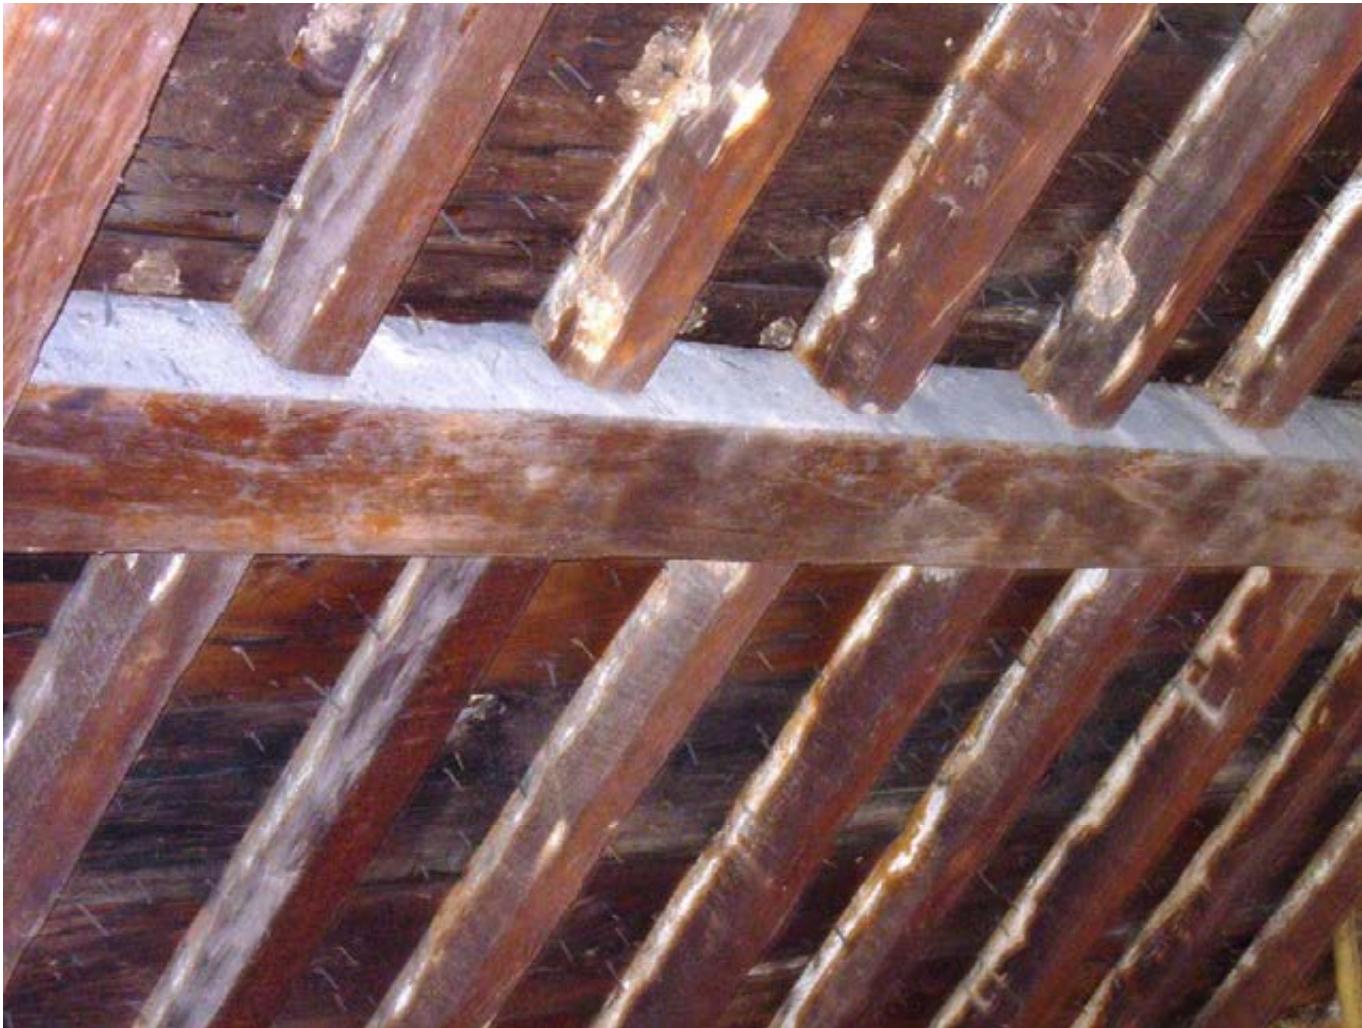
Figure 7-9. Common rafters and purlin in the attic's south bay. Note the areas of mold bloom. Photograph by Kathleen Manicke.

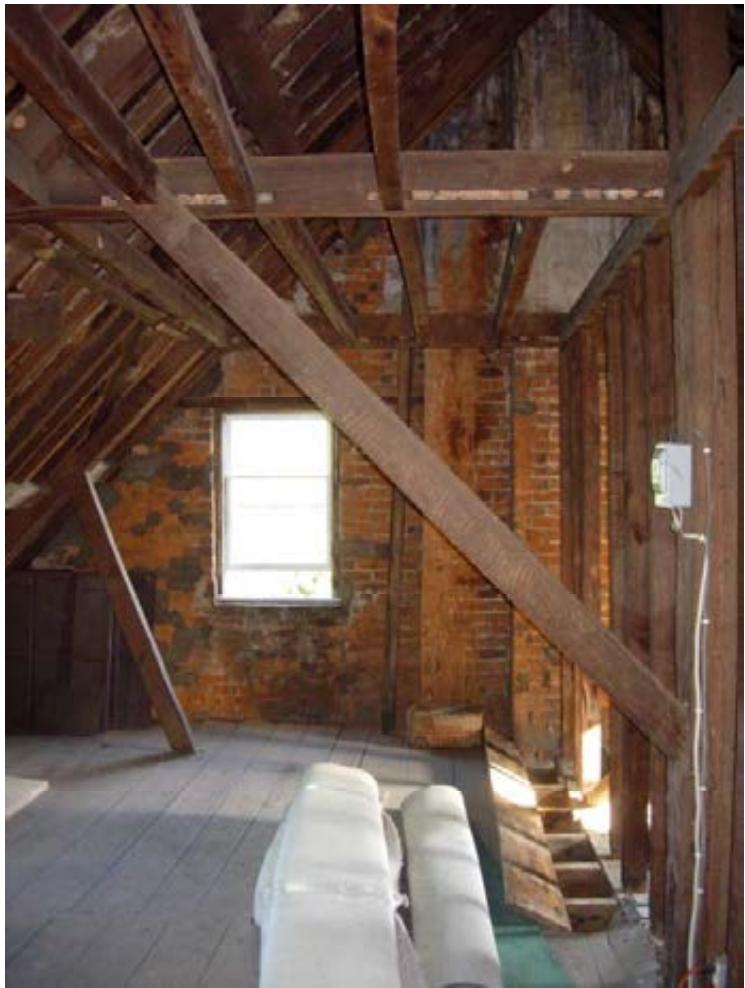
Figure 7-11. The south wall window and chimney. The diagonal brace is part of the king post. Photograph by Kathleen Manicke.

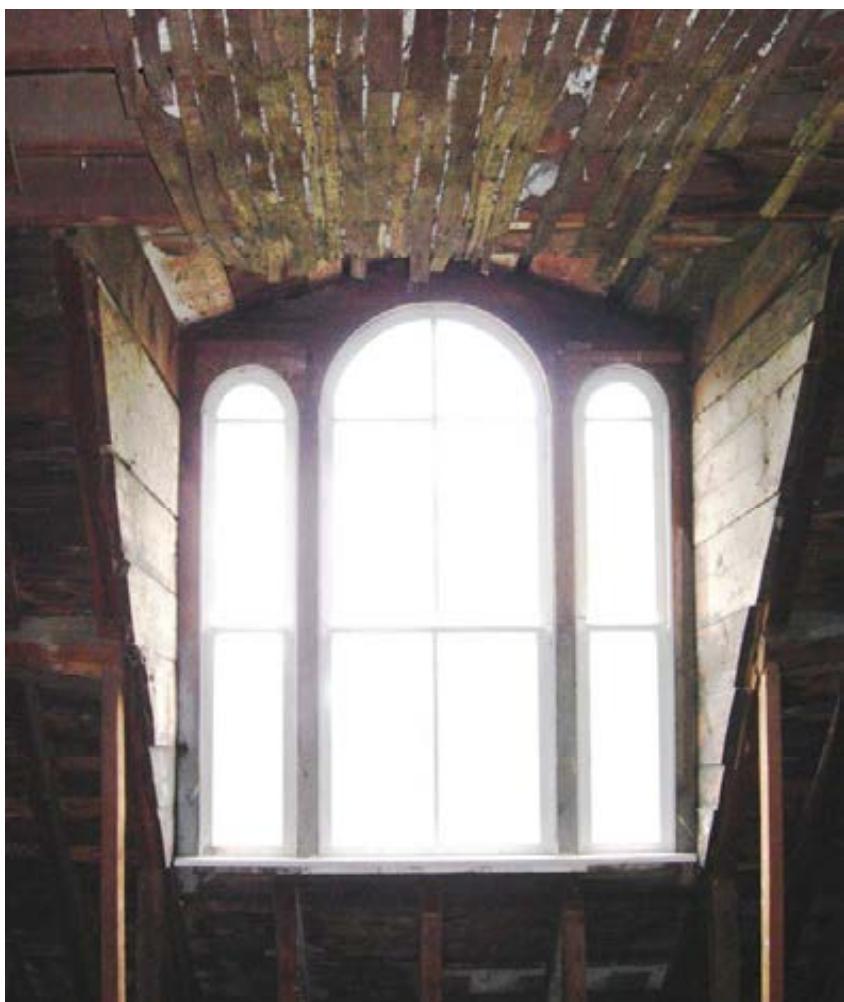
Location: Attic Central Bay					
Item	Date	Size	Description	Condition	Figure #
Dormer	19th century	69" W x 121" H	Dormers were added after house was built since lumber and construction techniques differ; sides and roof of dormer is 1" thick lumber of varying widths; lengths of lumber not sawn to size; some have evidence of old paint/whitewash; some of this lumber was sawn using a reciprocal saw; sill areas are supported by five uprights some with plaster marks indicating that they were brought in from elsewhere; lumber nailed in place using square-headed nails.	Generally good to fair condition; cutting of common rafters has caused some sagging of the roof in the area of the dormer.	7-12
Dormer window group	19th century	64" W x 75" H	One large, Victorian window with a round arch at the top flanked on either side by a single, smaller window with a similar round arch at the top; large window is 32" W x 75" H; the smaller windows are 13" W x 66" H; the larger window has four-over-two vertical lights; the smaller windows have two-over-one lights.	Fair to good condition; painted finish.	7-12

Figure 7-12. The dormer window and ceiling in the central bay. Photograph by Kathleen Manicke.

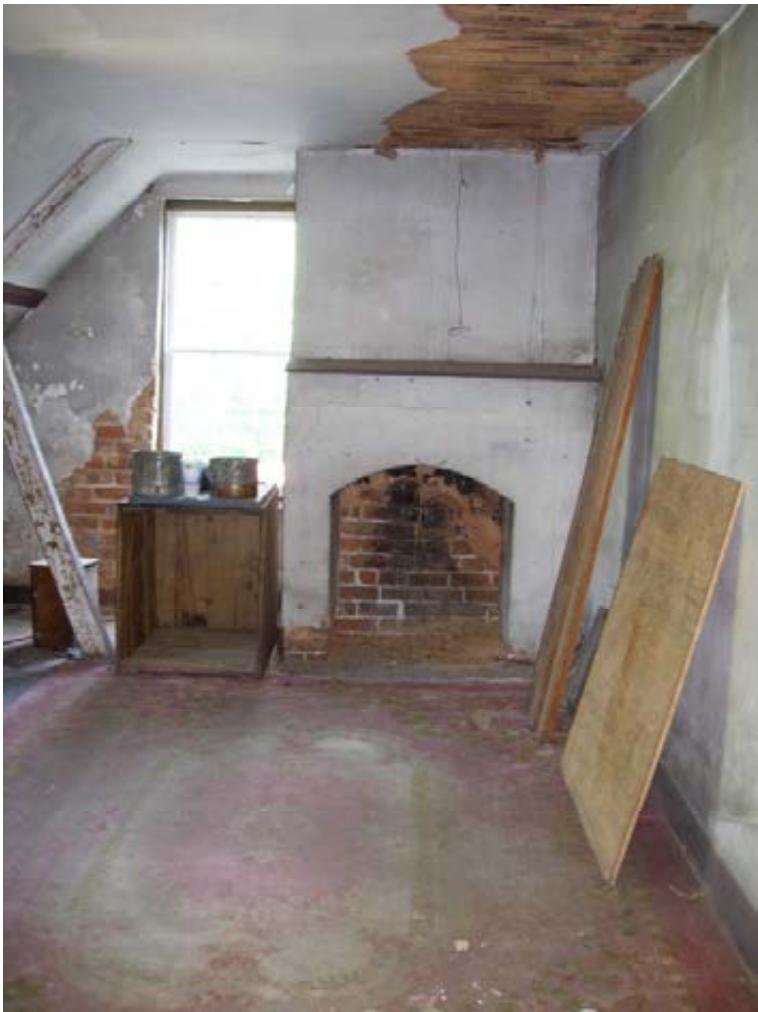
North wall windows (2)	20th century	32" W x 52" H	Six-over-six; wooden, double sash window with rough lumber frame; wire nails.	Good condition; painted finish; painted shut.	7-15

Figure 7-15. The northwest chamber in the attic's north bay. Photograph by Kathleen Manicke.
