Building at Risk:

A Historic Structure Report for Bostwick in Bladensburg, MD

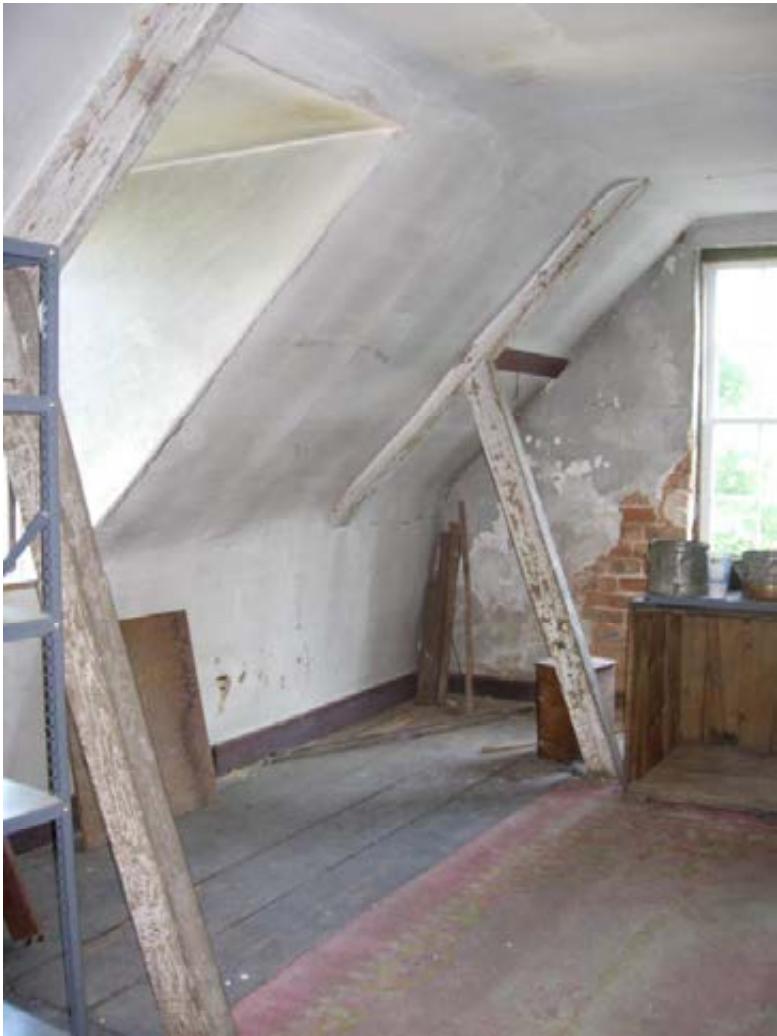
Bracing in the northwest chamber	1746		Braces from principal rafters to floor are visible and contain the scribe marks I, II, and III.	Good condition.	7-17
West and south walls in the northwest chamber	18th-19th century		Flat plaster over masonry; large structural crack in the northeast corner where the chimney meets the east wall; significant cracking on other walls; some spalling of the plaster.	Poor condition.	7-17
Ceiling in the northwest chamber	18th-19th century		Flat plaster over riven lath; significant portions have dropped to floor; remaining plaster is loose most likely because of broken keys.	Poor condition.	7-17 7-18
Dormer in northwest chamber	19th century	37"W x 103"H	Flat plaster over wood and lath.	Fair to poor condition.	7-17
Floor	18th - 19th century		Random width boards of an undetermined variety; top nailed with square-headed nails.	Generally good condition.	7-17

Figure 7-17. Principle rafters and bracing on a plastered wall in the northwest chamber. Photograph by Kathleen Manicke.

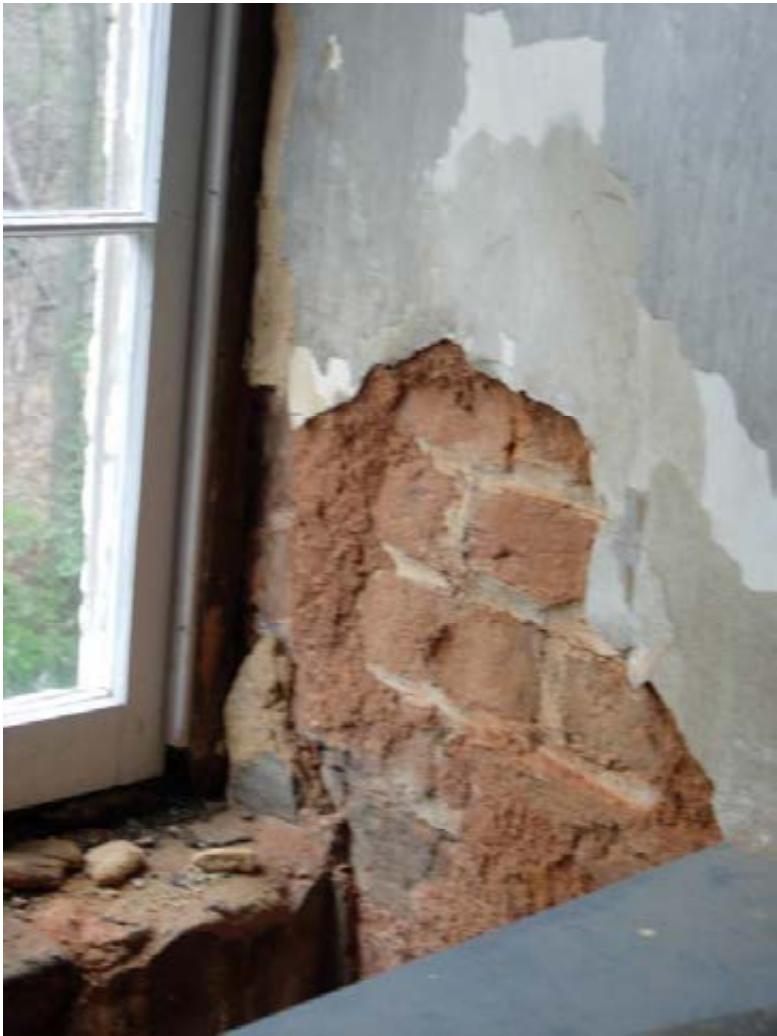
Figure 7-19. Spalling plaster on the fireplace wall in the northwest chamber. Photograph by Kathleen Manicke.

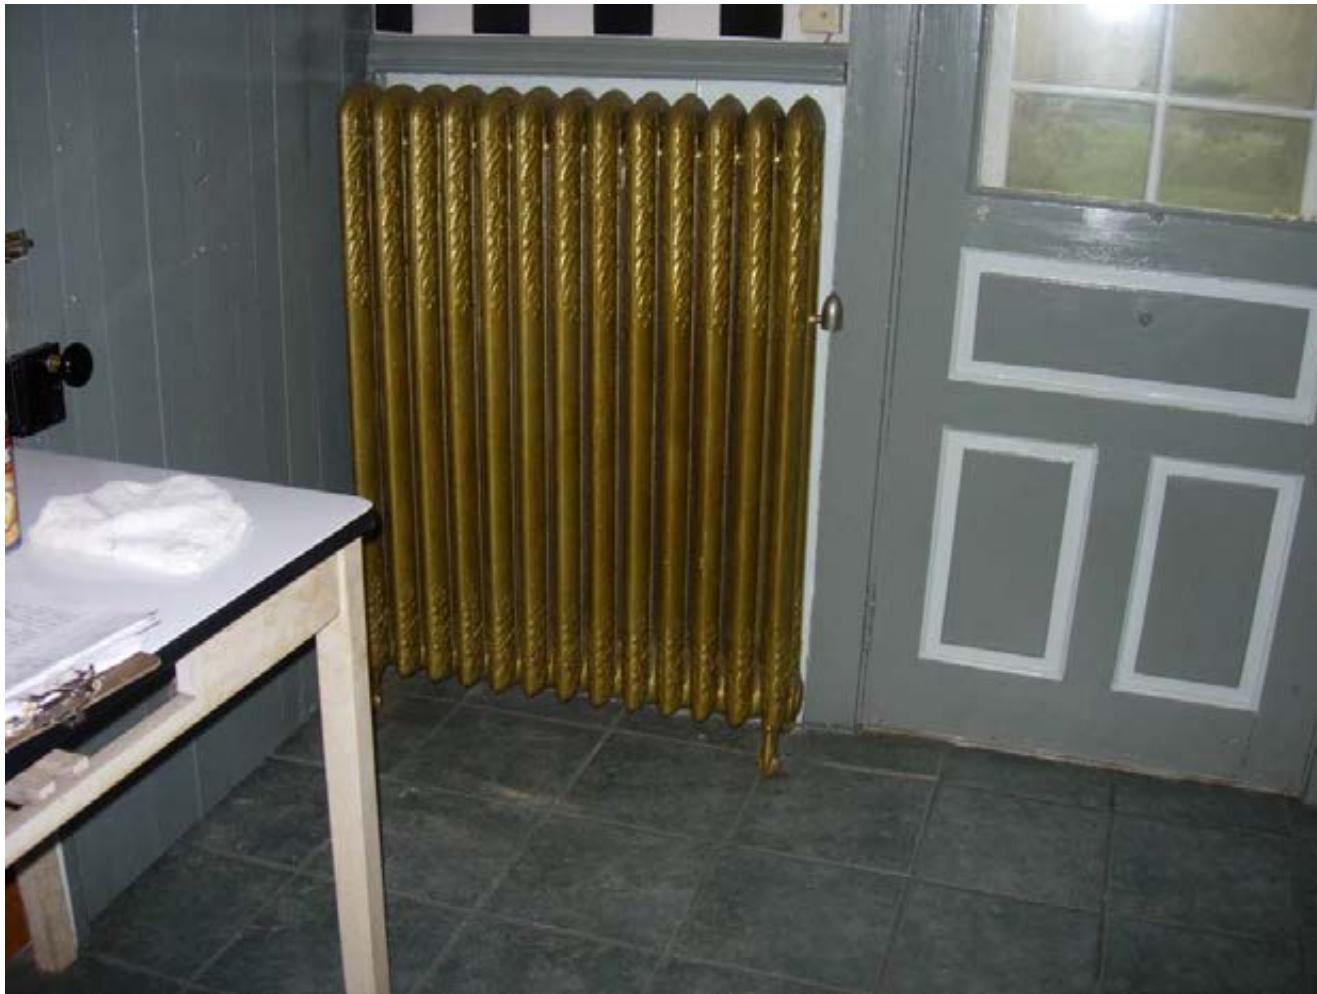
Figure 8-3. The radiator on the first floor in the Stoddert addition. Notice the basement and west wall doors. Photograph by Kathleen Manicke.

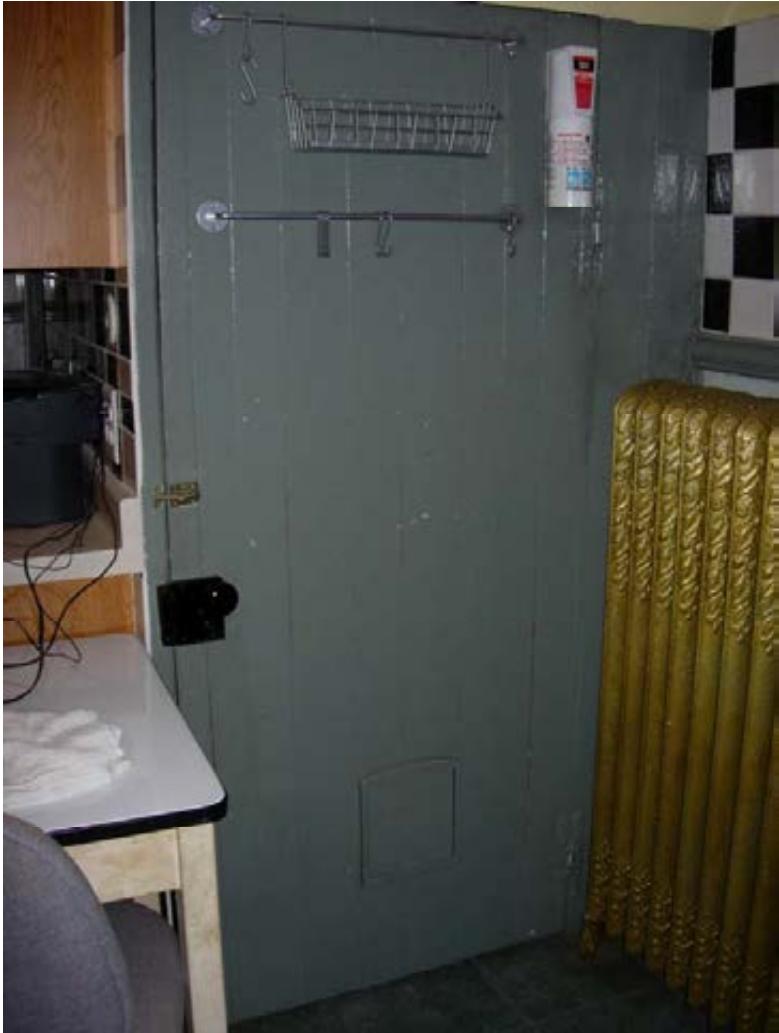
Figure 8-4. The door to the basement from the first floor of the Stoddert addition. Photograph by Kathleen Manicke.

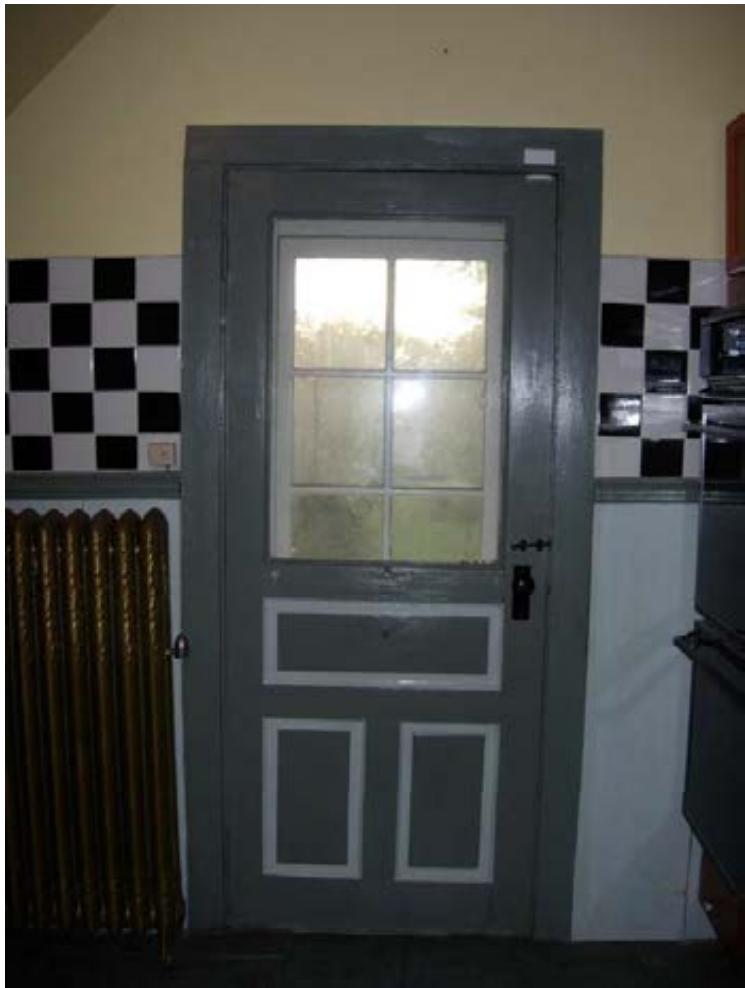
Figure 8-5. The door in the west wall of Bostwick's Stoddert addition. Notice the wainscoting on the wall opposite the radiator.
Photograph by Kathleen Manicke.

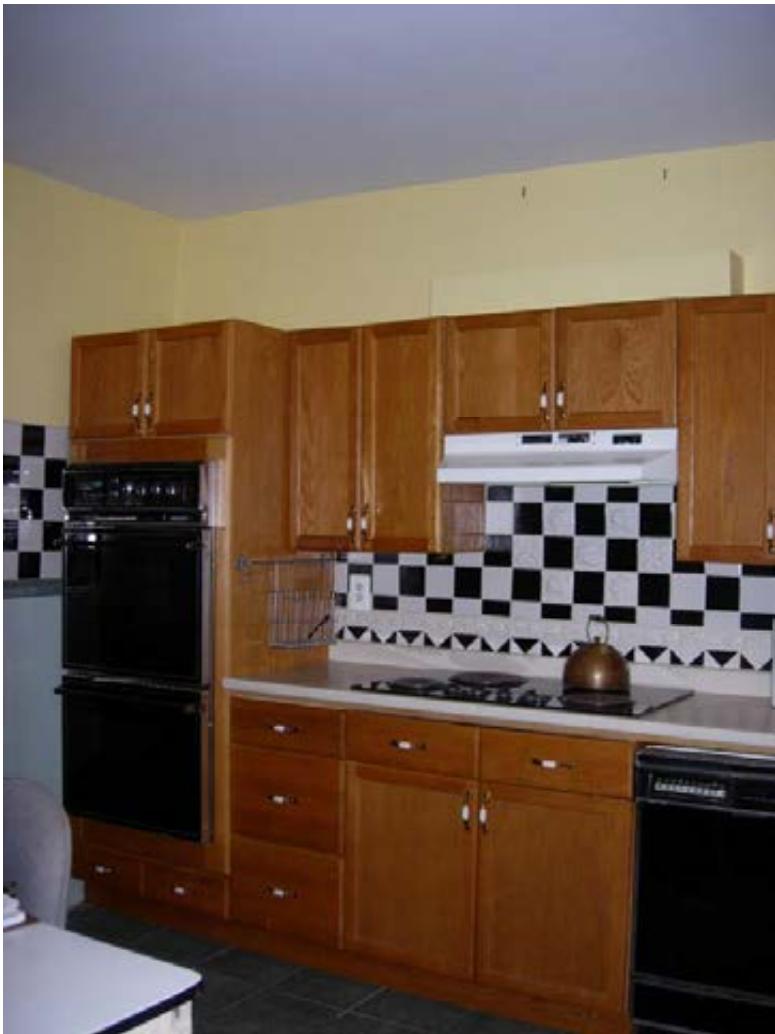
Figure 8-6. The north wall of Bostwick's kitchen as it appeared in June of 2007. Photograph by Kathleen Manicke.

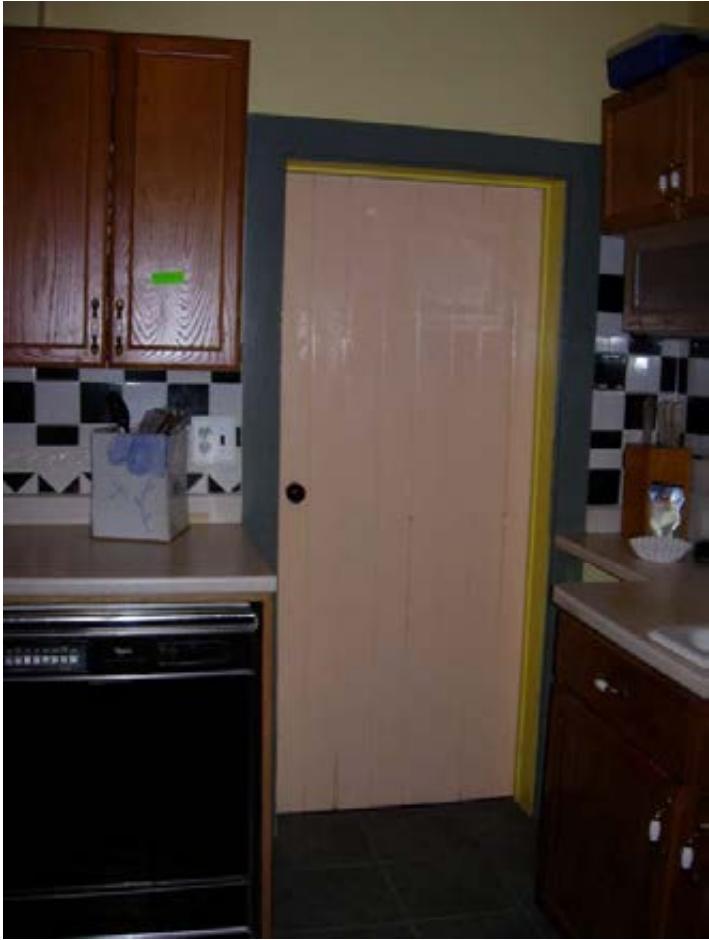
Figure 8-7. The door from the kitchen to the bathroom in Bostwick's Stoddert addition. Photograph by Kathleen Manicke.

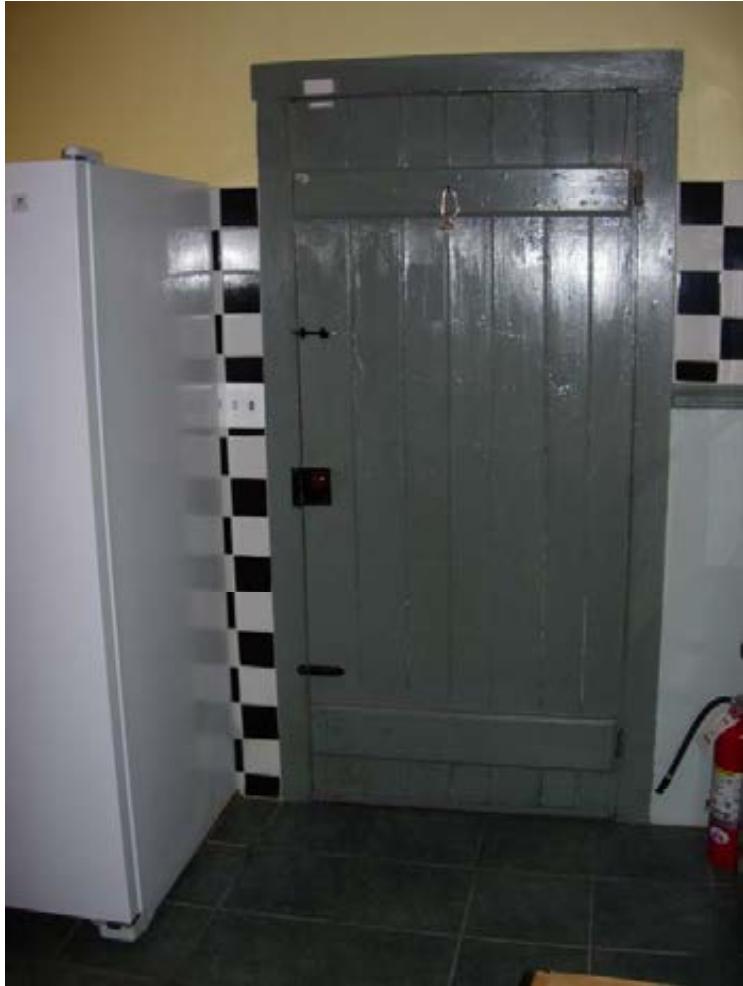
Figure 8-8. Door on the east wall of Bostwick's Stoddert addition. The door leads to the rear-facing porch and back yard.
Photograph by Kathleen Manicke.

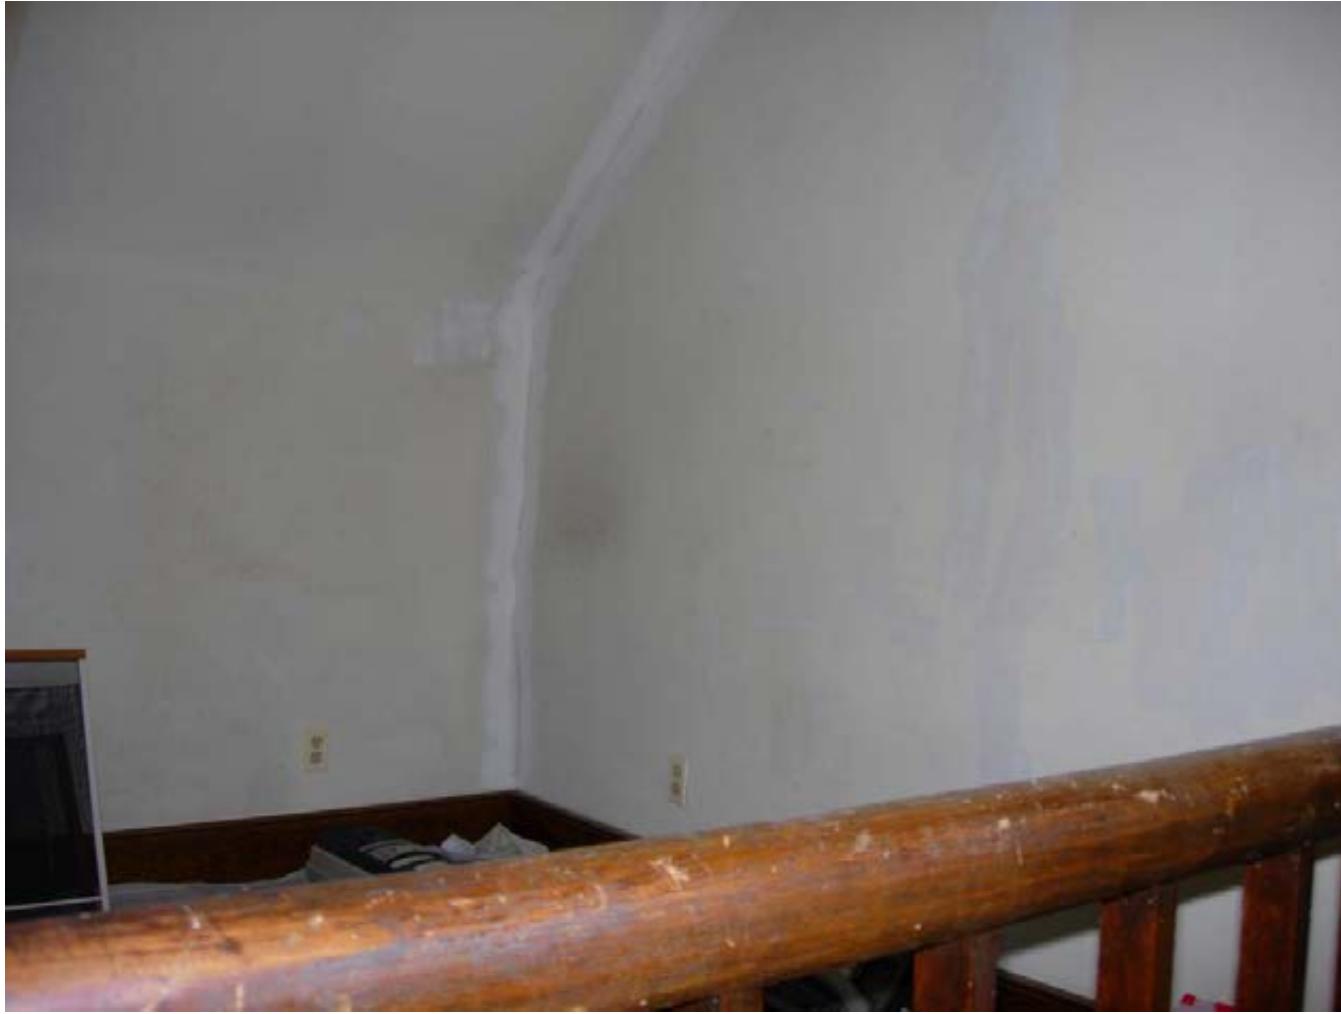
Figure 8-12. The south room of the Stoddert addition viewed from the stair landing area. Photograph by Kathleen Manicke.
